## Compliance Report: Translocation and Monitoring

### Squibbs Road Drainage Improvements and Clayton Drive Reserve Translocation Site, Spreyton, Devonport City Council, EPBC 2017/7956

October 2022

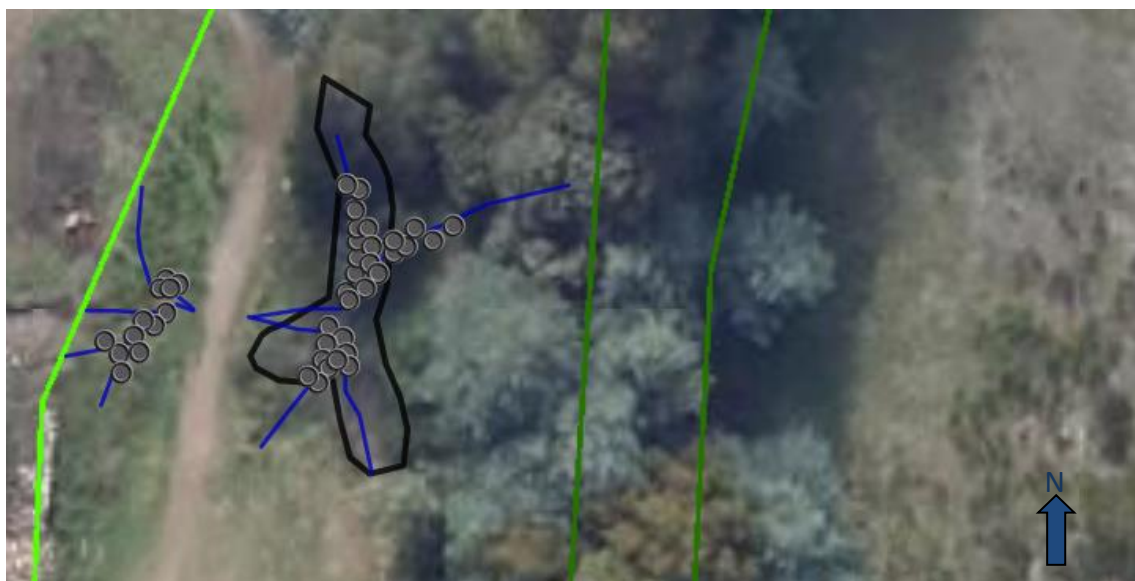
The numbers of burrows have increased beyond the target number of active burrows since the last count and in addition, despite the disturbance caused by the neighbouring landholder, the population is colonizing the western side of the track with many burrows noted along the drainage lines here. Most appeared to be relatively small (approximately 1-2 cm diameter) indicating possible dispersal of younger crayfish from the original translocation population. However, it was also noted that in areas of sediment accumulation resulting from erosion of the slopes following vegetation removal, no burrows were seen, indicating this disturbance is impacting on the colonization of this area by the crayfish. Remedial action through revegetation to the boundary with the neighbour would help stabilize the slope and reduce sedimentation. Figure 1 shows the main areas of burrows in the translocation site. The black outline indicates the approximate boundary of the translocation site, the blue lines show the

**Figure 1. Translocation site in black showing main active burrow areas along drainage lines.**

drainage lines while the gray dots are the main burrow clusters. Figure 3 shows active burrows.

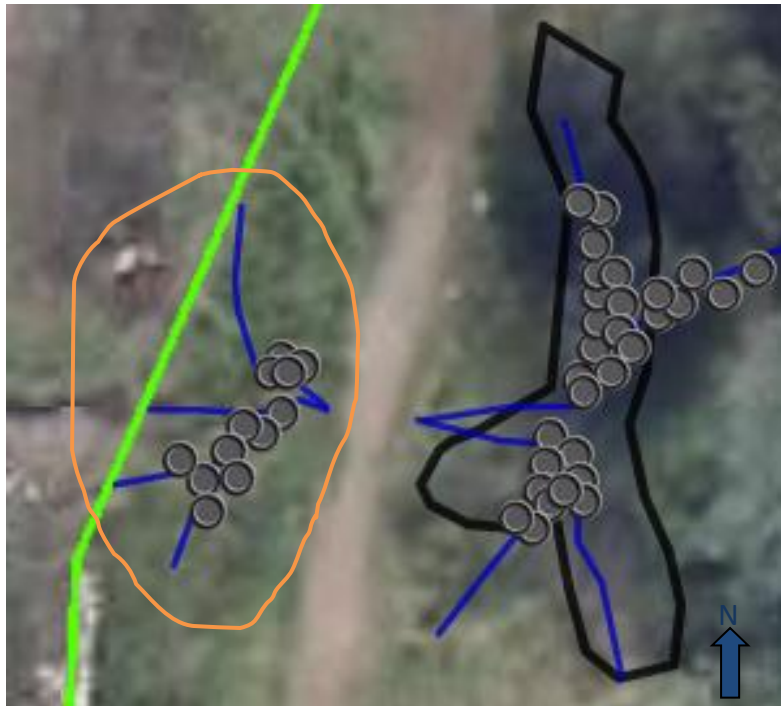
On the western side of the track, amongst the native reeds and rushes (*Carex* and *Juncus* spp), the burrowing crayfish are colonizing (Figure 2). In areas of disturbance and sedimentation the crayfish are absent or in low numbers only. This extension of the CNBC population indicates the translocation population is breeding and dispersal is occurring (Figure 4).

**Figure 3. In the swampy land to the west of the track (shown in orange) and opposite the translocation site, burrowing crayfish are colonising areas free of sediment**

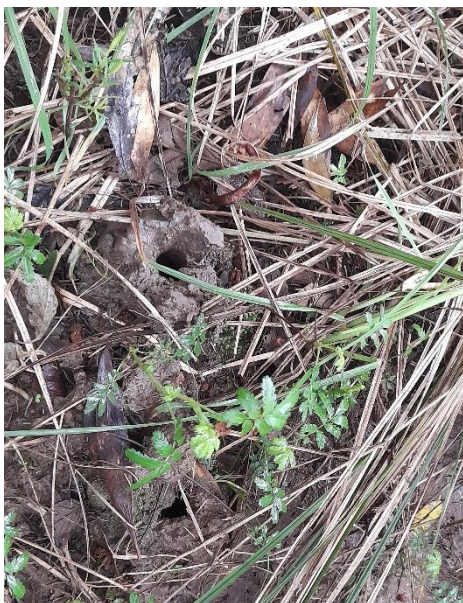
**Figure 4. Central north burrowing crayfish activity under swamp paperbark in translocation area.**

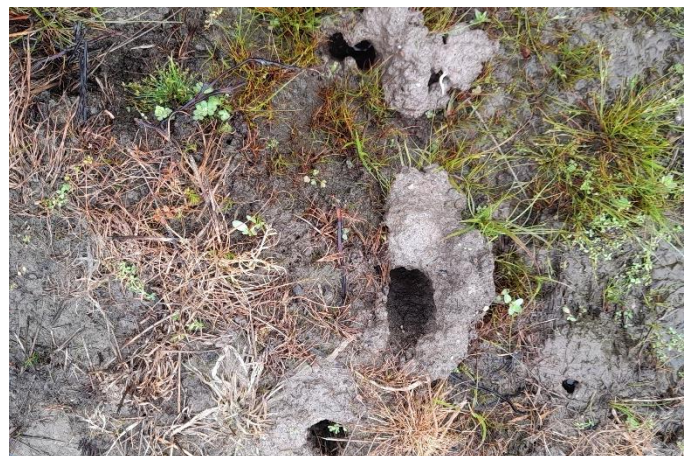
**Figure 2. Crayfish activity in swampy area opposite translocation site**

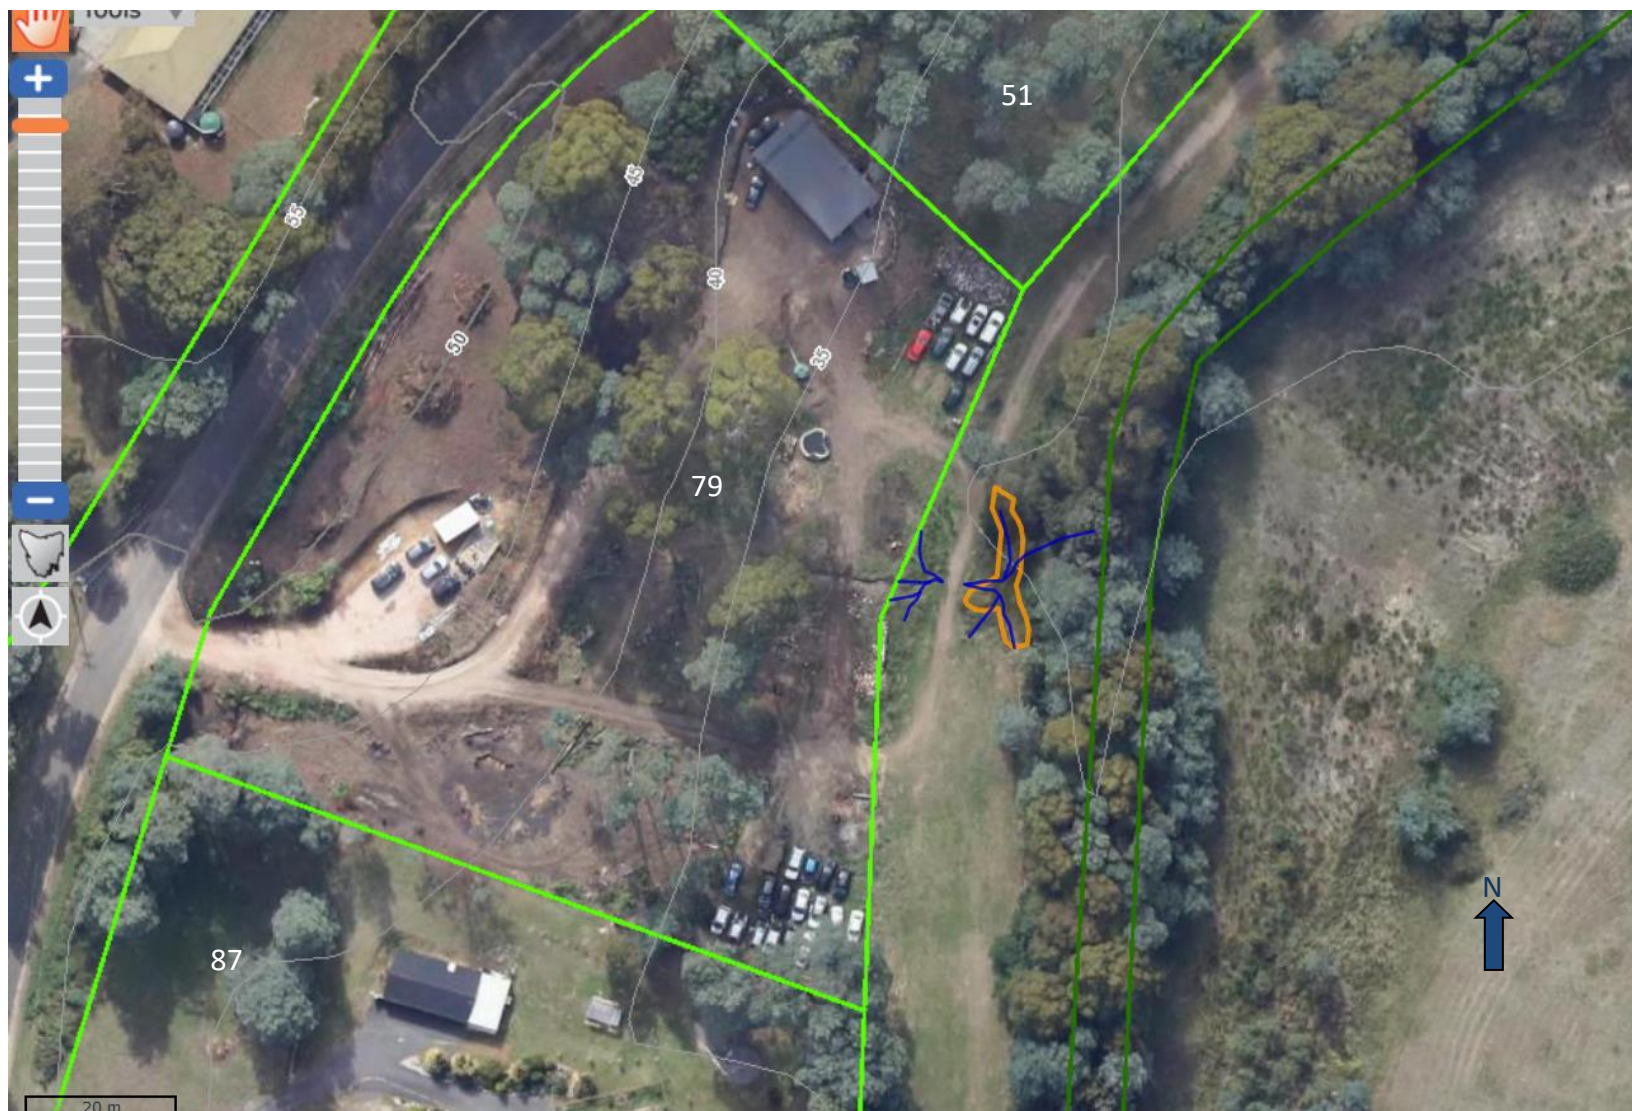
The vegetation clearance and earthmoving on the neighbouring land and extending into the Reserve, as reported as an *Incident* in the 2020 Compliance Report, continues to contribute to erosion and sedimentation within the drainage lines running through the translocation site. Despite this, the CNBC are extending their area of colonization. There is a drop in elevation of approximately 25m over a distance of 80 m from Clayton Drive to the base of the slope on the western edge of the track at the translocation site. A comparison of the site surrounds between November 2021 and February 2020 is shown in Figures 5 and 6 respectively.

**Figure 5. Translocation site taken approximately November 2021, showing the property boundaries and extent of vegetation clearance at 79 Clayton Drive, and resultant exposed soils above the translocation site (Map source ListMap).**

Revegetation with *Melaleuca ericifolia* within the disturbed area would stabilize the slope and protect the CNBC from further erosion and sedimentation.

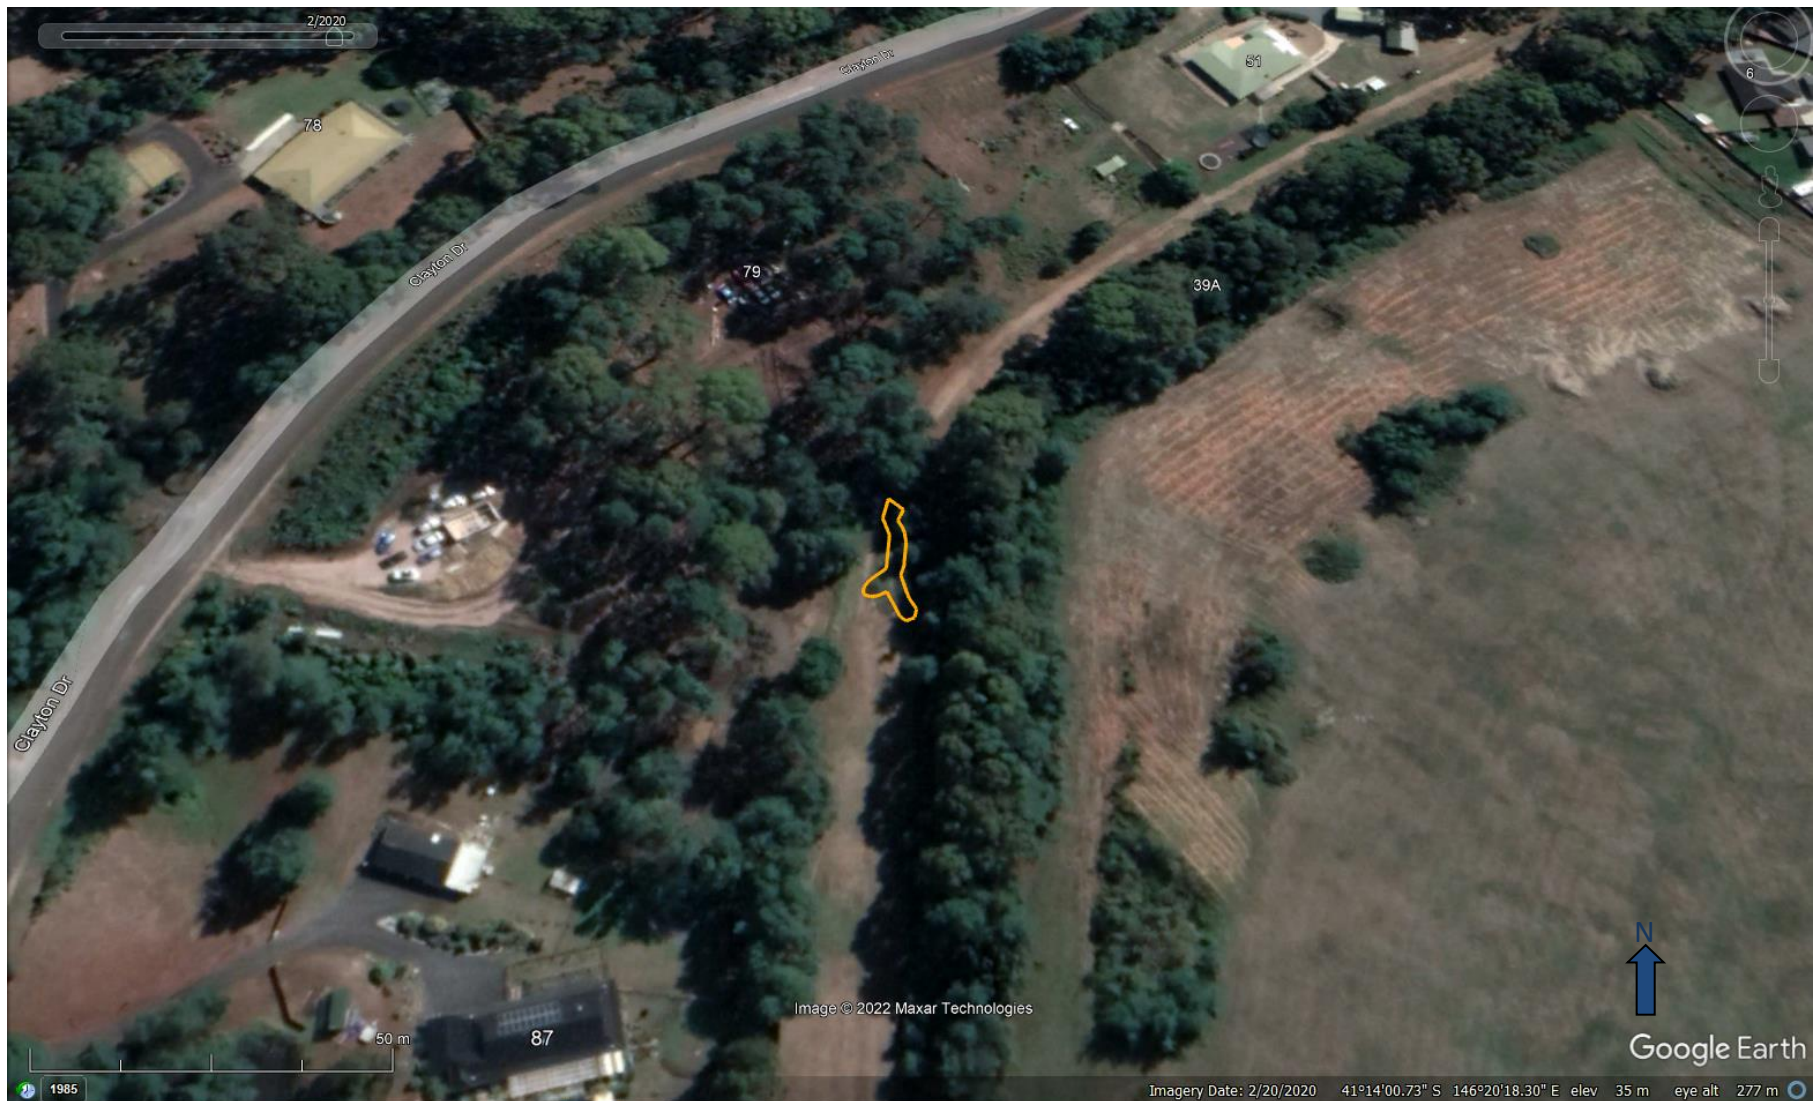
Figure 6. Translocation site taken approximately February 2020, showing the extent of the preclearance vegetation above the translocation site (Map source GoogleMap.

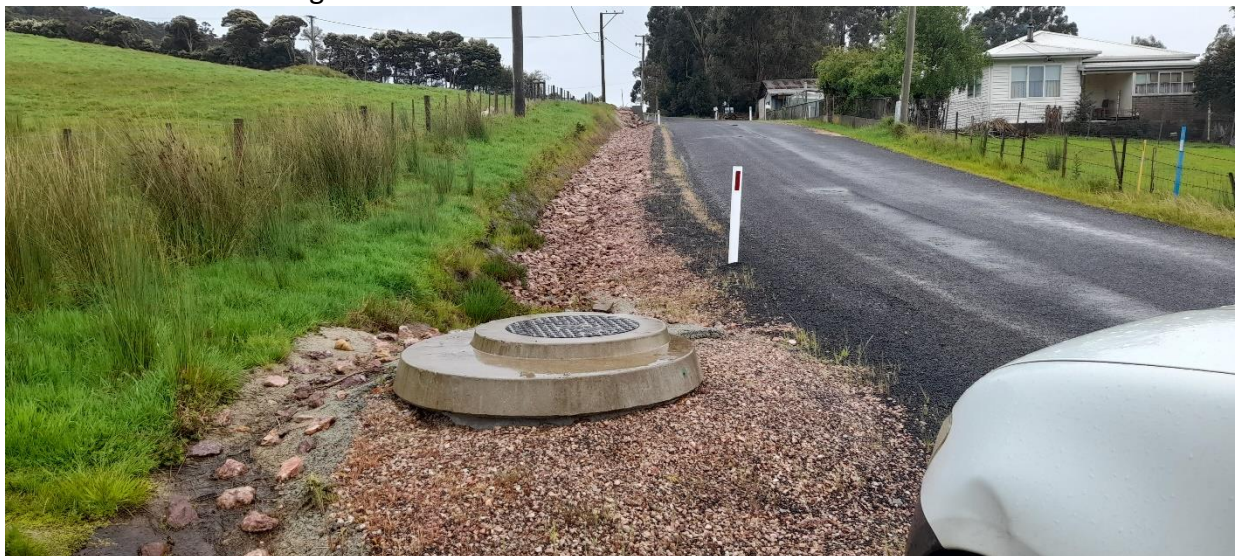
The rock work within the works area drain is well bedded down and appears to be working efficiently to slow water flow and prevent erosion (Figure 7). No recent sedimentation or erosion was noted along this area.

Figure 7. Completed drainage works on Squibbs Rd showing no signs of erosion following recent high rainfall events

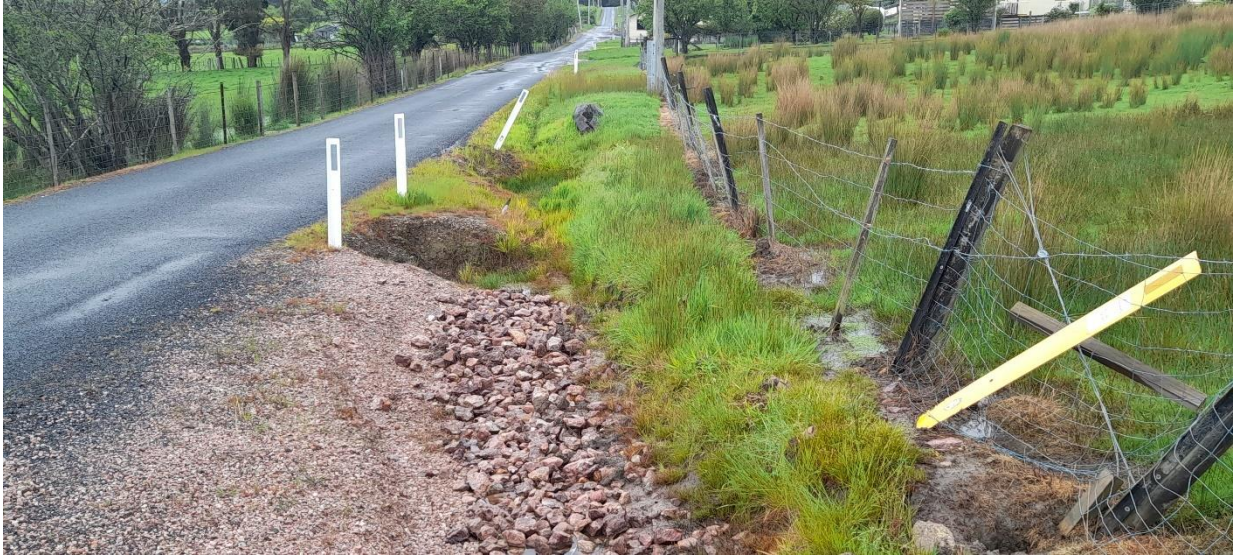
**Figure 8. The southern end of the drainage works on Squibbs Rd shows the reeds in the adjacent swampy paddock and extending along drain providing habitat for the CNBC**

Due to the recent rains, the water table was high and there was surface water flowing across the swampy area above the existing drain. This can be seen in Figure 8 above.

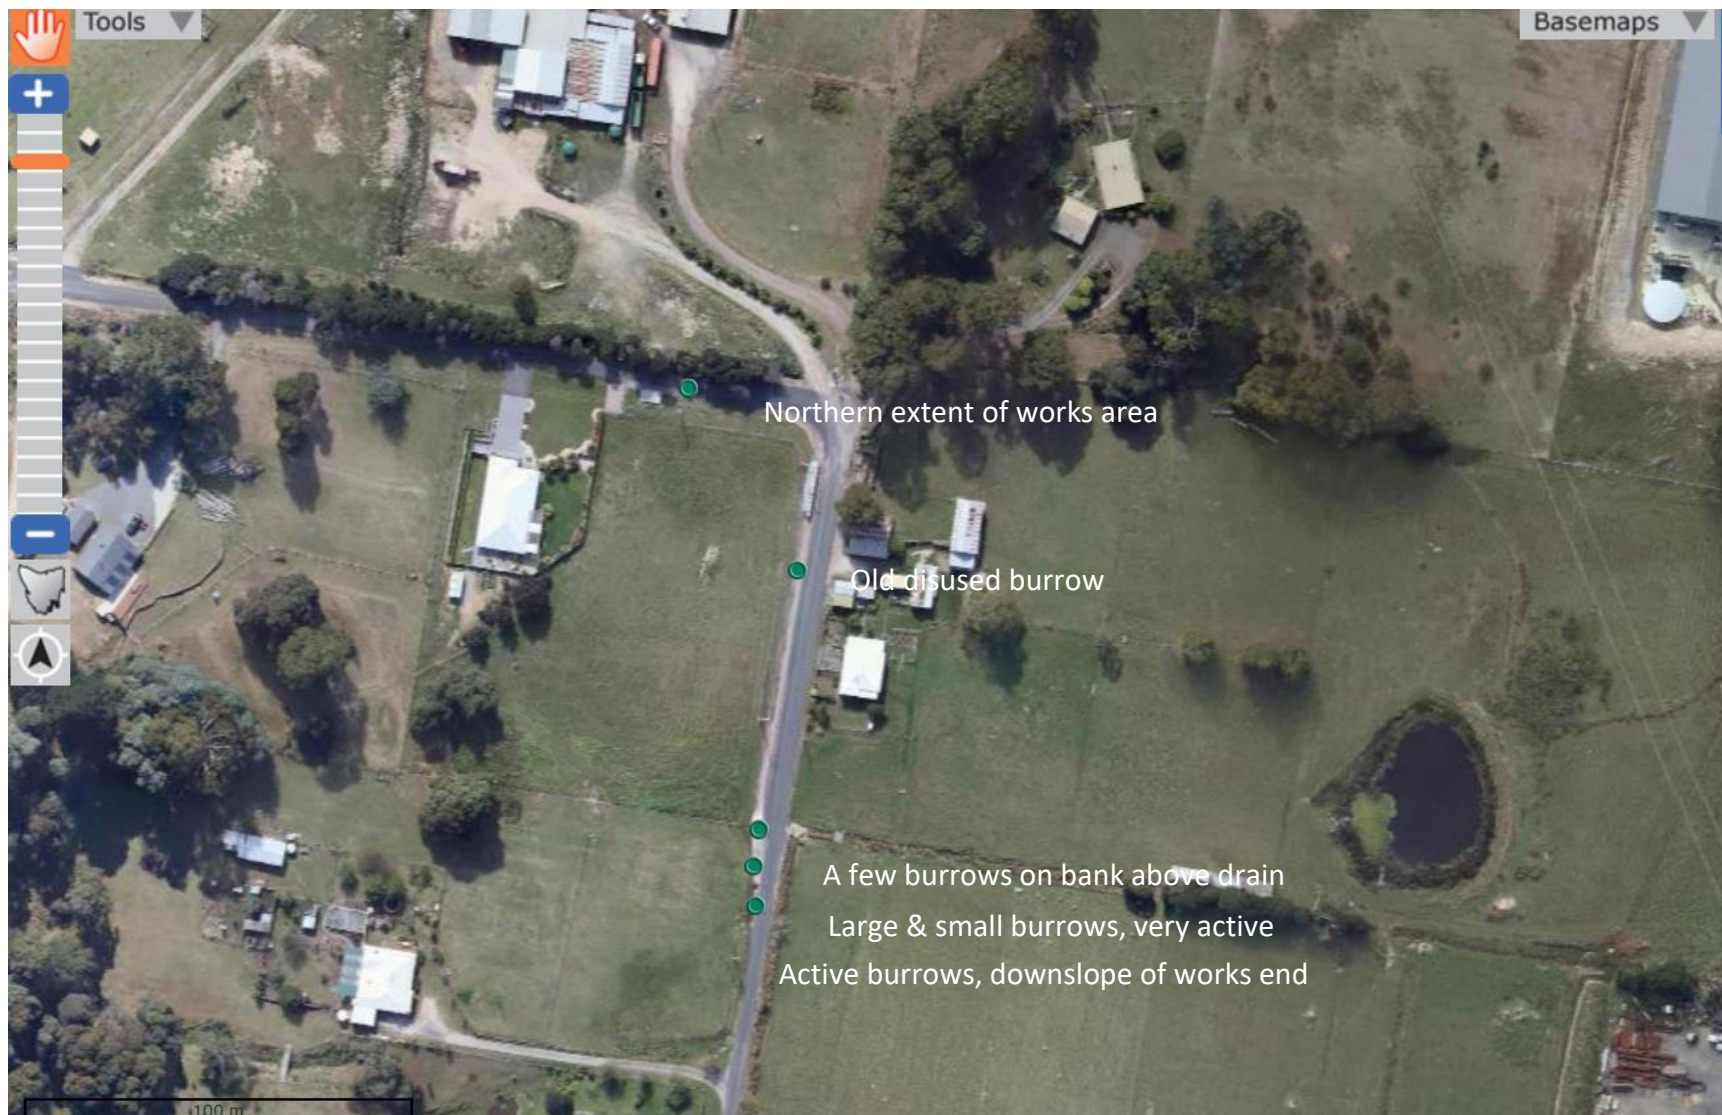
At the southern end of the works area, within the existing drain and on the flat swampy area above, the CNBC are very active. There are many burrows of varying sizes indicating a healthy breeding population (Figure 8). At the top of the bank reeds *Juncus* sp. grow amongst the pasture species improving the habitat for the CNBC. Figure 9 shows the points where burrowing crayfish are active.

**Figure 9. Squibbs Rd drainage works area. Showing points extent of drainage works and burrowing crayfish activity**

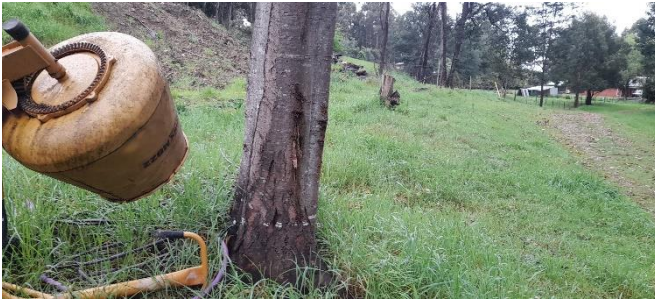
Figure 10. Photopoint 1, North, showing steep cleared bank

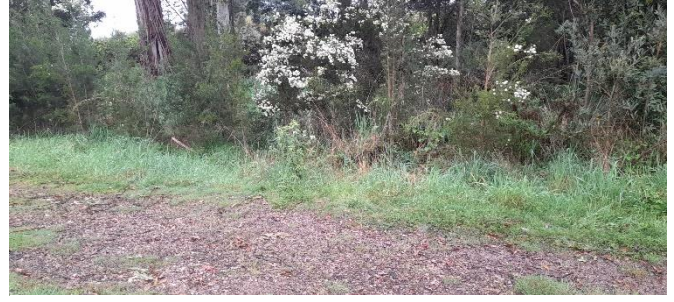
Figure 11. Photopoint 1, East, towards the creek buffer and revegetation area

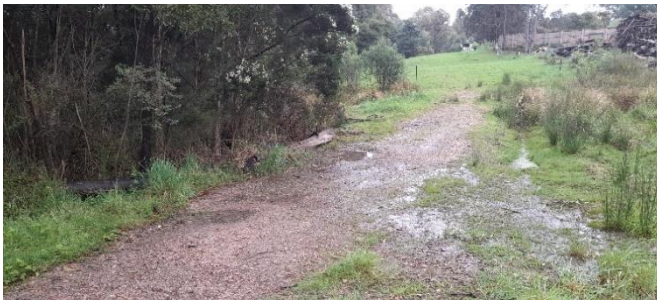
Figure 12. Photopoint 1, South towards the translocation site

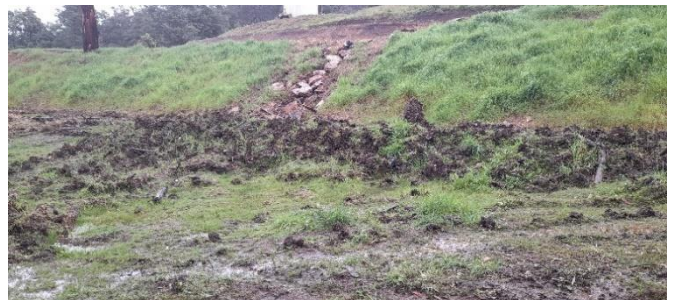
Figure 13. Photopoint 1, West towards the cleared bank and disturbed soils adjacent to translocation site

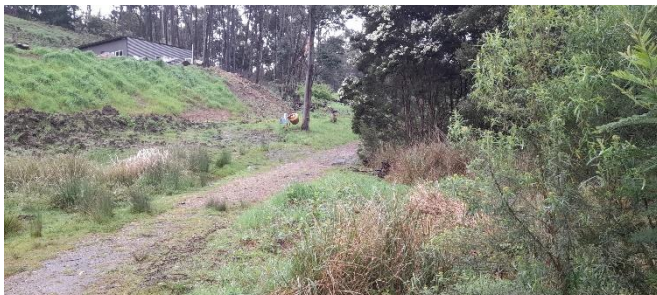
Figure 14. Photopoint 2, North, towards Pp1, showing the cleared slope above

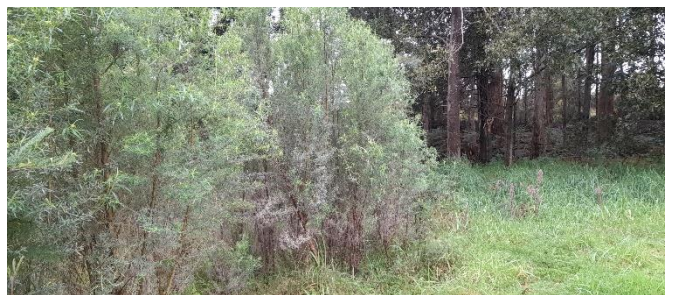
Figure 15. Photopoint 2, East towards creek and southern end of translocation site

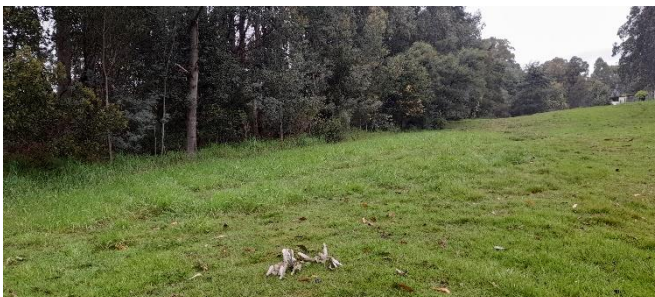
Figure 16. Photopoint 2, South, beyond translocation area

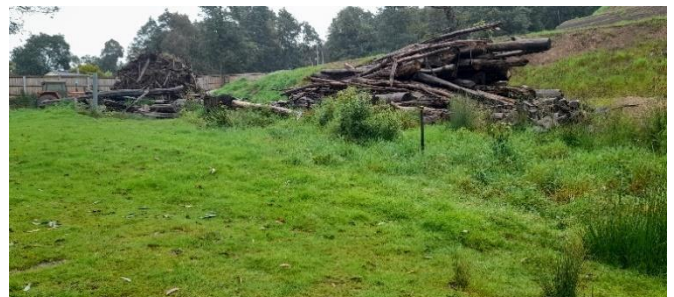
Figure 17. Photopoint 2, West towards Pp3 and new natural colonisation area

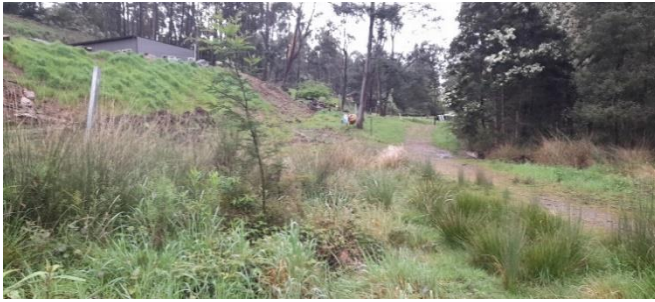
**Figure 18. Photopoint 3, North towards Pp1, across new natural colonisation area**

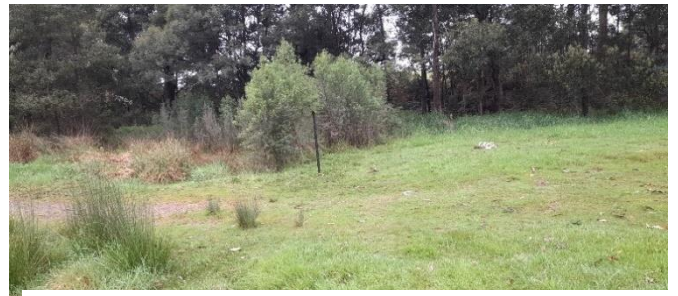
**Figure 19. Photopoint 3, East over translocation site and Pp2**

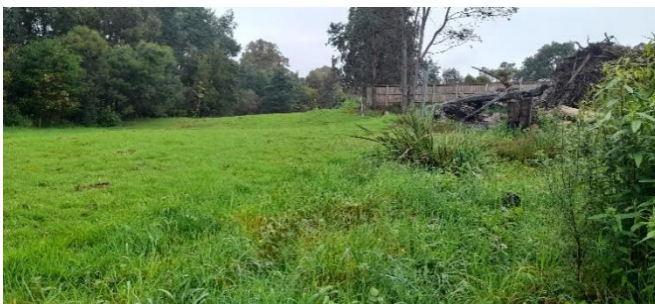
**Figure 20. Photopoint 3, South on edge of disturbed area on property boundary**

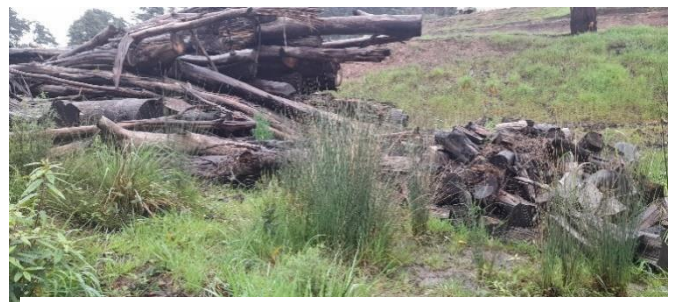
**Figure 21. Photopoint 3, West over the disturbed area and log piles left after vegetation clearance.**

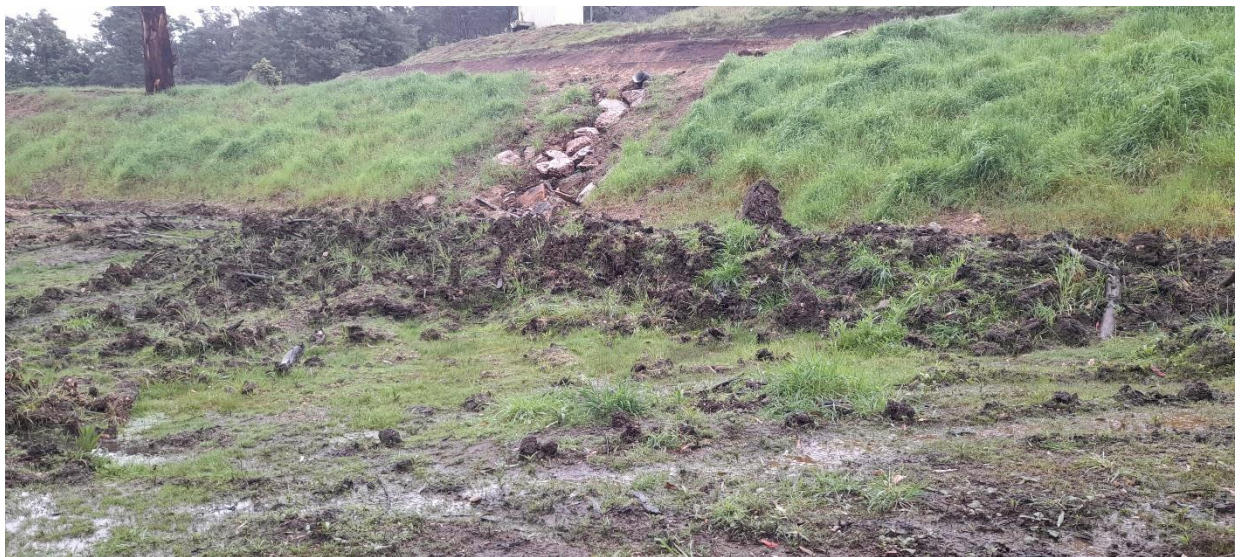
The 2020 Translocation and Monitoring Report reported as *Incident* consistent with Condition 17 of the EPBC 2017/7956 documentation. The burrowing crayfish appear to be recolonizing on the western side of the access track which was impacted by earthworks and removal of trees on the adjoining property, however following rain events there has been substantial erosion of the slope and resultant sedimentation into the drainage line running from the neighbouring property and through the track culvert into the translocation area. There was no visible crayfish activity in these heavily sedimented areas. Images in Appendix E.

**Figure 22. Current state of the adjoining land showing some work to reduce erosion on bank.**

To stabilize the area where the neighbouring landholder has removed vegetation and pushed fill downslope, it is recommended that revegetation be conducted. Planting moisture loving trees/shrubs such as the *Melaleuca ericifolia* in this area will not only stabilise the stream edges but create a more natural habitat for the burrowing crayfish that is commonly found in the local swamp paperbark communities. It would also assist in controlling the exotic grasses through shading, while allowing growth of the native sedges and rushes. Nearby there is also the weed Caper Spurge *Euphorbia lathyris* which is toxic and capable of spreading and should be controlled.

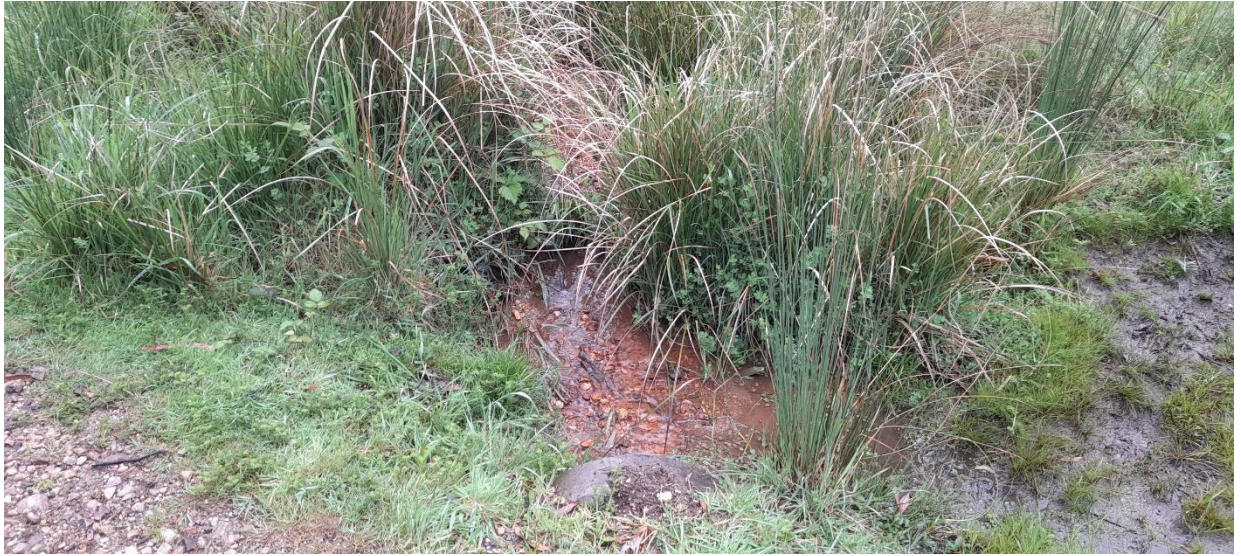
**Figure 24. Gravel and sediments at the Reserve culvert, run-off from up-slope erosion**

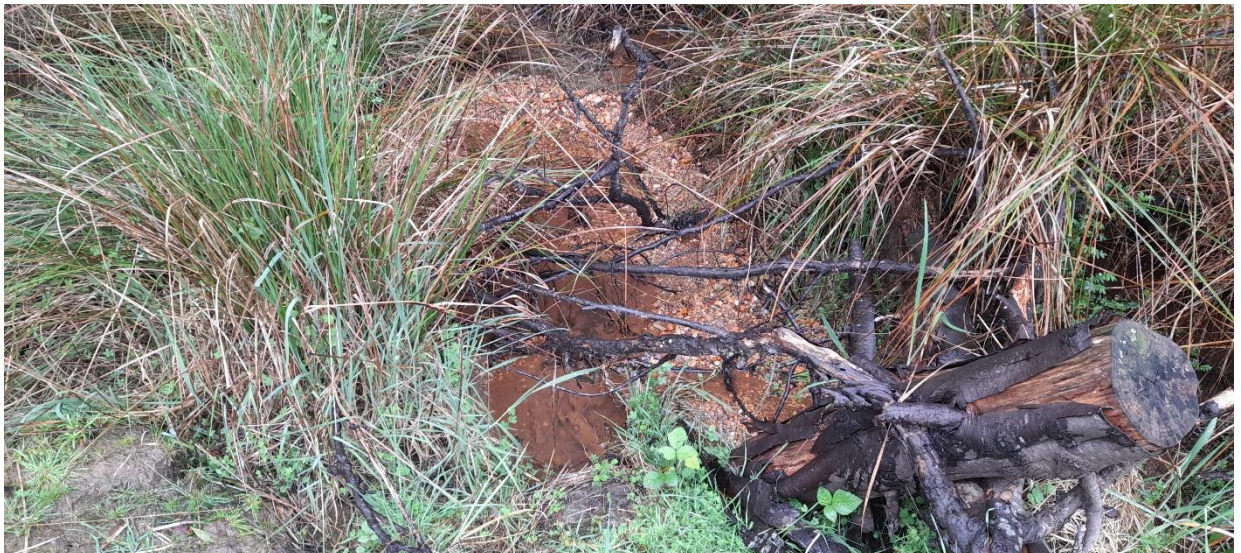
**Figure 23. Downstream side of culvert with the accumulated sediments and gravel**
