# **CLAYTON DRIVE RESERVE, SPREYTON DEVONPORT CITY COUNCIL**

***ENGAEUS GRANULATUS* MONITORING PLAN  
JUNE 2017**

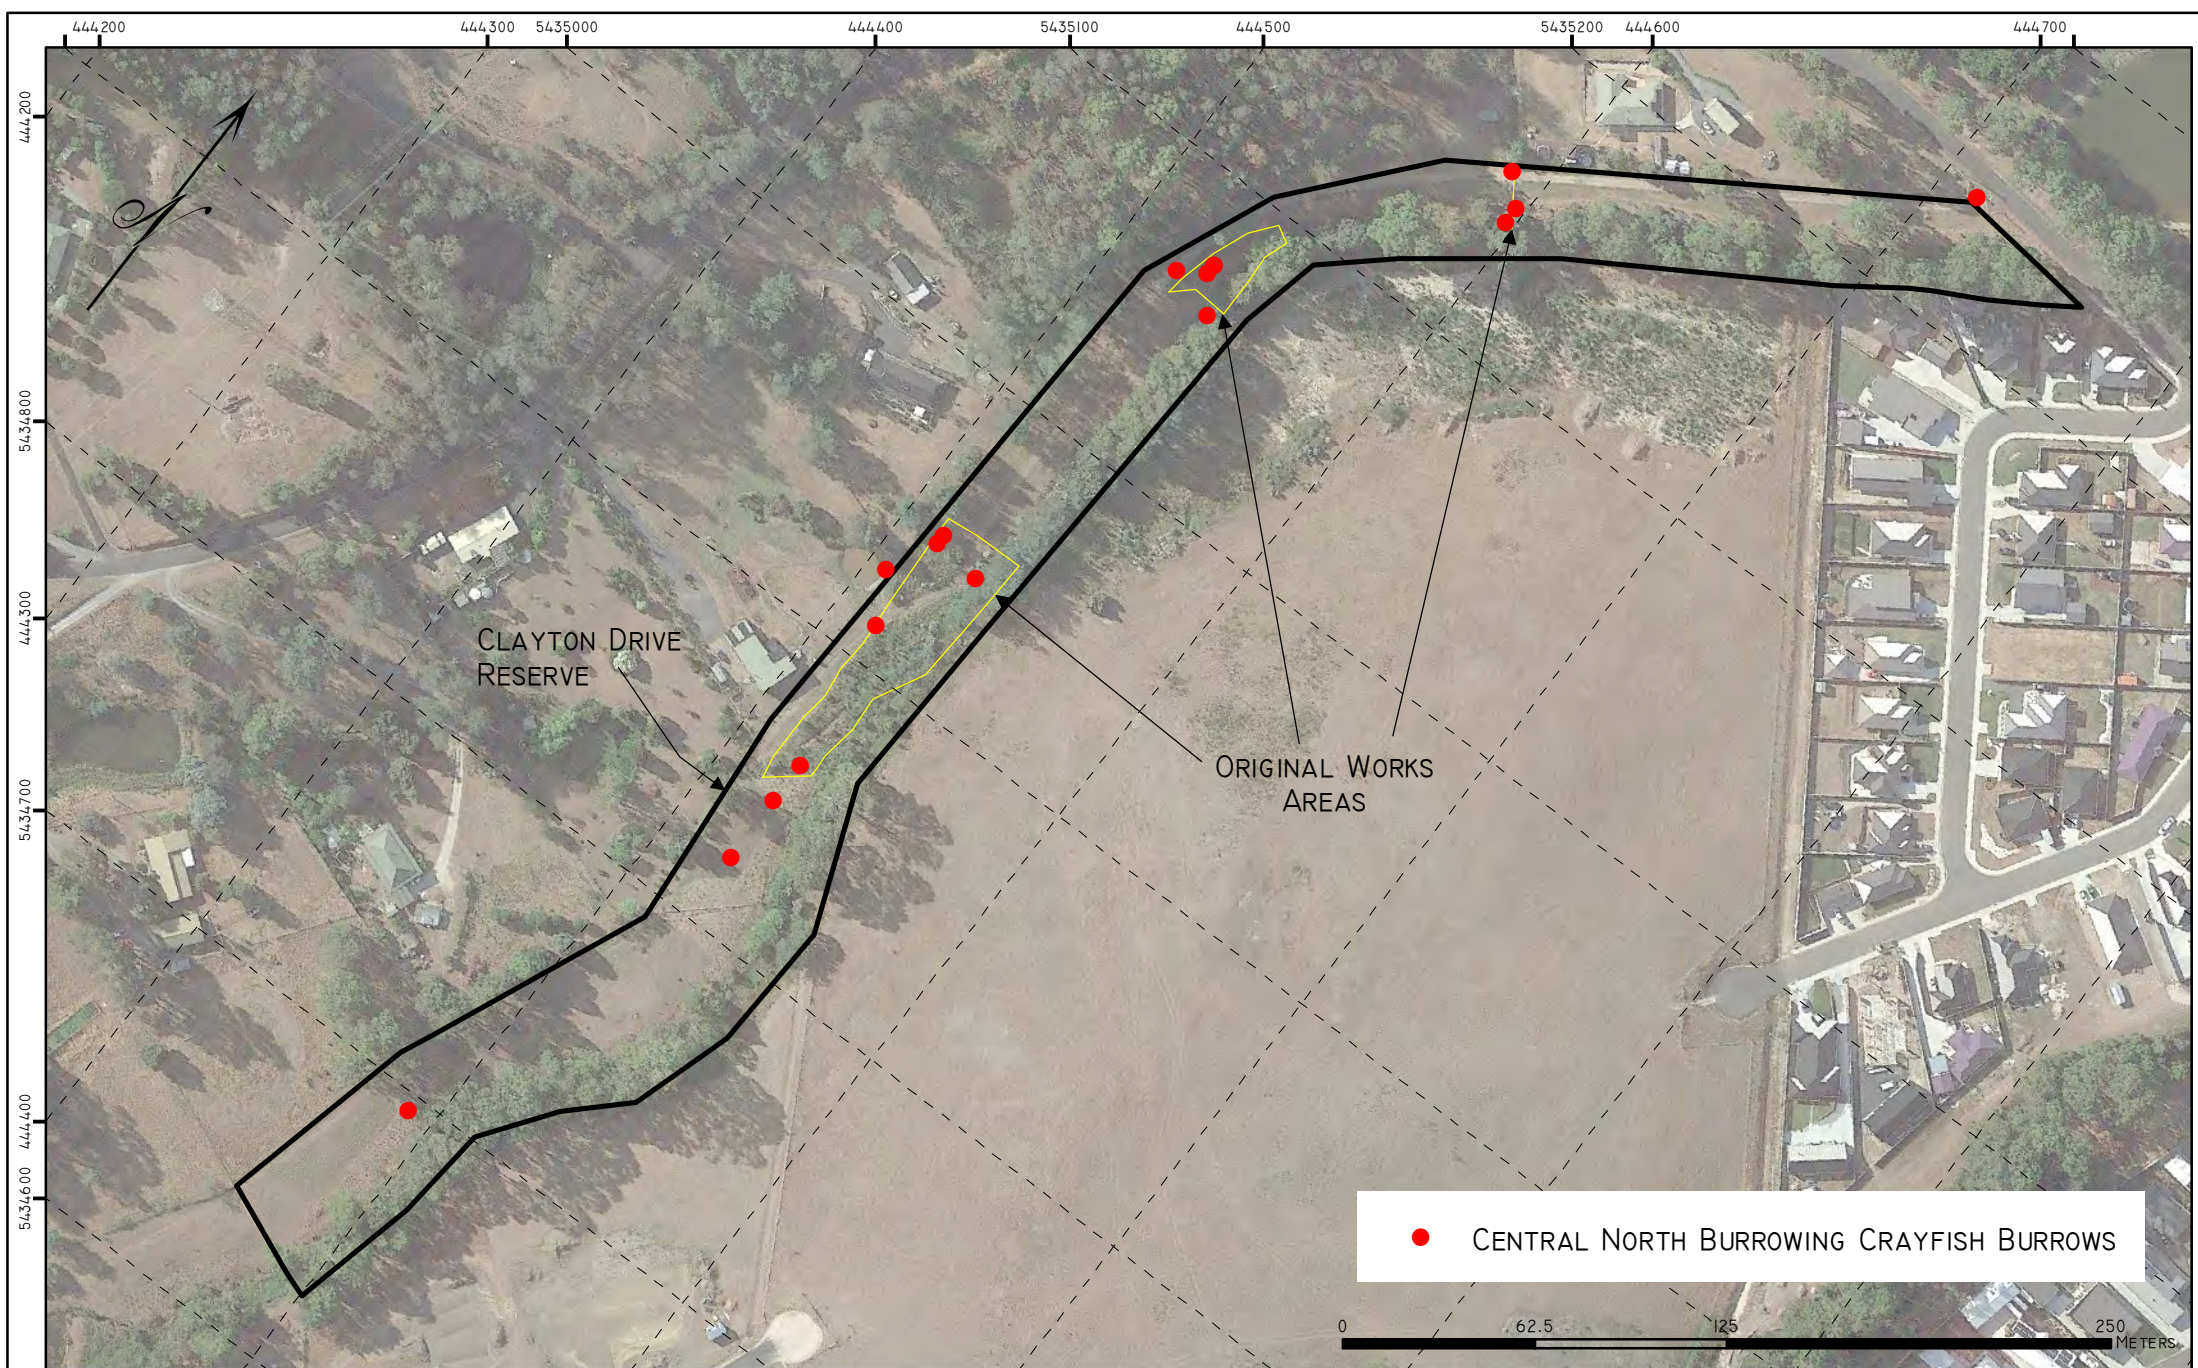
FIGURE 3: CENTRAL NORTH BURROWING CRAYFISH BURROWS (OBSERVED JUNE 2017)

Figure 2 shows the areas where burrows were located during the searching, which shows that *Engaeus* are widespread across the site which is comparable to the results from the previous annual monitoring event.

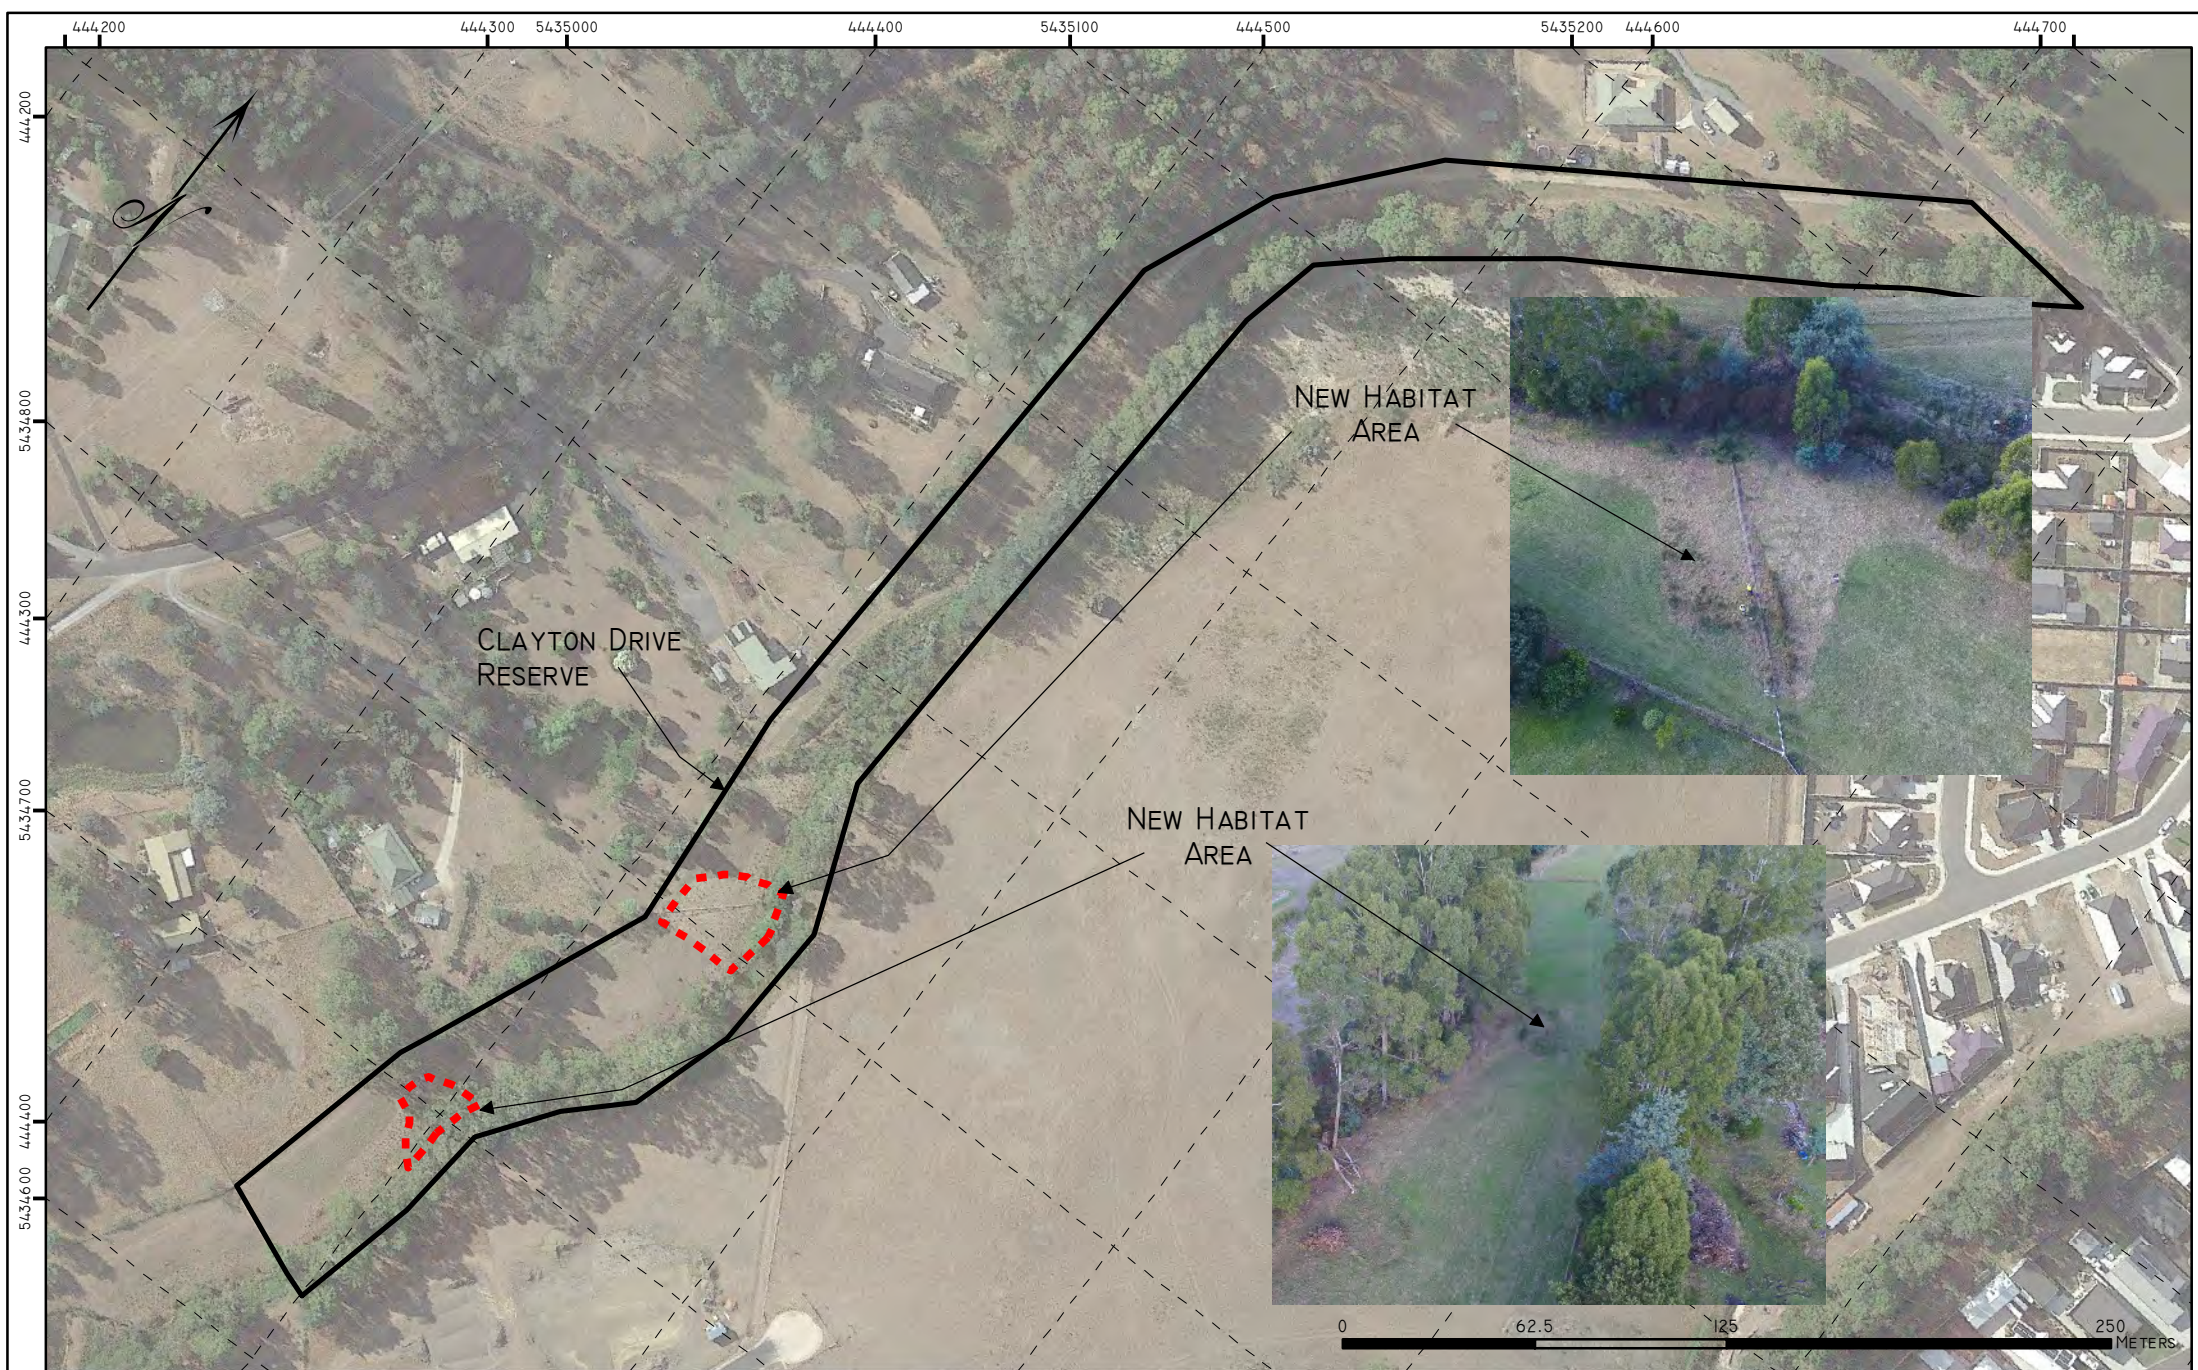
FIGURE 4: NEW CENTRAL NORTH BURROWING CRAYFISH HABITAT AREAS  
(AREAS WHERE ANIMALS WERE NOT RELEASED BUT HAVE APPEARED SINCE 2016)

Figure 4 shows the two areas where *Engaeus* were observed to have colonised in June 2016, and they are still present in June 2017 – no animals were translocated to these areas, and none were present in these areas when the project commenced. It is recommended that the two areas ('new habitat area') identified in Figure 4 be physically identified on-ground (eg using wooden stakes with blue tape, comparable to other areas identified in this way) and left undisturbed from mechanical activities including slashing, mowing etc.

The two areas identified in May 2016 as now containing *Engaeus* (see Figure 4) should be physically identified on-ground (eg using wooden stakes with blue tape, comparable to other areas identified in this way) and be left undisturbed from mechanical activities including slashing, mowing etc. These areas could (optional) be planted with sedges and sagg to encourage further colonisation by *Engaeus*.

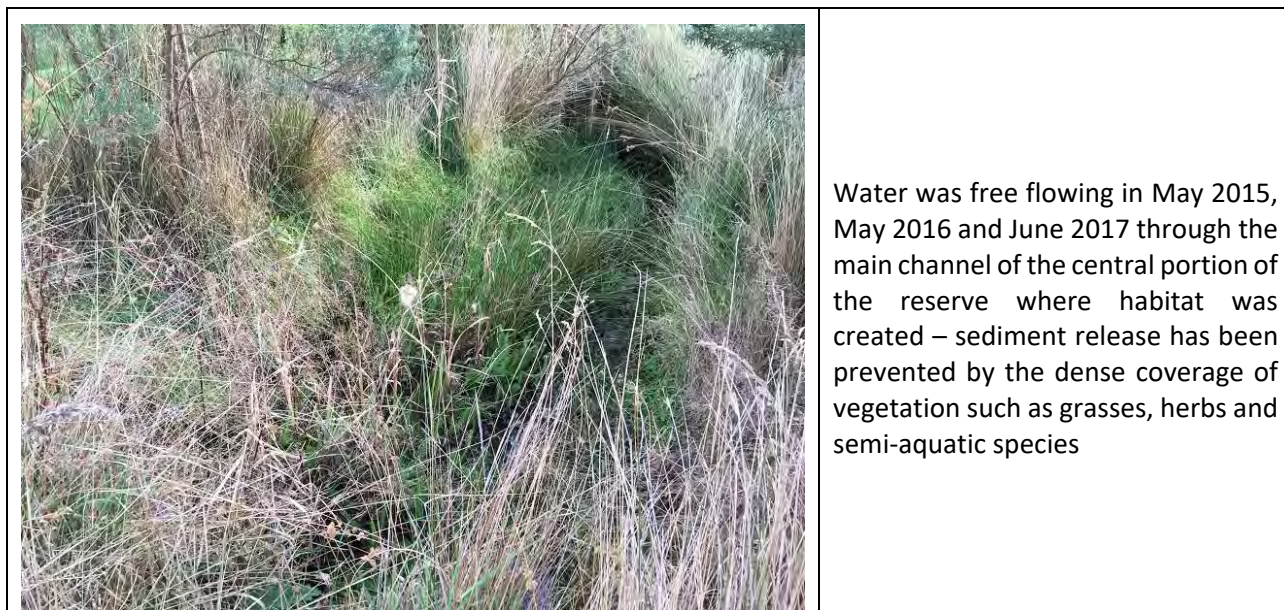
Water is ponding in the deepest parts of the drainage system which supports aquatic species such as water milfoil (*Myriophyllum*)

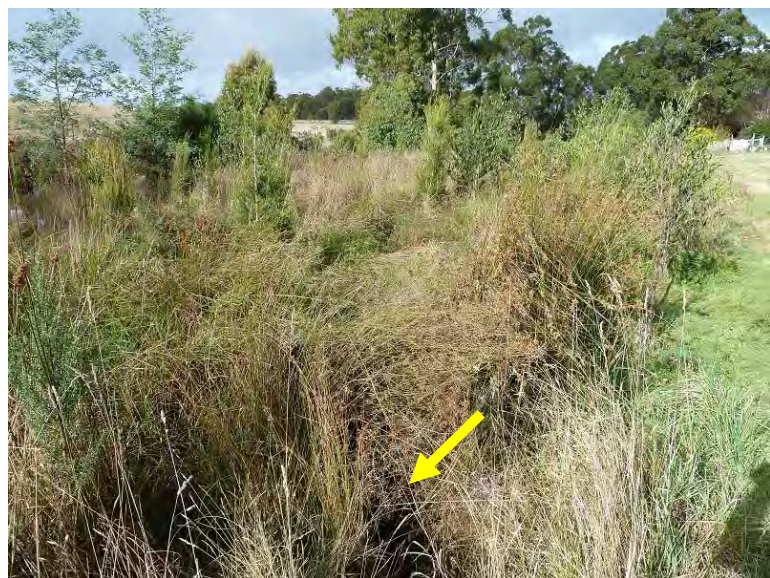
#### May 2015

The sedges and rushes that have grown in the areas of created habitat provide shelter for bandicoots and other wildlife – several 'runs' are present through these areas (see arrow in adjacent image)

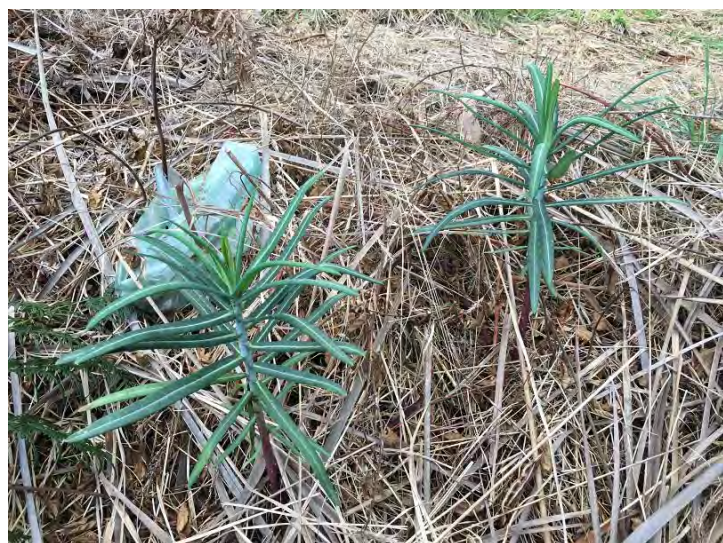
#### Spurge

The poisonous weed spurge (*Euphorbia* species) was observed in areas where the existing vegetative cover had been lost due to spraying. This is a very opportunistic species which can colonise areas of disturbed ground very quickly.

These plants should be pulled out whilst wearing gloves as the sap (white) of the plant can be toxic. Hands and clothing should be thoroughly washed afterwards or throw-away overalls used.

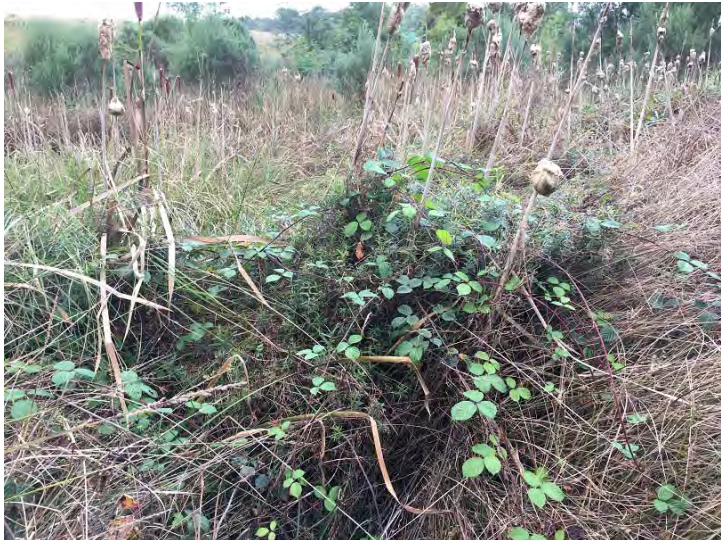
<p><b>Blackberry</b></p> <p>Vines and small thickets of this woody weed occur mainly on the edge of rehabilitated areas and fencelines to the west of the reserve.</p> <p>Care should be taken when spraying this weed such that other, desirable plants are not impacted upon. There were several areas observed where native species (eg <i>Carex appressa</i> and <i>Juncus pauciflorus</i>) had been sprayed and were consequently dead or unhealthy.</p> <p>Cutting and pasting blackberry stems, while time consuming, can minimise secondary impacts to surrounding vegetation.</p>

A weed spraying program should be done in spring 2017 to further target thistles and blackberry – care must be exercised when spraying blackberry such that **only** the target plant is sprayed. Blackberry should mainly be sprayed along the edge of the rehabilitated areas where there are high light conditions for their growth and the fencelines along the western boundary. Neighbours should first be advised that the spraying is going to occur such that they are aware of the use of herbicides along the boundary line.

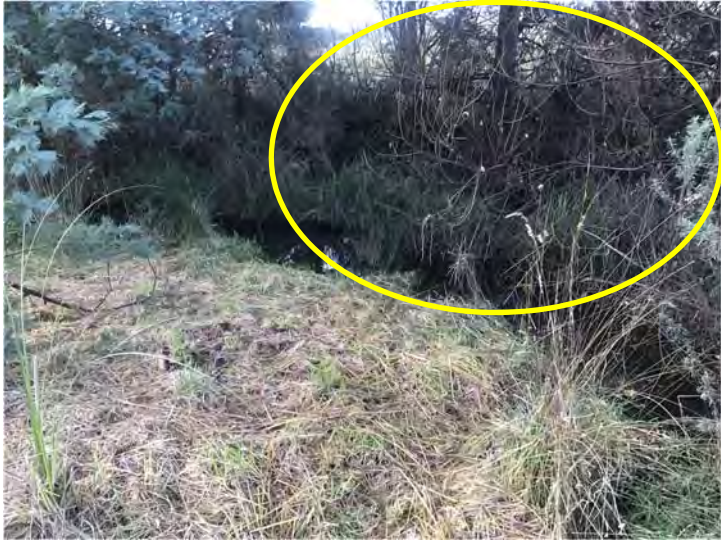
<p><b>Willow</b></p> <p>A few willow occur on the creekline near the major area of rehabilitation works for <i>Engaeus</i>. These should be removed.</p> <p>Cutting and pasting the stem is the most effective way of treating willow. It is important to not allow any small fragments of stem or branches to become liberated in the stream as they may establish as new plants further downstream.</p>

There are several willows in the creekline, especially near areas of habitat created for *Engaeus*. It is recommended that these be removed via a cut and paste herbicide technique.
