CLAYTON DRIVE RESERVE, SPREYTON DEVONPORT CITY COUNCIL

***ENGAEUS GRANULATUS* MONITORING PLAN JULY 2018**

CLAYTON DRIVE RESERVE - MONITORING REPORT 2018

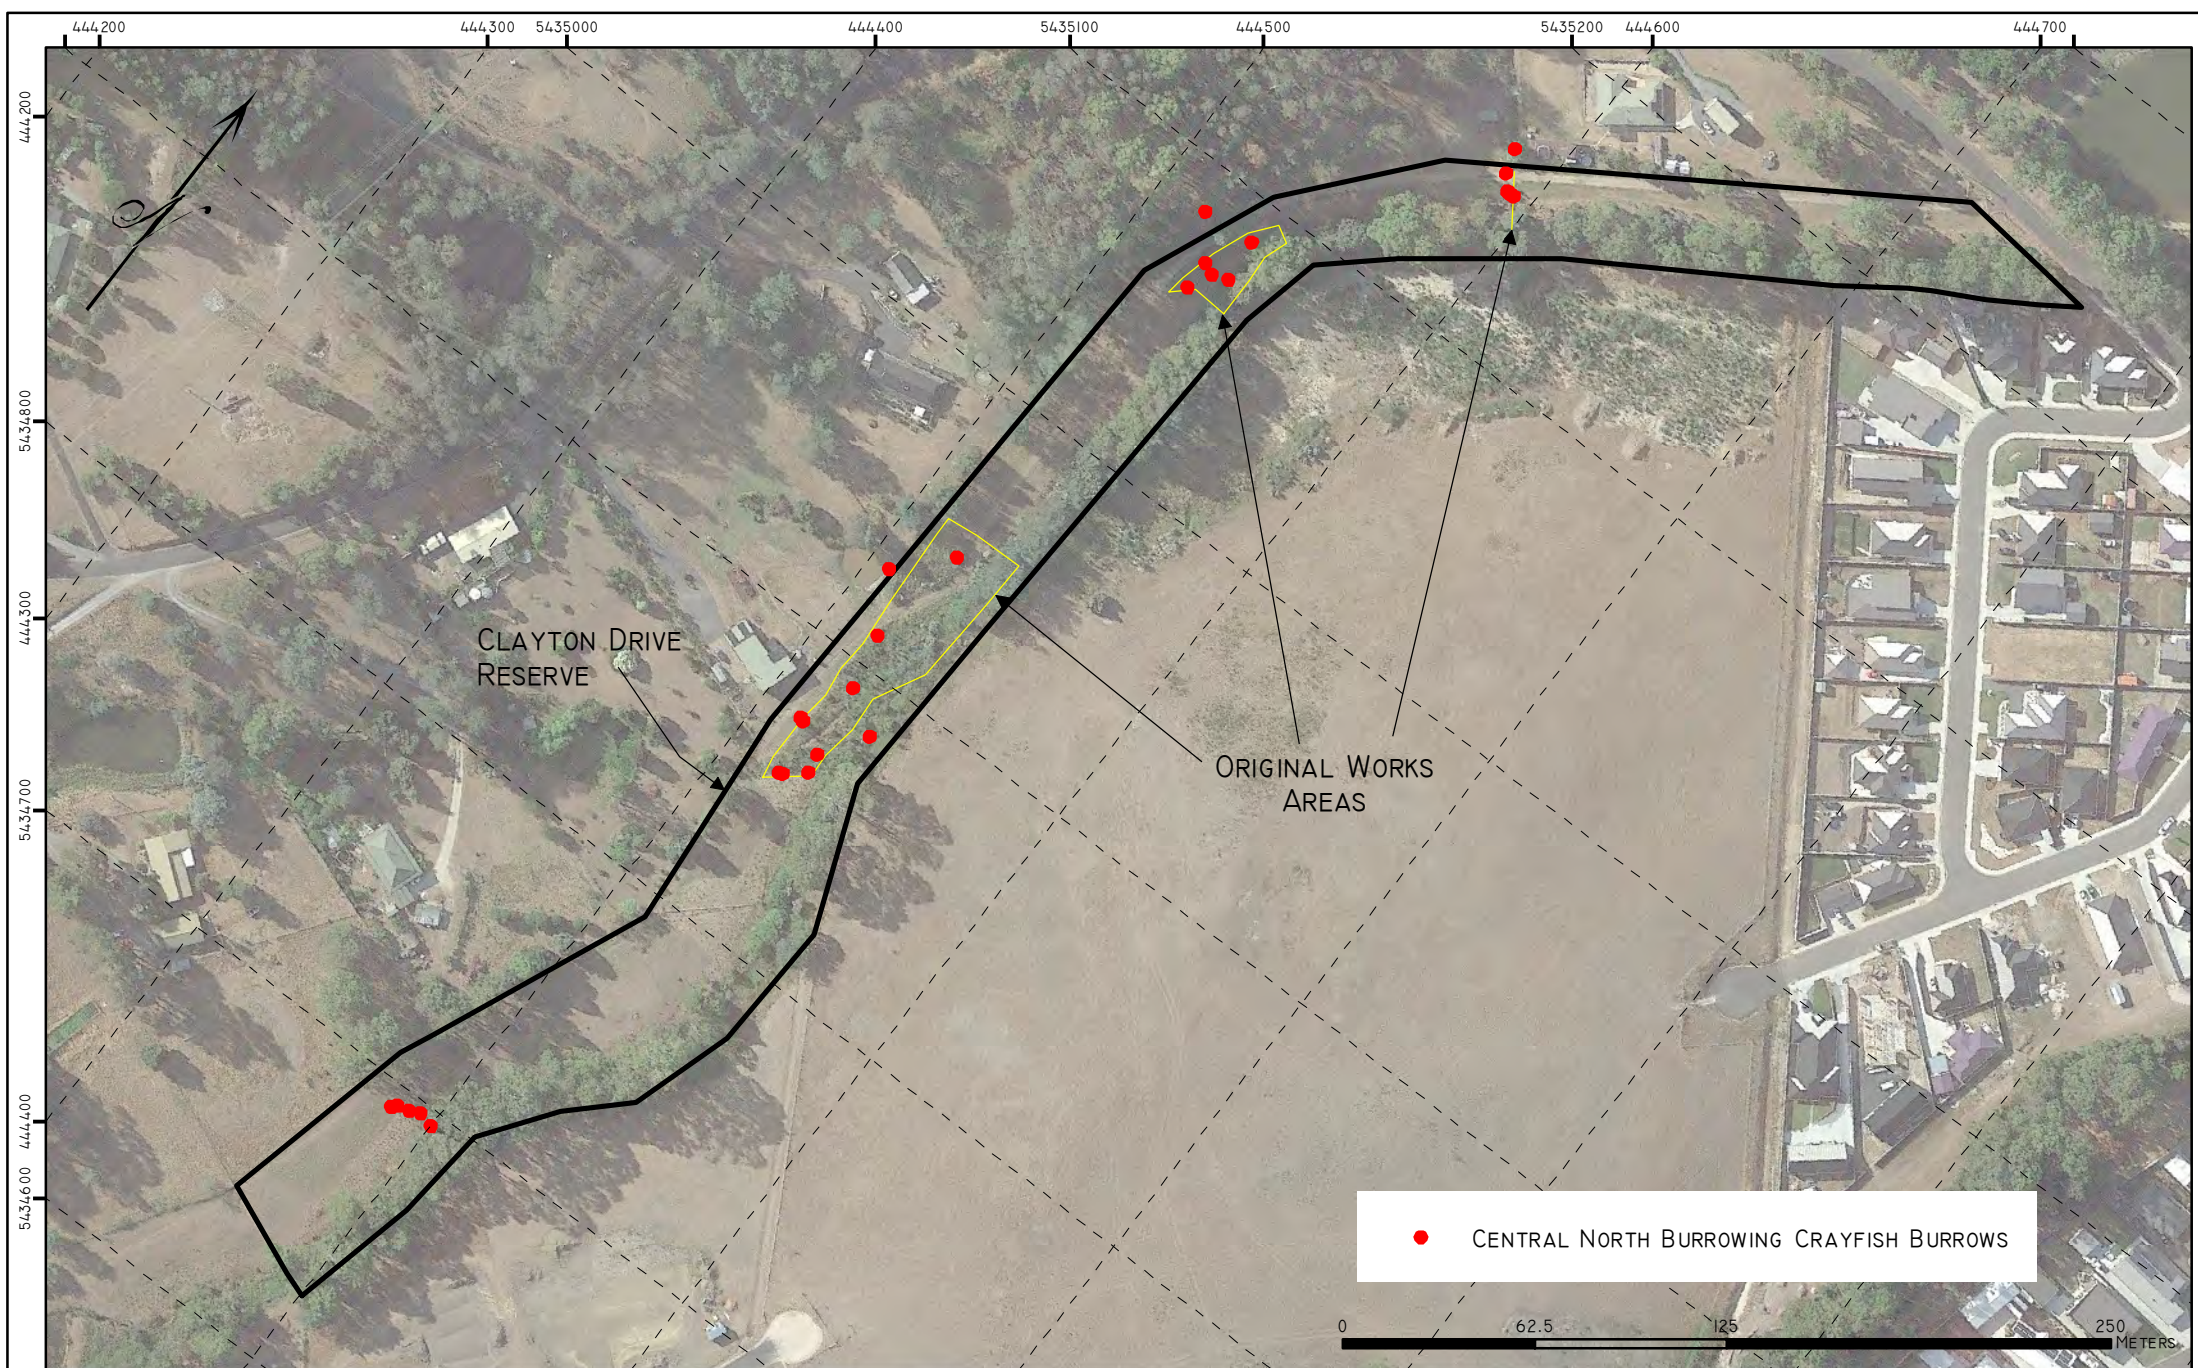
FIGURE 3: CENTRAL NORTH BURROWING CRAYFISH BURROWS (OBSERVED JULY 2018)

Figure 2 shows the areas where burrows were located during the searching, which shows that *Engaeus* are widespread across the site which is comparable to the results from the previous annual monitoring event.

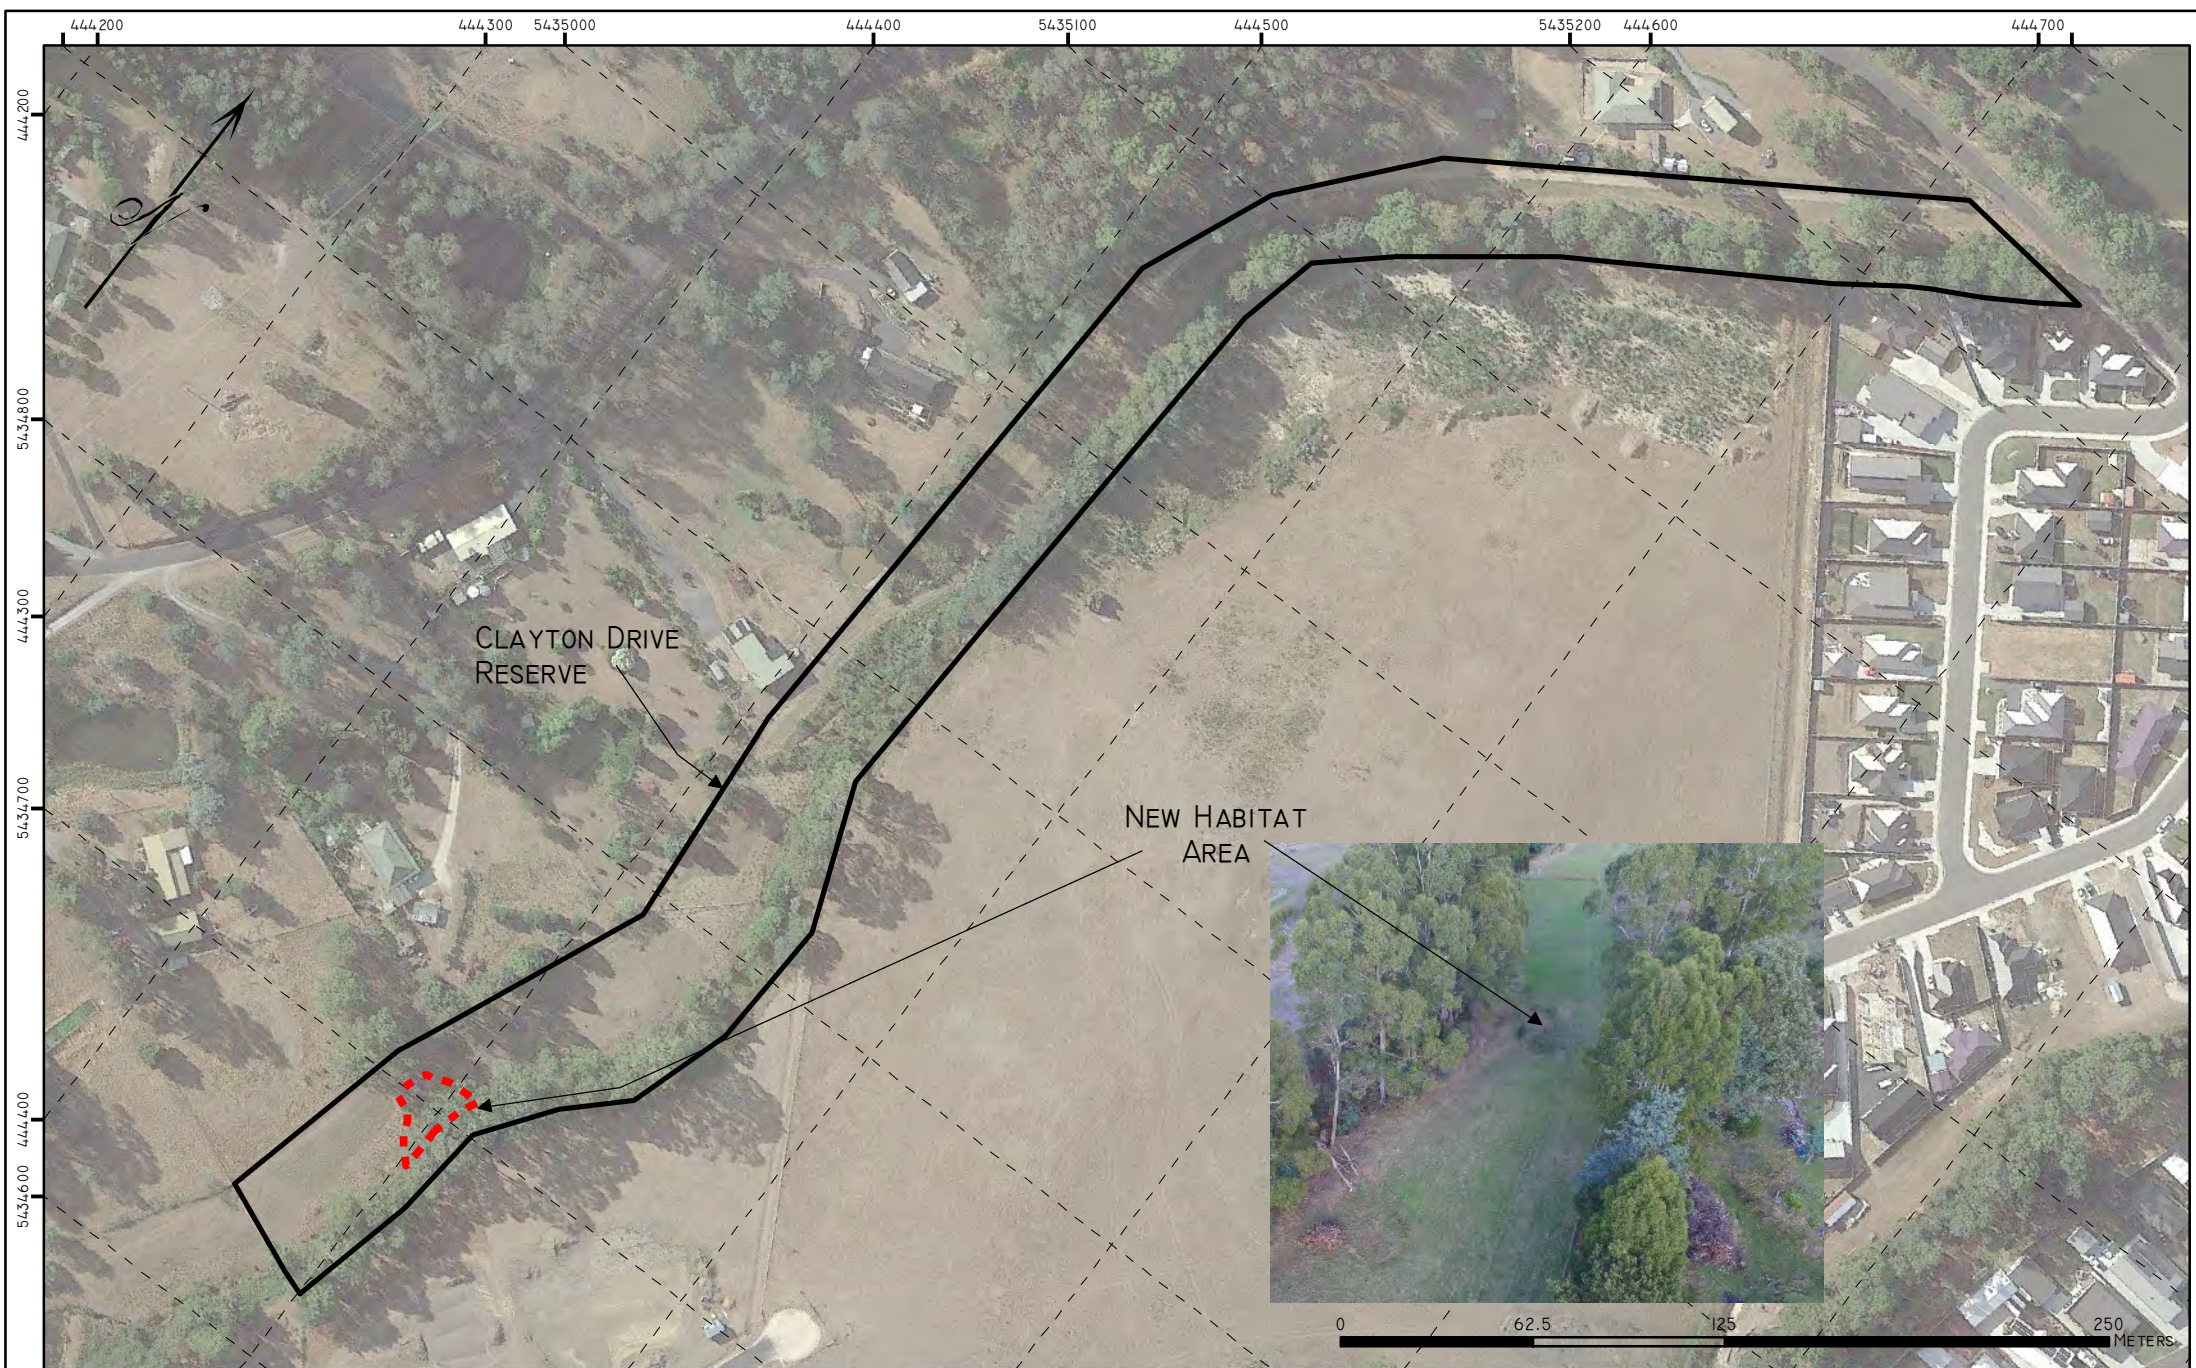
FIGURE 4: NEW CENTRAL NORTH BURROWING CRAYFISH HABITAT AREAS
(AREAS WHERE ANIMALS WERE NOT RELEASED BUT HAVE APPEARED SINCE 2016)

Figure 4 shows the two areas where *Engaeus* were observed to have colonised in June 2016, and they are still present in July 2018 – no animals were translocated to these areas, and none were present in these areas when the project commenced. It is recommended that the two areas ('new habitat area') identified in Figure 4 be physically identified on-ground (eg using wooden stakes with blue tape, comparable to other areas identified in this way) and left undisturbed from mechanical activities including slashing, mowing etc.

The two areas identified in May 2016 as now containing *Engaeus* (see Figure 4) should be physically identified on-ground (eg using wooden stakes with blue tape, comparable to other areas identified in this way) and be left undisturbed from mechanical activities including slashing, mowing etc. These areas could (optional) be planted with sedges and sagg to encourage further colonisation by *Engaeus*.

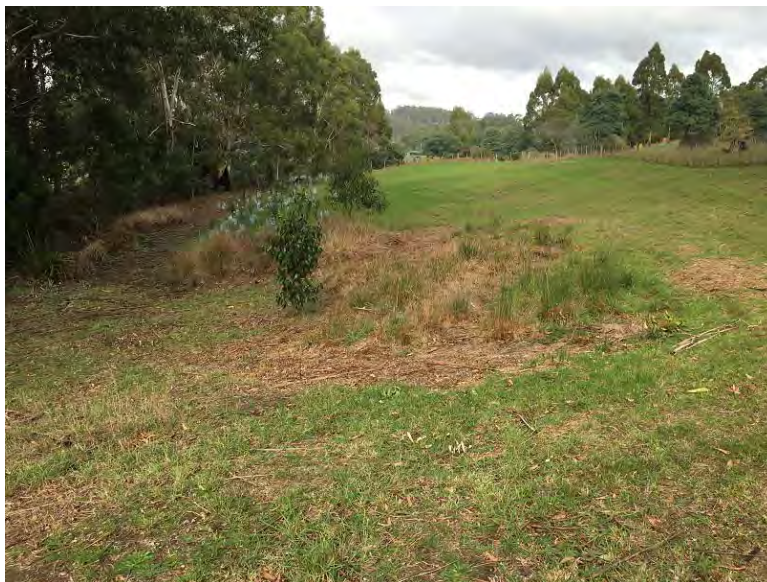
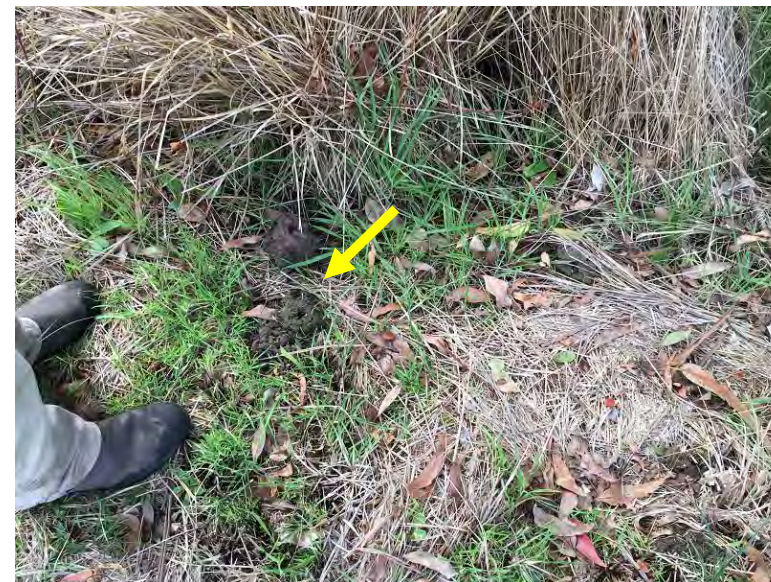
The southern-most damp area within the reserve was observed in May 2016 to have been colonised by *Engaeus* species. Six burrows were observed in May 2016.

The same location in June 2017 also supported burrows but they were very hard to find due to the dense grass cover from grass slashing.

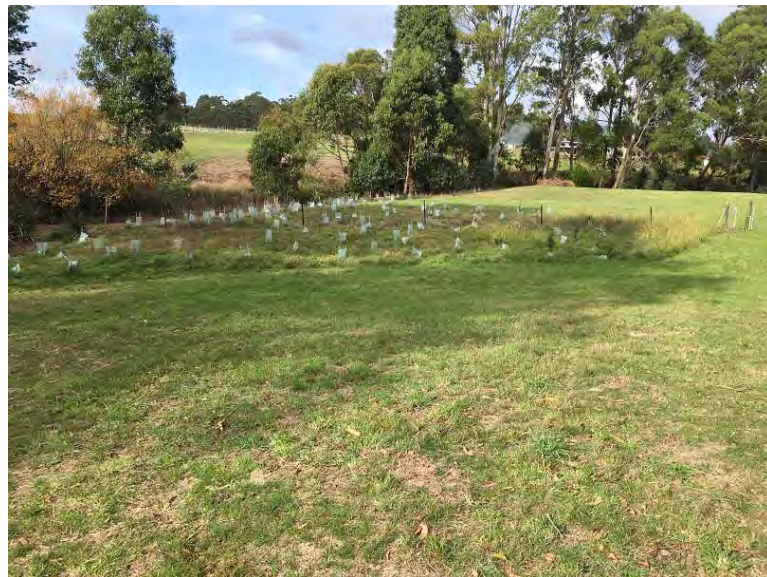
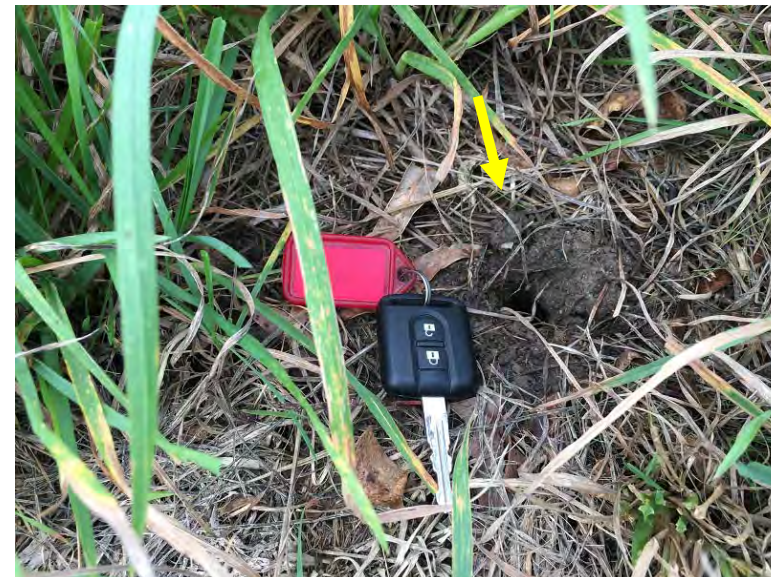
The area to the immediate north of the southern-most damp area within the reserve was observed in May 2016 to be colonised by *Engaeus*. Most burrows lacked chimneys, probably due to the area being mown. Ten burrows were observed, mainly in and around rank pasture grasses.

The same location in June 2017 also supported burrows but they were very hard to find due to the dense grass cover from grass slashing. None were observed in July 2018.

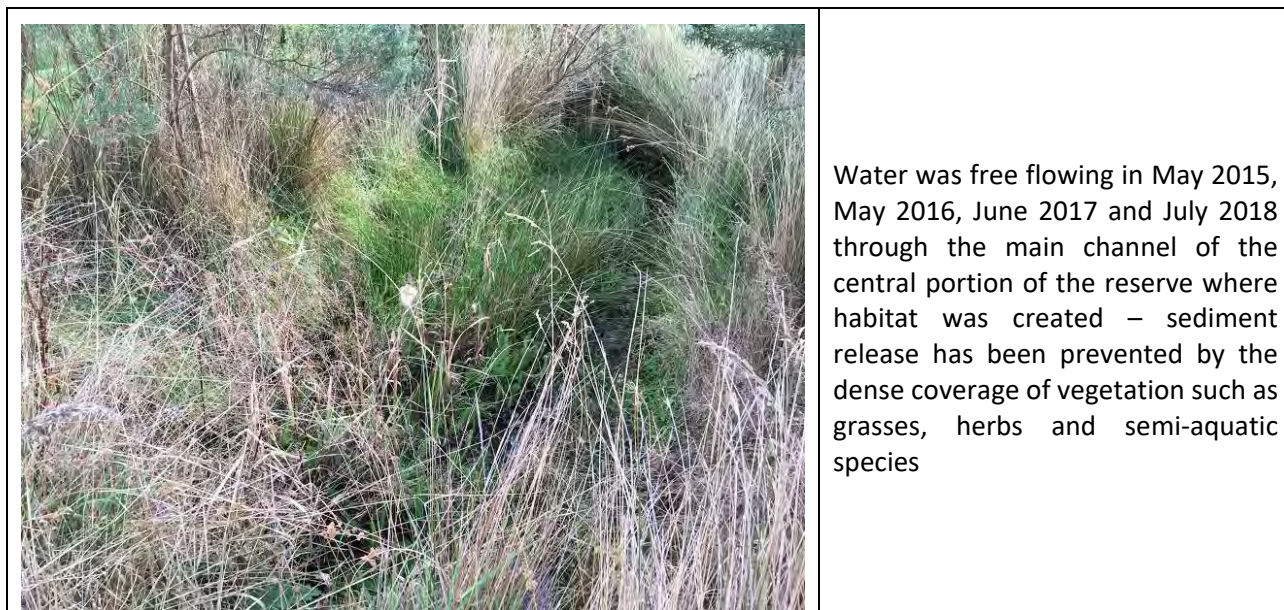
Water is ponding in the deepest parts of the drainage system which supports aquatic species such as water milfoil (*Myriophyllum*)

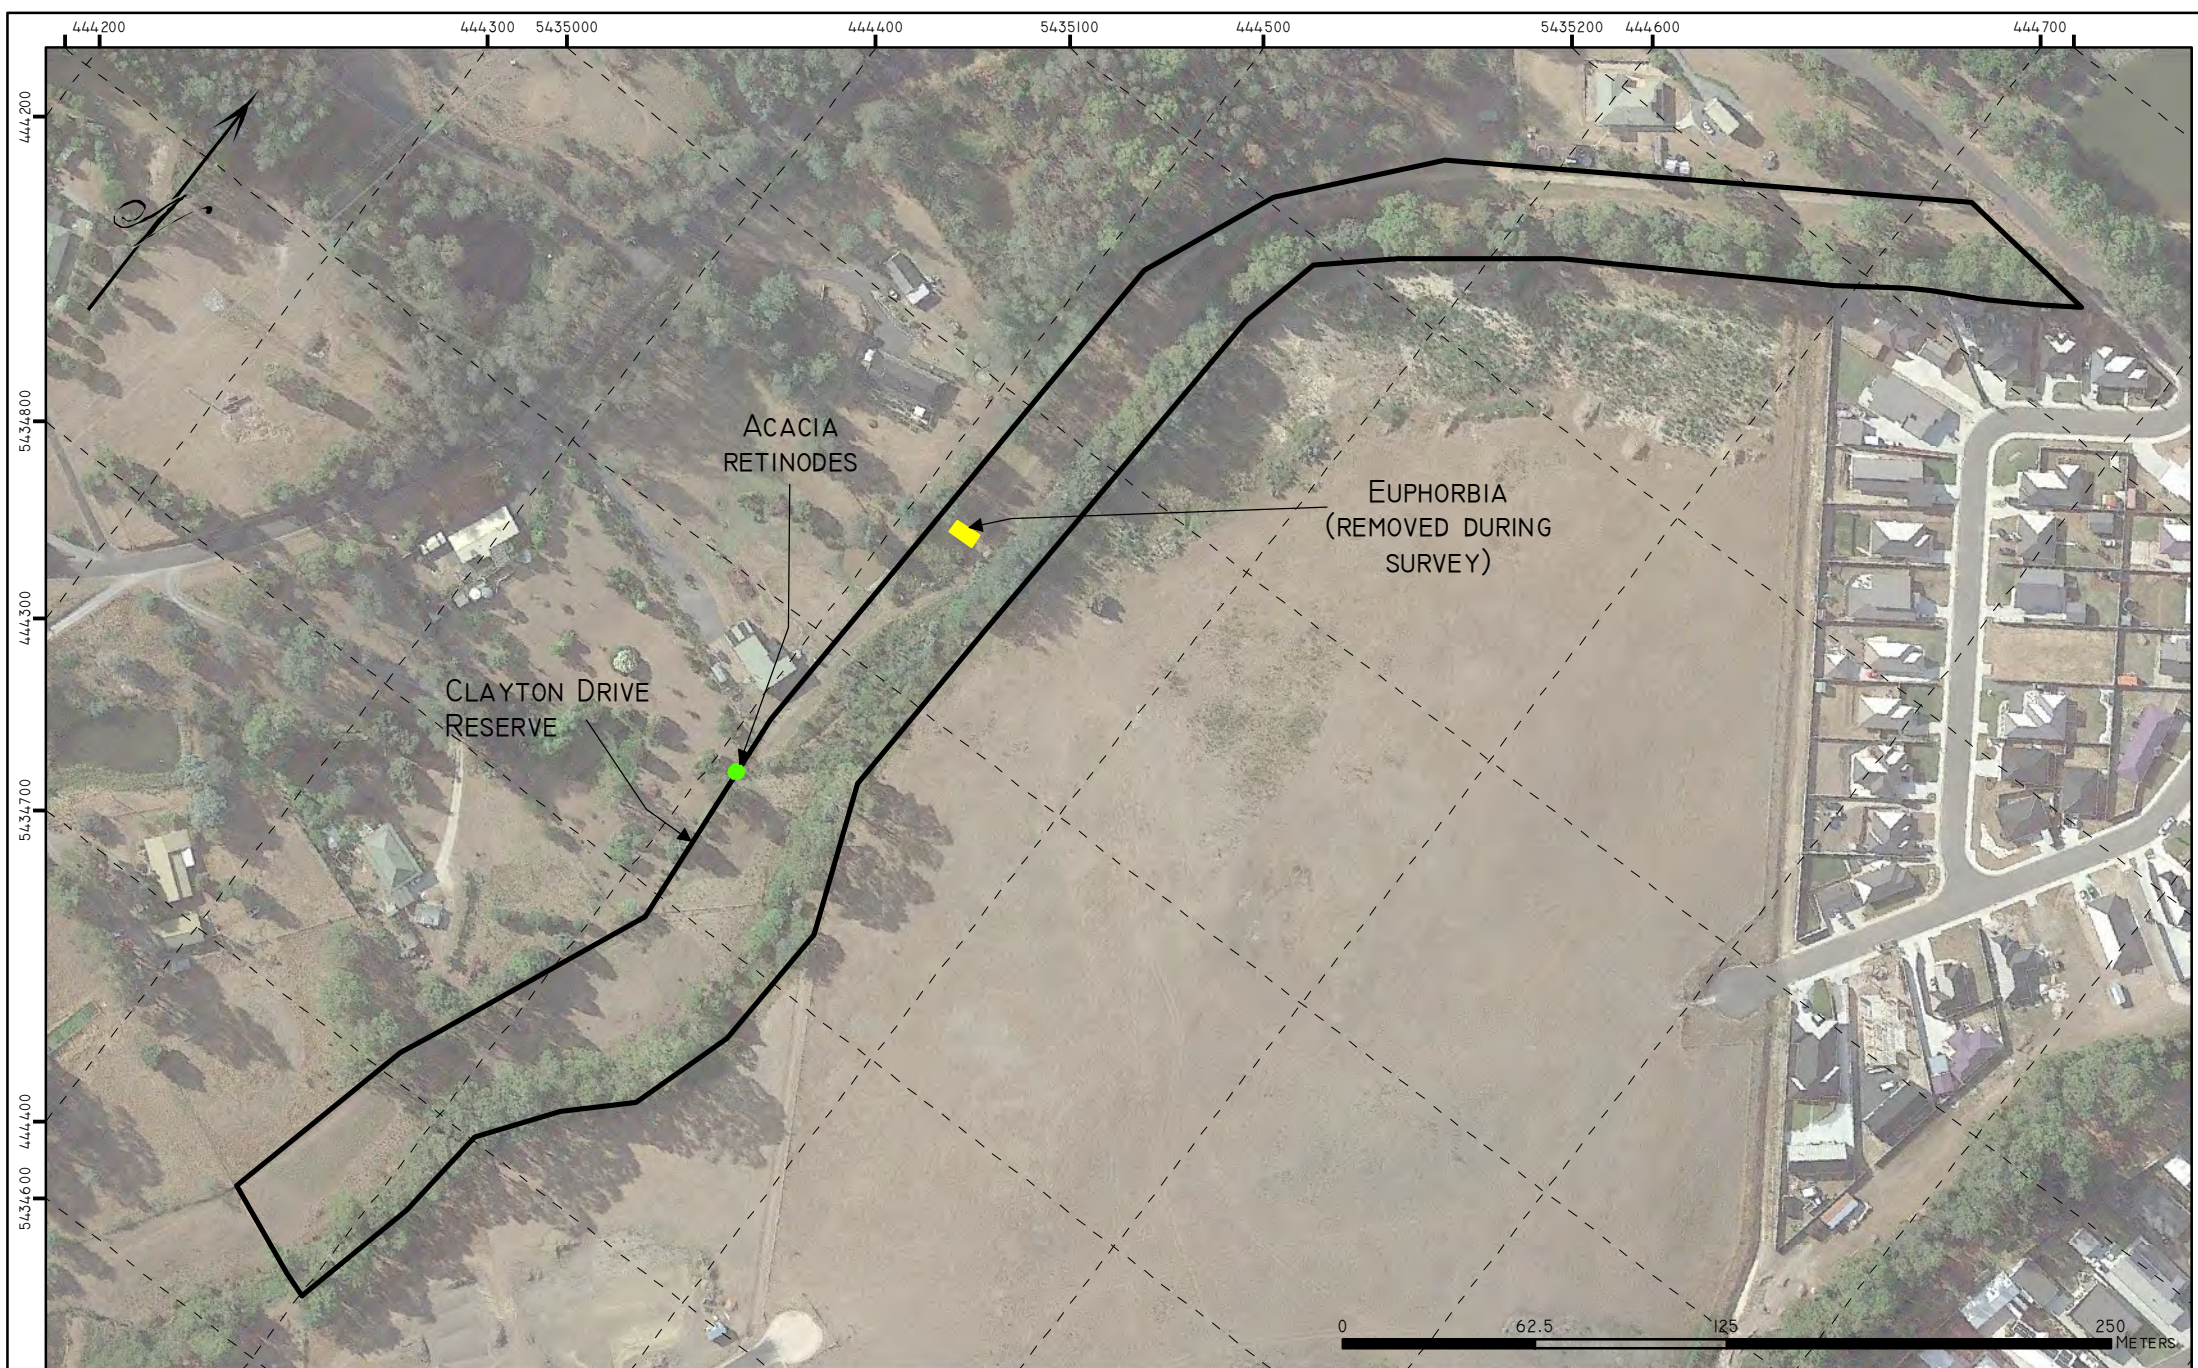
FIGURE 5: SIGNIFICANT WEEDS WITHIN THE CLAYTON DRIVE RESERVE

Significant weeds observed in the July 2018 survey are shown in Figure 5.

Blackberries remain the dominant weed along fencelines and in some areas of pasture regrowth. They have also started to become locally dominant in areas of created habitat due to the high rainfall and warming temperatures throughout spring. In some areas, as expected, their cover has reduced as the cover of trees, grasses and shrubs has increased – blackberries are high light requiring plants which do not generally grow or fruit well under a dense cover of grass or shrubbery.

The mature bushes of Montpelier broom that had been recorded near the western boundary in one location all appeared dead in June 2017 and July 2018. The site should continue to be monitored for regrowth as a few seedlings were observed near the dead parent trees (these were removed by hand when the survey was conducted).

There are several willows in the creekline, especially near areas of habitat created for *Engaeus*. It is recommended that these be removed via a cut and paste herbicide technique.

A weed spraying program should be done in spring 2018 to further target thistles and blackberry – care must be exercised when spraying blackberry such that **only** the target plant is sprayed. Blackberry should mainly be sprayed along the edge of the rehabilitated areas where there are high light conditions for their growth and the fencelines along the western boundary. Neighbours should first be advised that the spraying is going to occur such that they are aware of the use of herbicides along the boundary line.

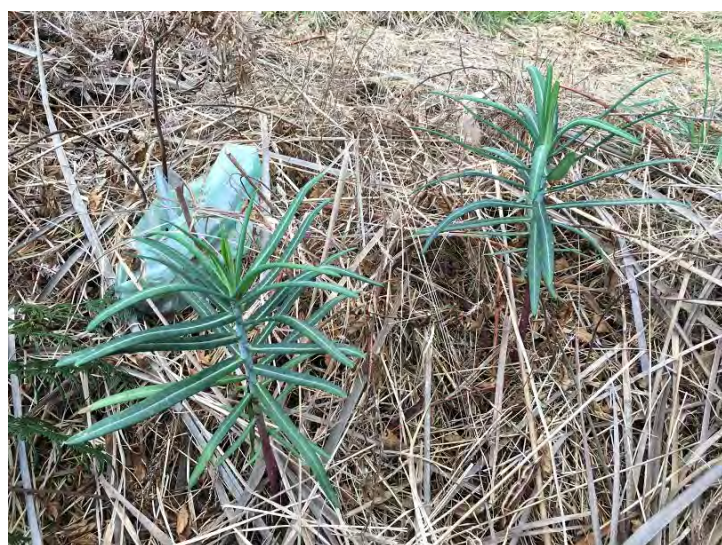
Caper spurge

The poisonous weed spurge (*Euphorbia* species) was observed in areas where the existing vegetative cover had been lost due to spraying. This is a very opportunistic species which can colonise areas of disturbed ground very quickly.

These plants should be pulled out whilst wearing gloves as the sap (white) of the plant can be toxic. Hands and clothing should be thoroughly washed afterwards, or throw-away overalls used.

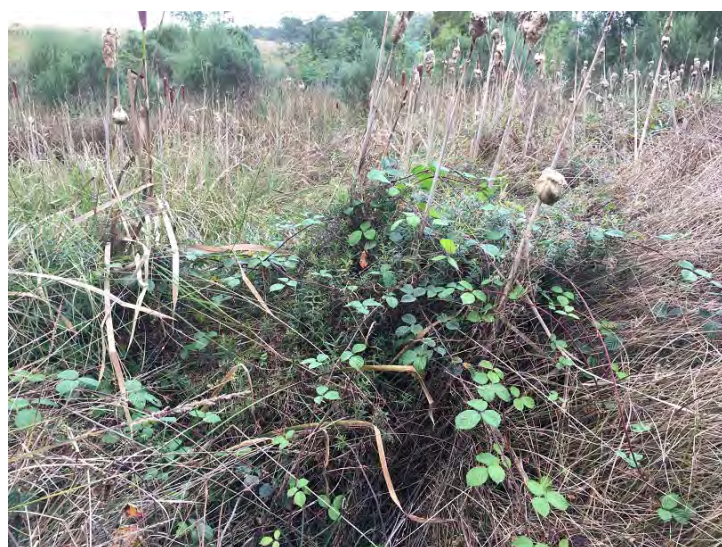
Blackberry

Vines and small thickets of this woody weed occur mainly on the edge of rehabilitated areas and fencelines to the west of the reserve.

Care should be taken when spraying this weed such that other, desirable plants are not impacted upon. There were several areas observed where native species (eg *Carex appressa* and *Juncus pauciflorus*) had been sprayed and were consequently dead or unhealthy.

Cutting and pasting blackberry stems, while time consuming, can minimise secondary impacts to surrounding vegetation.

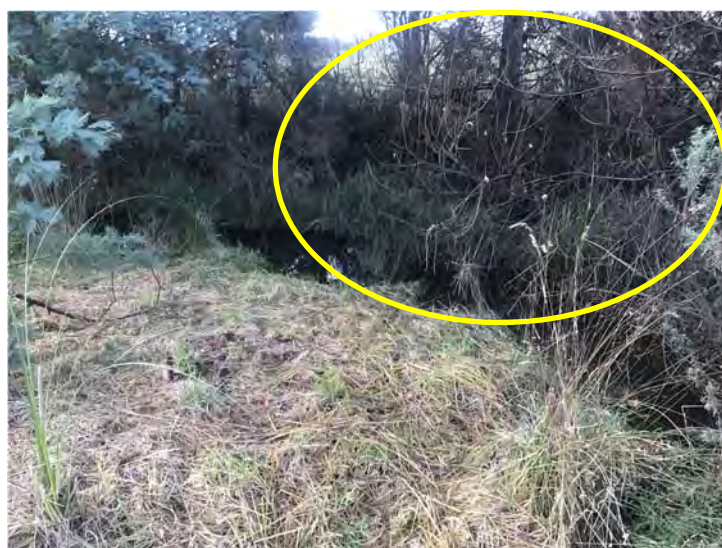
Willow

A few willows occur on the creekline near the major area of rehabilitation works for *Engaeus*. These should be removed.

Cutting and pasting the stem is the most effective way of treating willow. It is important to not allow any small fragments of stem or branches to become liberated in the stream as they may establish as new plants further downstream.
