CLAYTON DRIVE RESERVE, SPREYTON

***ENGAEUS GRANULATUS* MONITORING PLAN** **JUNE 2015**

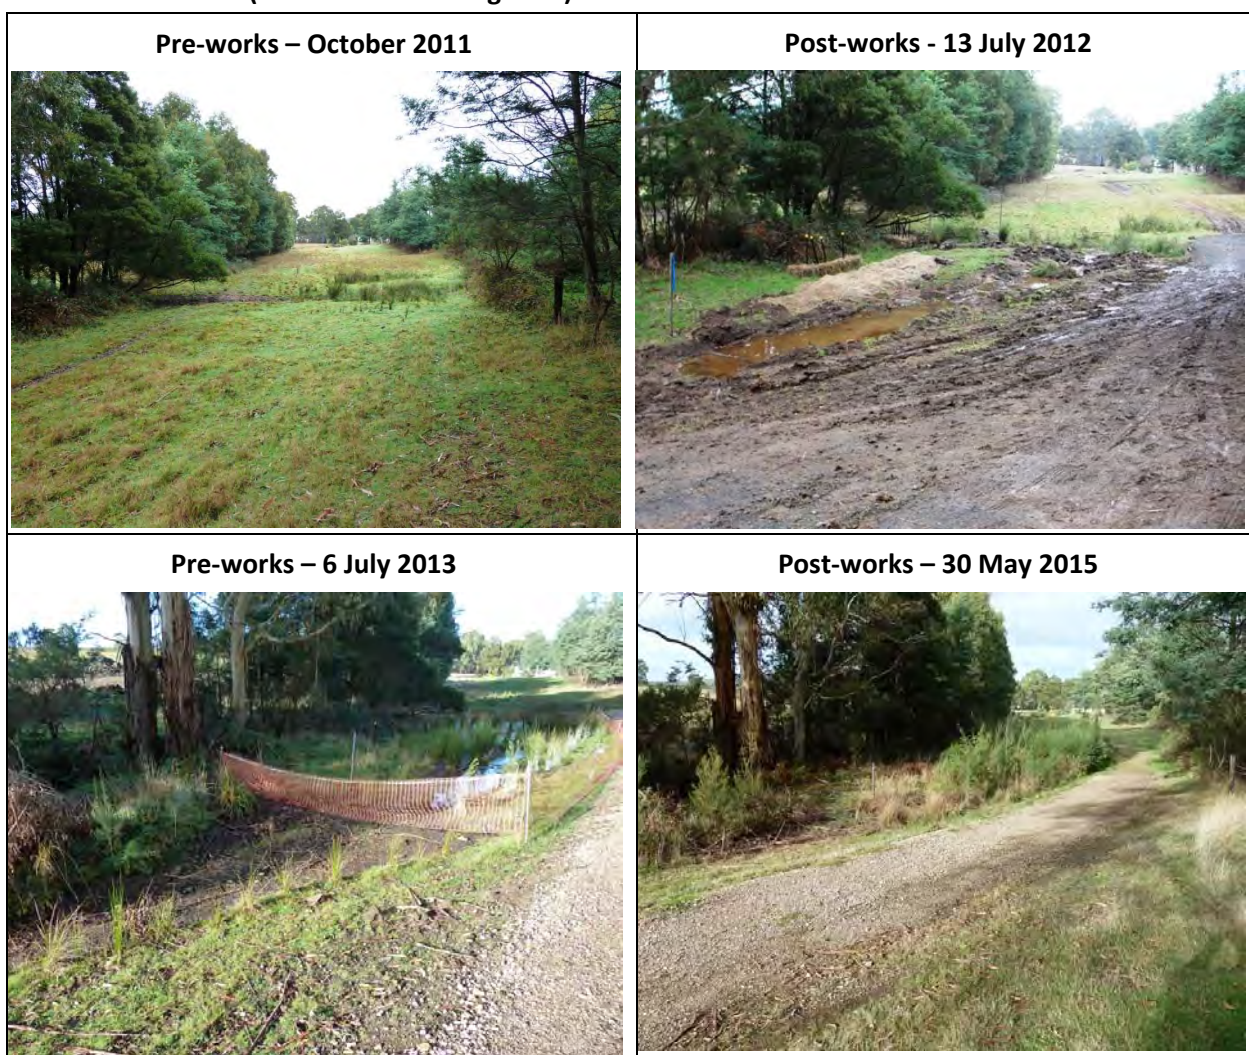
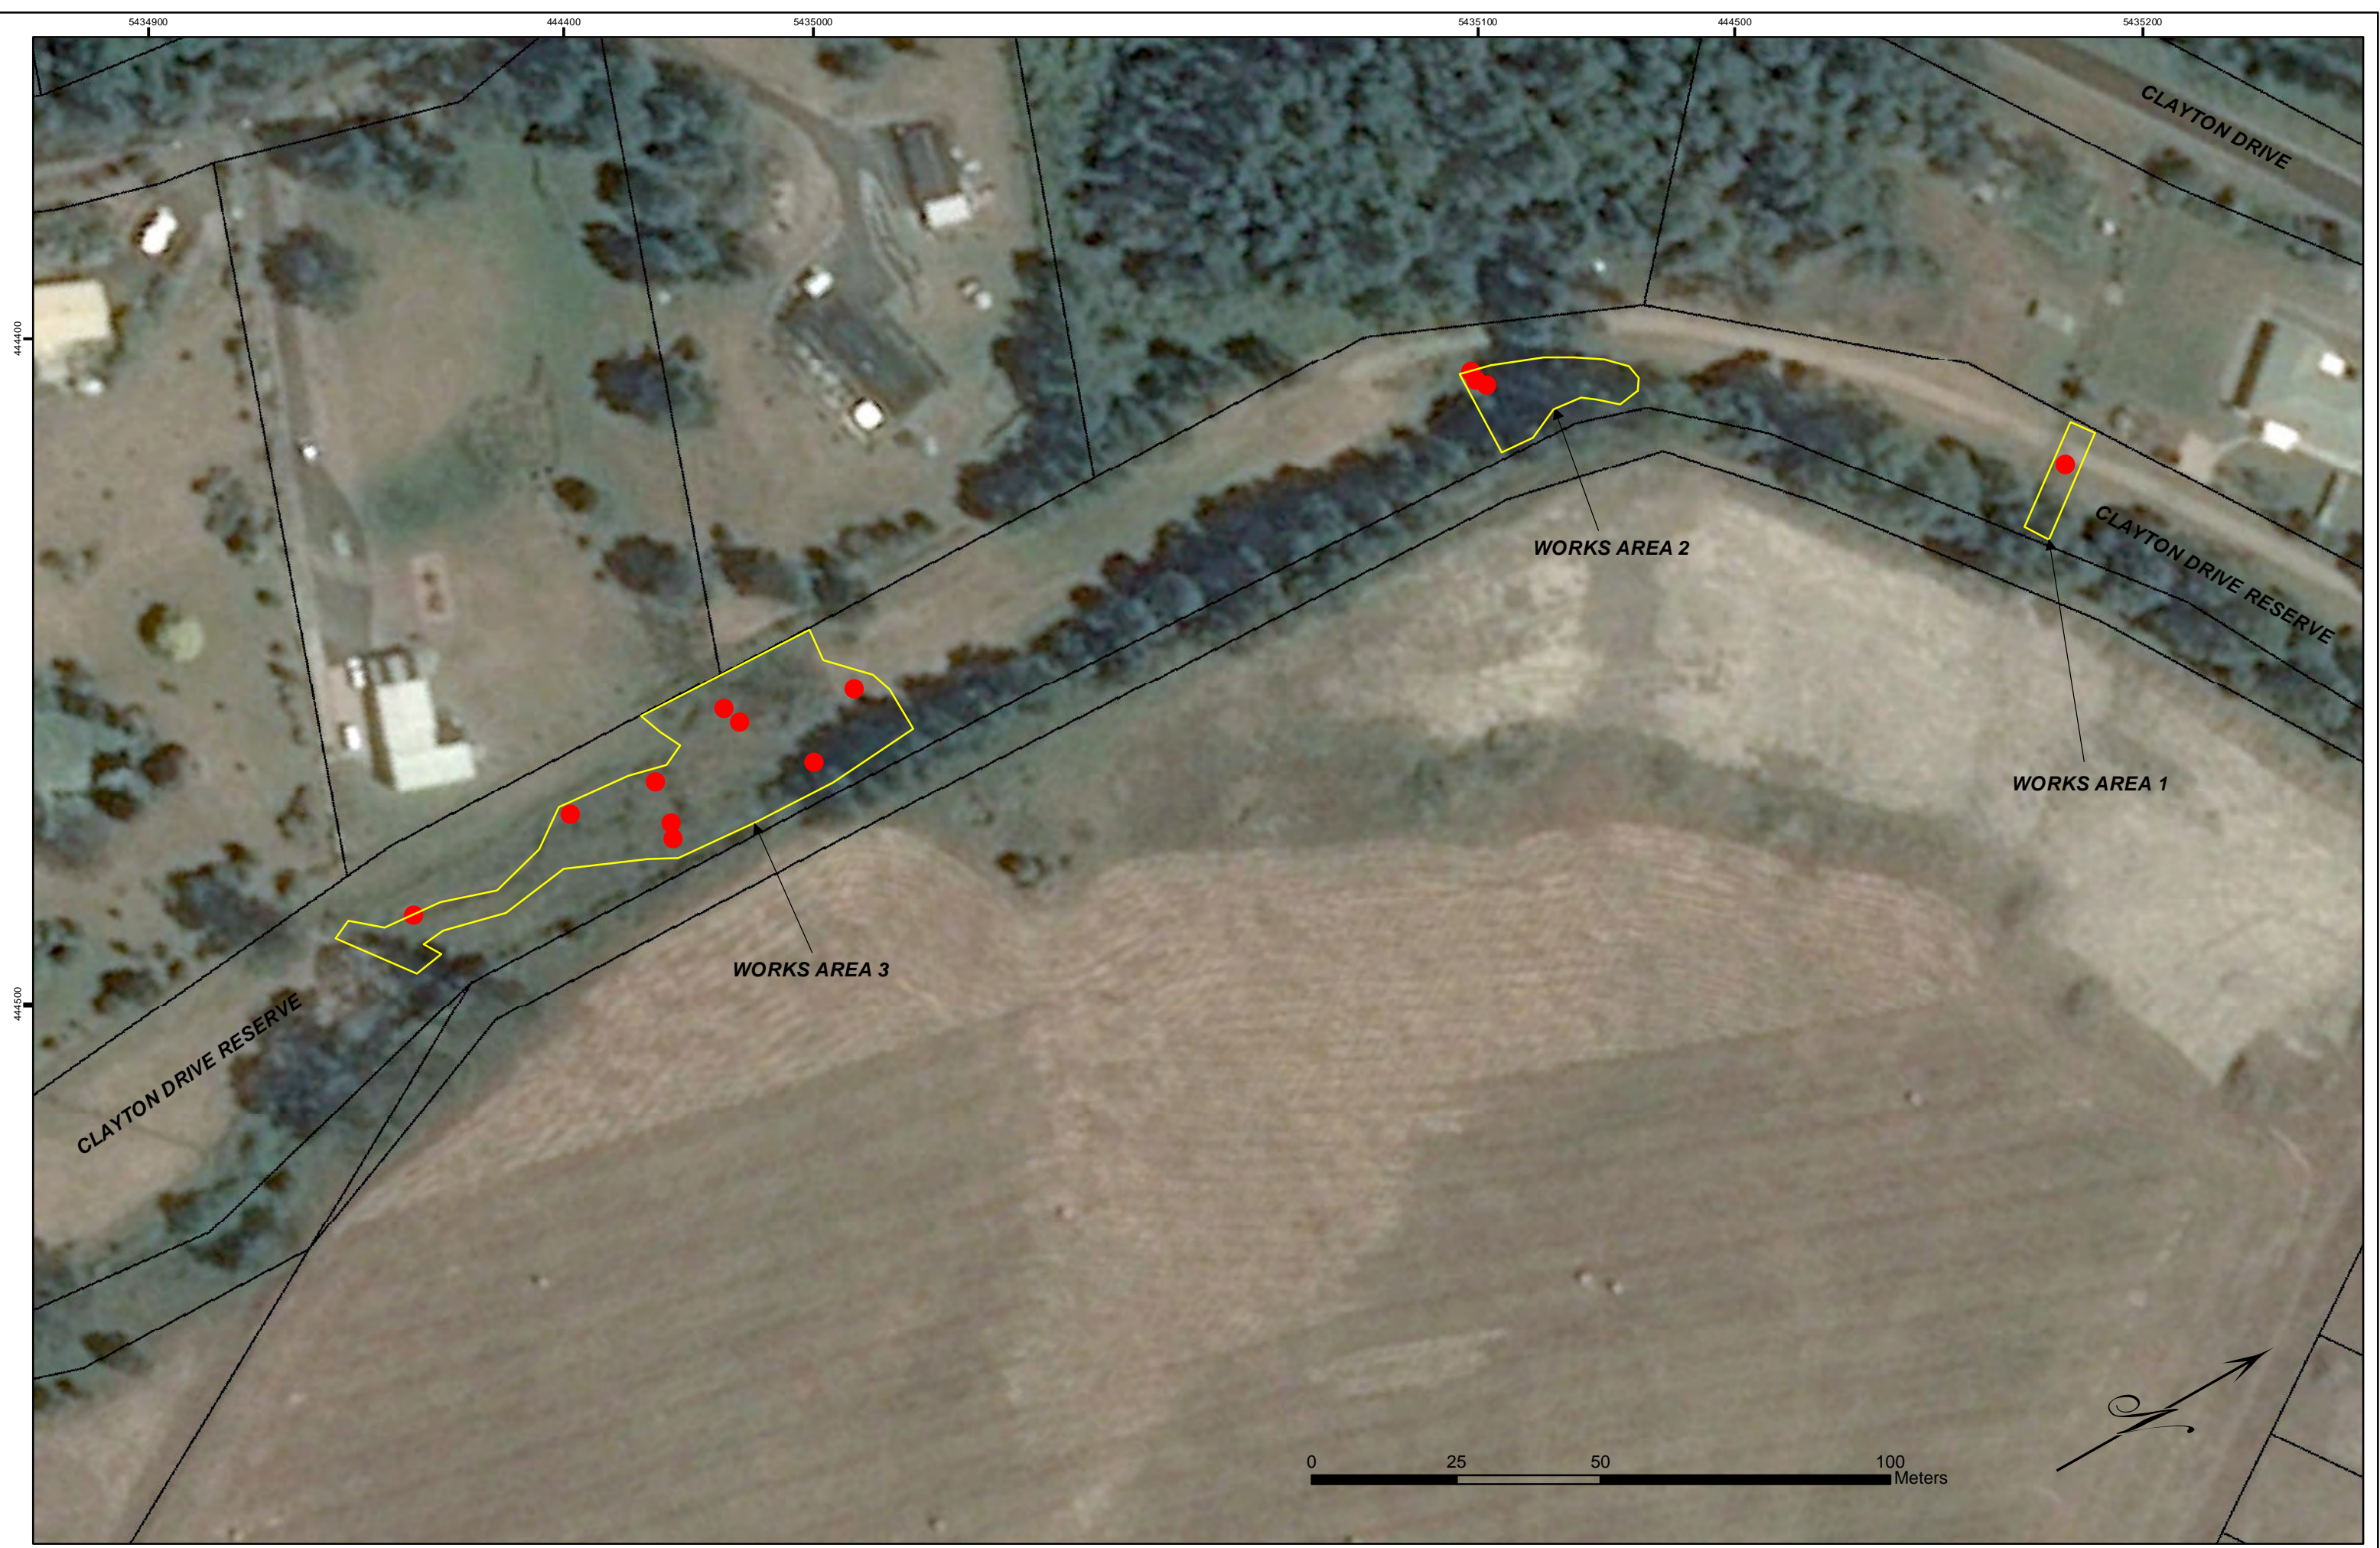
Translocation Area 2 (Works Area 2 on Figure 1)

The following images show various stages of rehabilitation since the on-ground works were completed. There has been considerable improvement in the quality and quantity of habitat available for *Engaeus* and for other native fauna, such as bandicoots. In effect what was pasture in the habitat creation/improvement areas has become, in most parts, damp to wet *Engaeus* habitat areas dominated by native plant species. These areas should continue to improve over time with little intervention or remedial works.

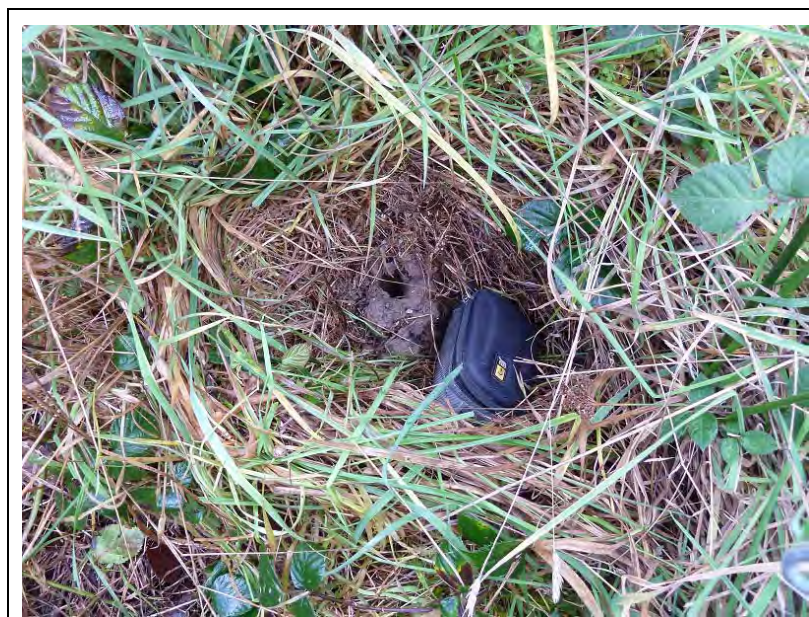
The assessment proved extremely difficult to locate burrows due to the dense grass – sedge sward that covered most of the areas of habitat created. The images below highlight the dense nature of the sward and the hidden nature of the burrows/chimneys. It quickly became apparent during searching that no matter how much care was applied, damage was being caused to the chimneys that had been built underneath or inter-twined with the sward.

An *Engaeus* burrow discovered underneath a dense sedges – grass sward

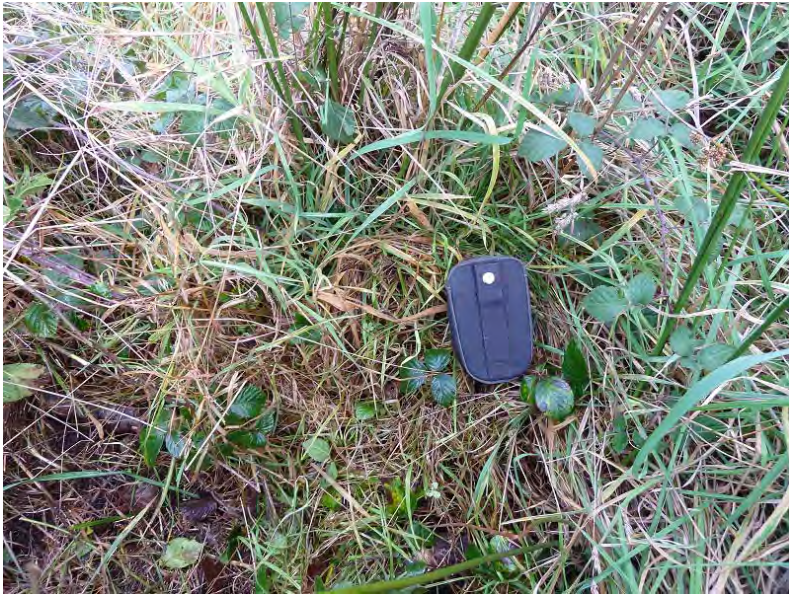
The same burrow pictured above but with the dense sedge – grass sward placed back in its natural location - the burrows are well hidden by the vegetative cover, which provides wind protection and shade as well as cover from predators when they emerge from their burrows

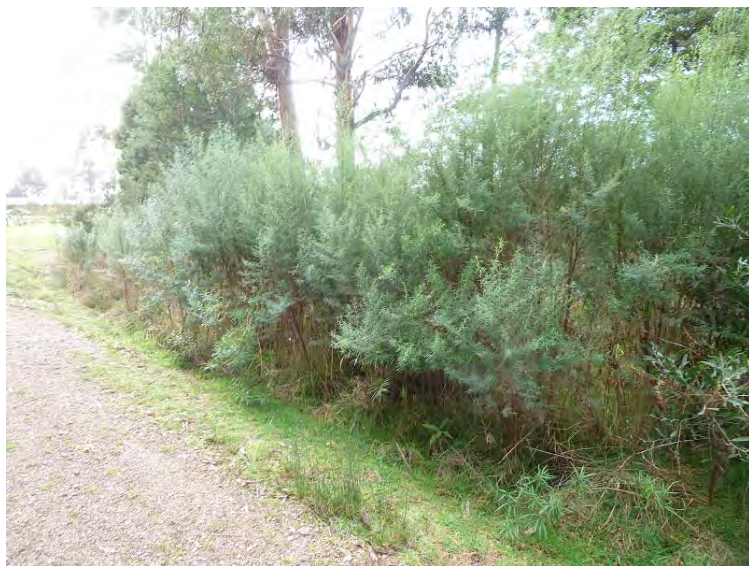
Healthy strong growth in *Cassinia aculeata* was observed in areas where it has been planted

Plant guards and bamboo stakes should be removed from those plants which no longer require them.

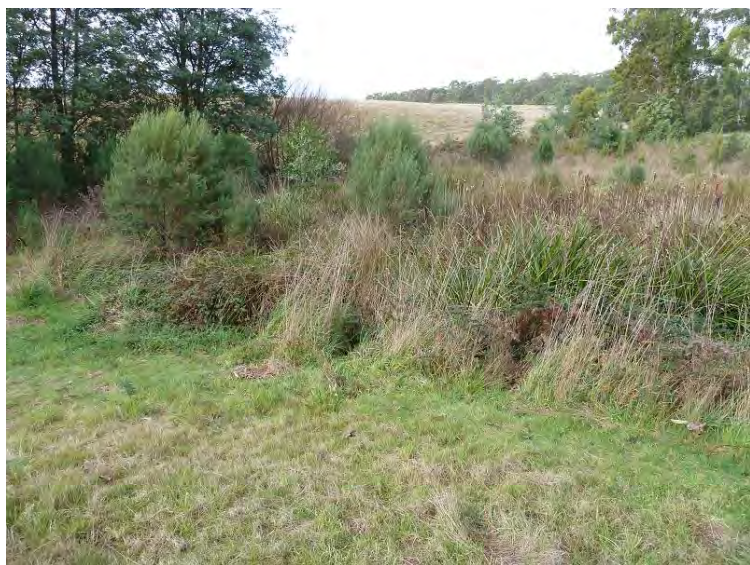
Vigorous growth in *Cassinia aculeata*, *Acacia melanoxylon* and *Melaleuca ericifolia* has occurred in most parts of the created habitat and 10m buffer strip to Figure of Eight Creek – the sedges, rushes and rank grasses has provided habitat for terrestrial mammals as well as provide shade and wind protection to crayfish habitat

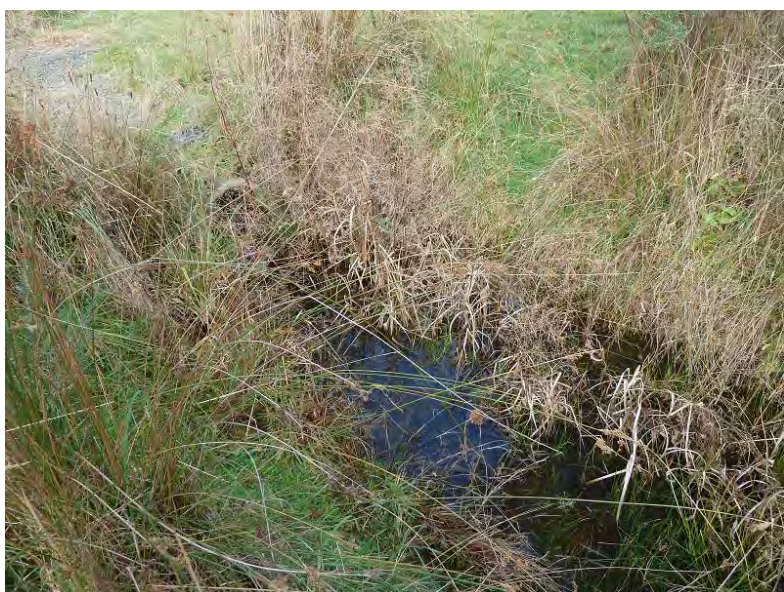
Water is ponding in the deepest parts of the drainage system which supports aquatic species such as water milfoil (*Myriophyllum*)

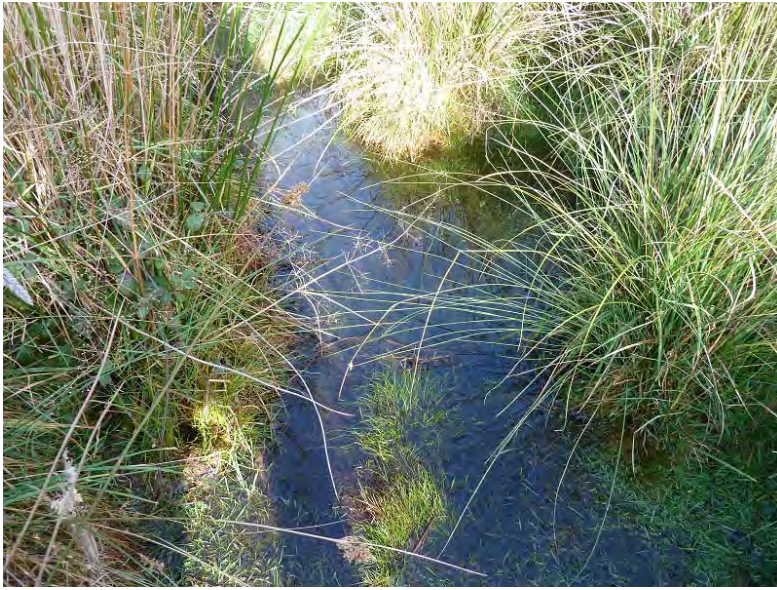
A visual assessment was made of the channels and watercourses that flow through areas of created and improved habitat before entering the main watercourse that flows into Figure of Eight Creek. Erosion has virtually ceased in the main channel and associated pooling areas as a grass and herb cover has formed which stabilises the surface over which water is flowing. Those areas where grass has not been able to grow are relatively flat and areas where water ponds, enabling sediment to drop out and accumulate – these areas in particular have accumulated silt which has enabled aquatic species to take root and grow, such as water milfoil (*Myriophyllum*).

Water was free flowing in May 2015 through the main channel of the central portion of the reserve where habitat was created – sediment release has been stopped due to the dense coverage of vegetation such as grasses, herbs and semi-aquatic species

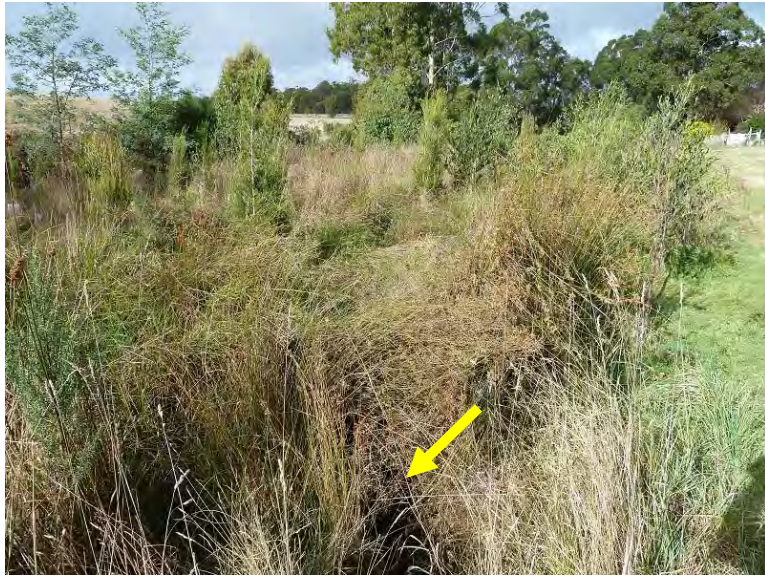
The sedges and rushes that have grown in the areas of created habitat provide shelter for bandicoots and other wildlife – several 'runs' are present through these areas (see arrow in adjacent image)
