**3.1 TENDER REPORT CONTRACT CB0126 DEVONPORT AQUATIC CENTRE**

## Pool Tiling Failure Report

### Devonport Splash Aquatic Centre

Issue 1. August 31, 2023

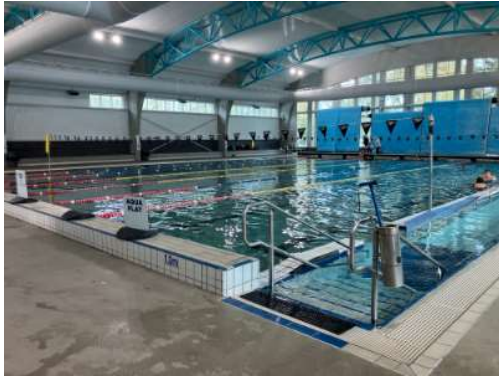
25m pool. Only above water tiles remaining.

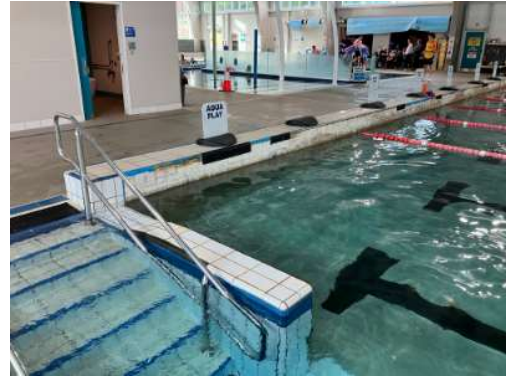
25m pool. Remaining step tiles.

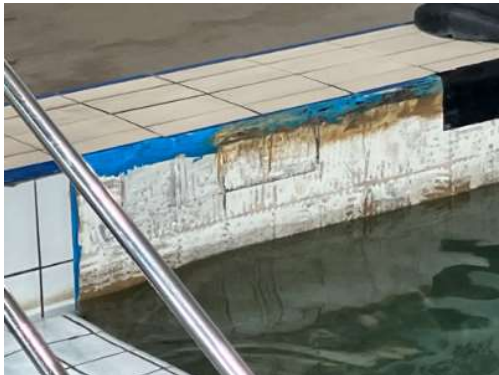
25m pool. Headwall tiles removed.

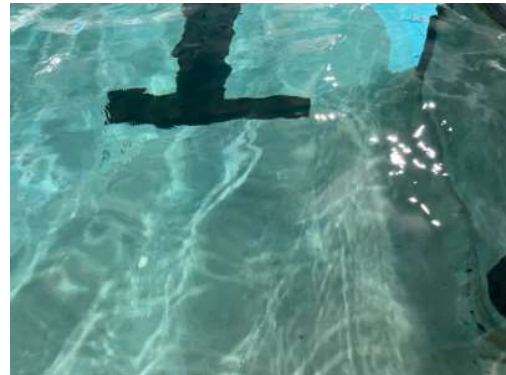
25m pool. Typical below water tiles removed.

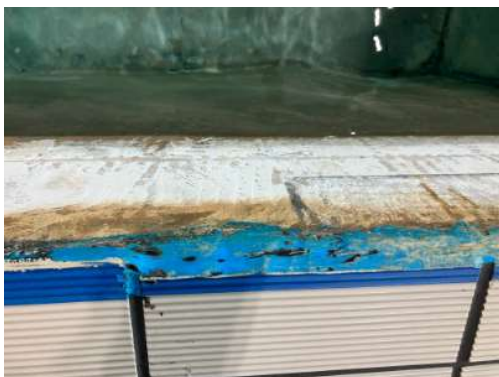
25m pool. Typical damaged edge tiles.

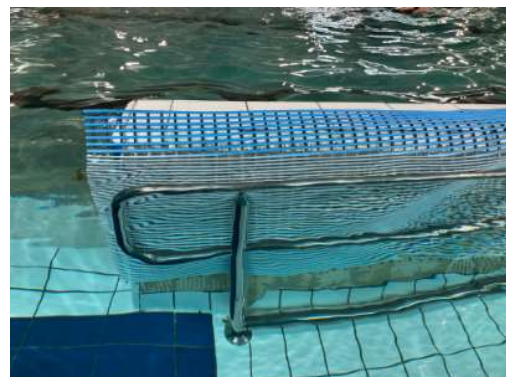
25m pool. Ramp section with failed wall tiles.

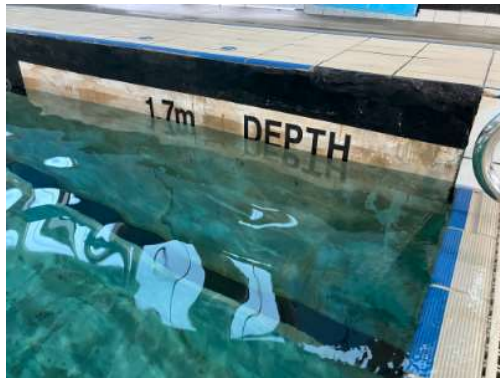
25m pool. Typical wall section.

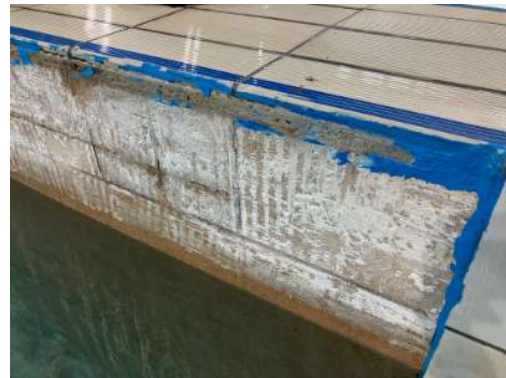
25m pool. Typical wall section.

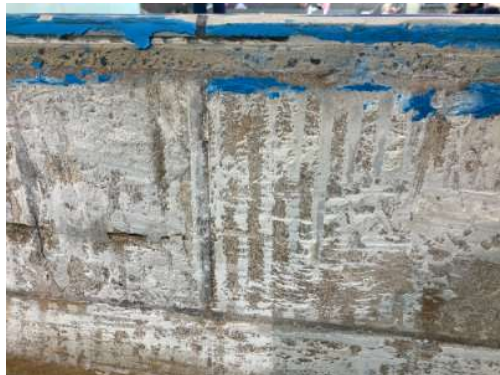
25m pool. Typical adhesive residue with notches.

Notch marks in the tiling adhesive are clearly visible in areas where tiles have failed. This indicates that the ridges of adhesive between the notches were not collapsed when bedding the tiles. This does not necessarily indicate that the 90% coverage as required for swimming pool tiles was not achieved, although total adhesion would be required at the ridges to achieve the 90% coverage requirement.

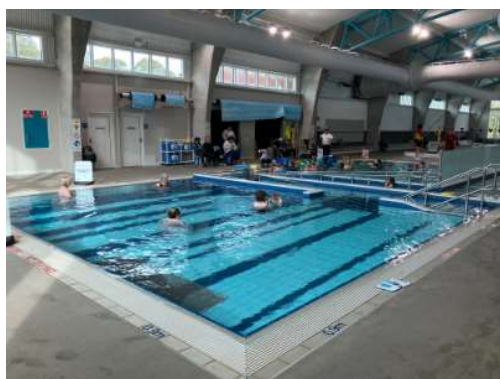
Tiles in the Leisure pool were intact except for a nominal 2m<sup>2</sup> area on the floor of the pool at the deepest point as indicated by the images below.

Leisure pool. Tiles missing on base at near wall.

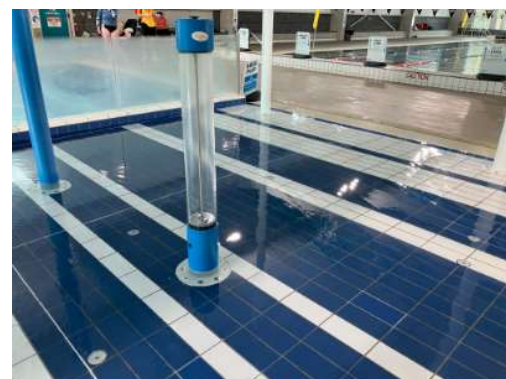
Leisure pool. Toddlers zone.

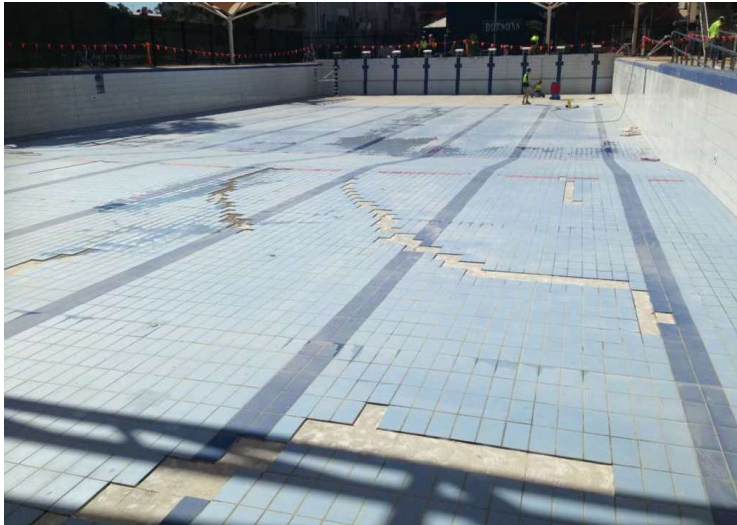
Example of pool floor tile delamination.

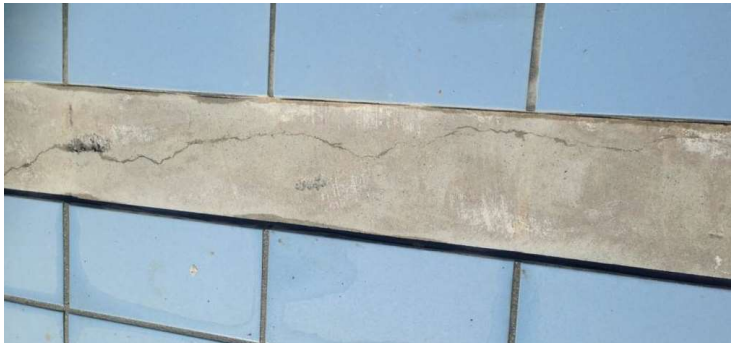
Example of concrete shrinkage crack not present before tiling,  
now present below row of failed pool tiles
