**CLAYTON DRIVE RESERVE, SPREYTON
DEVONPORT CITY COUNCIL**

***ENGAEUS GRANULATUS* MONITORING PLAN
JUNE 2016**

CLAYTON DRIVE RESERVE - MONITORING REPORT

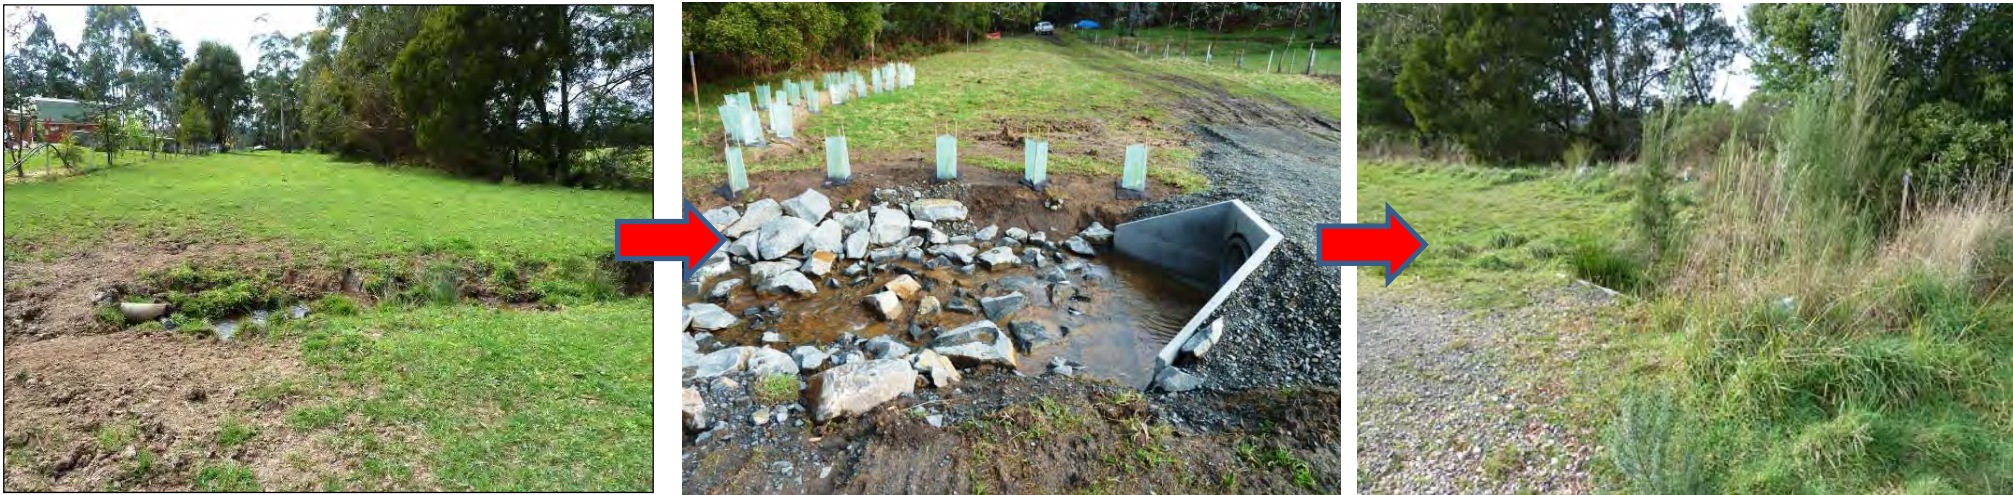
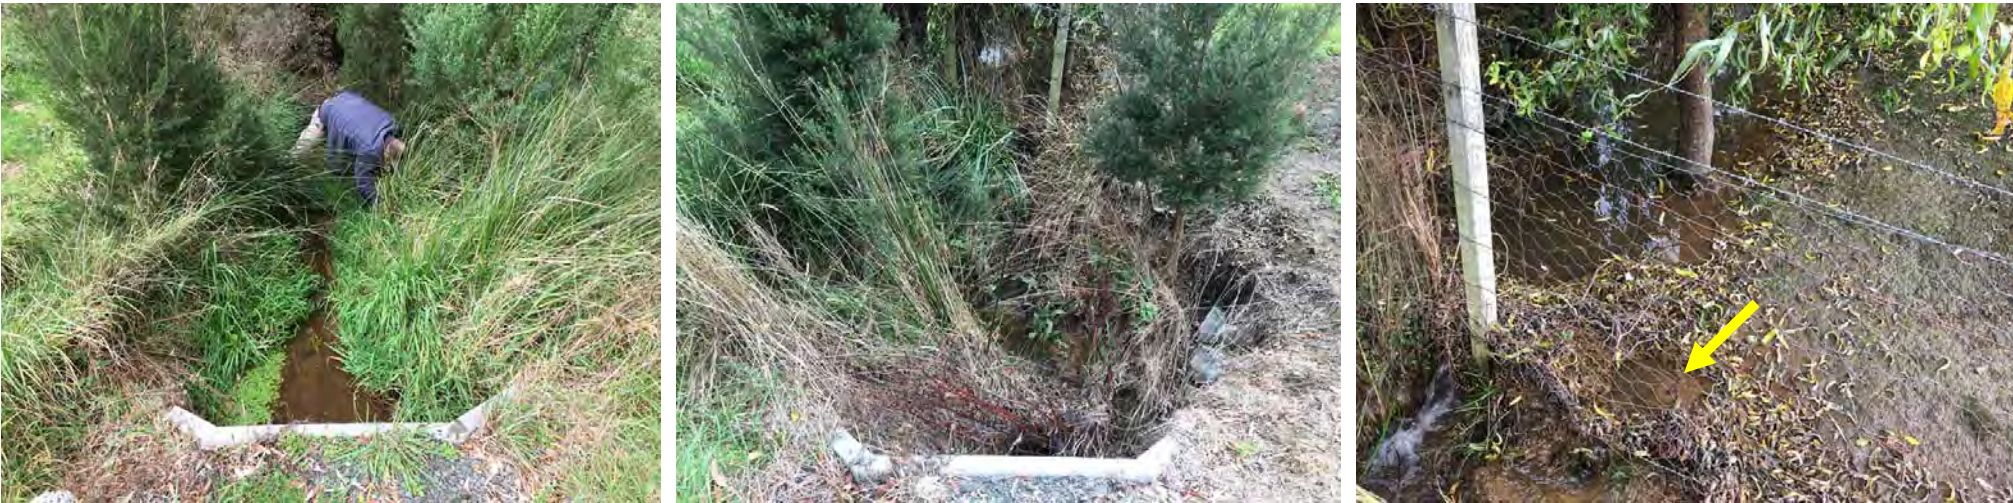
Translocation Area 1 Images from 2011, 2012, 2015 and 2016 (Works Areas 1 on Figure 2)

Post-works – 14 May 2016

Adjoining creek with burrows – 14 May 2016

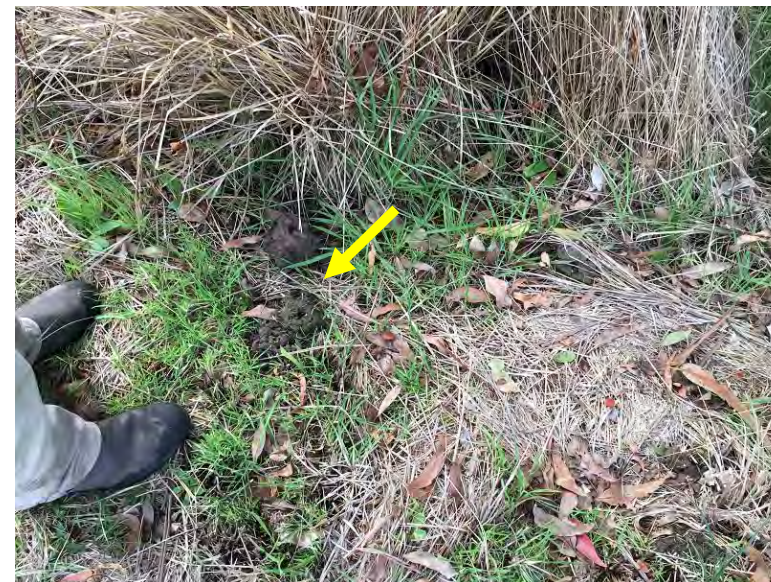
The southern-most damp area within the reserve has been colonised by *Engaeus* species as noted by the burrows with distinctive chimneys.

Six burrows were observed, mainly in and around sedges and tall pasture grasses where the height of the vegetation has enabled chimneys to be formed.

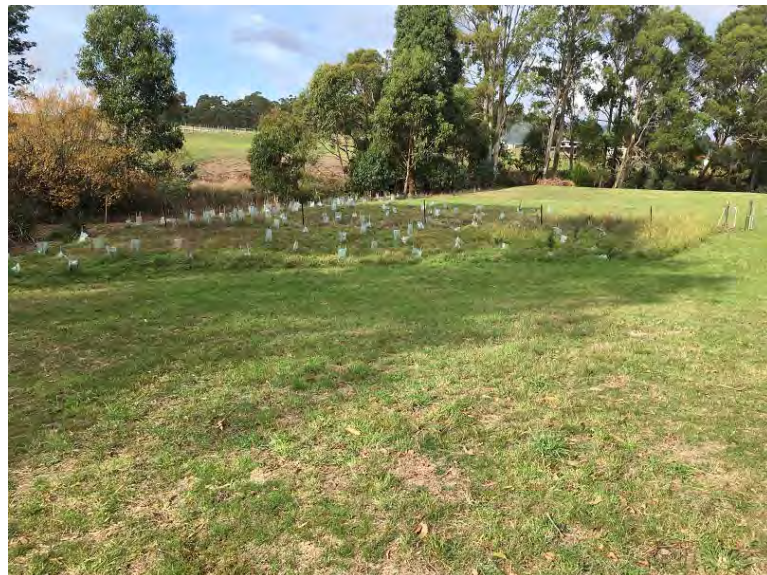
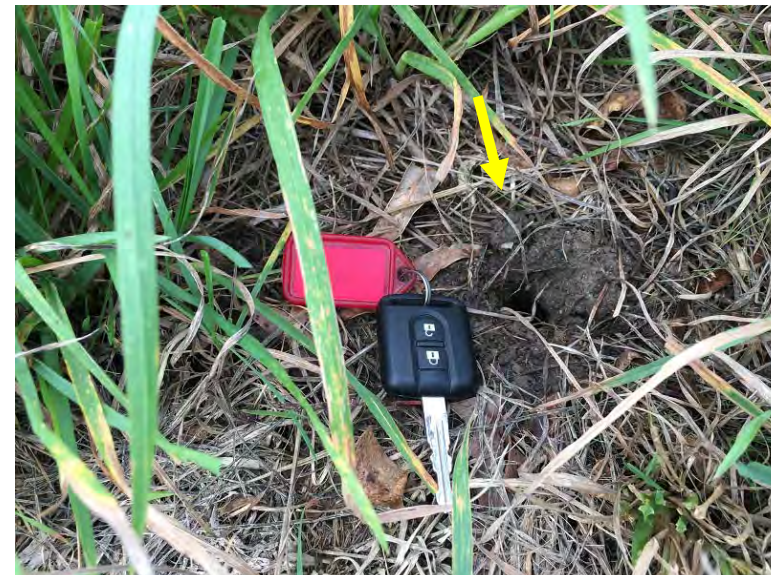
The area to the immediate north of the southern-most damp area within the reserve has also been colonised by *Engaeus* species as noted by burrows, some with classic 'dirt' workings near the entrance. Most burrows lacked chimneys, probably due to the area being mown.

Ten burrows were observed, mainly in and around rank pasture grasses.

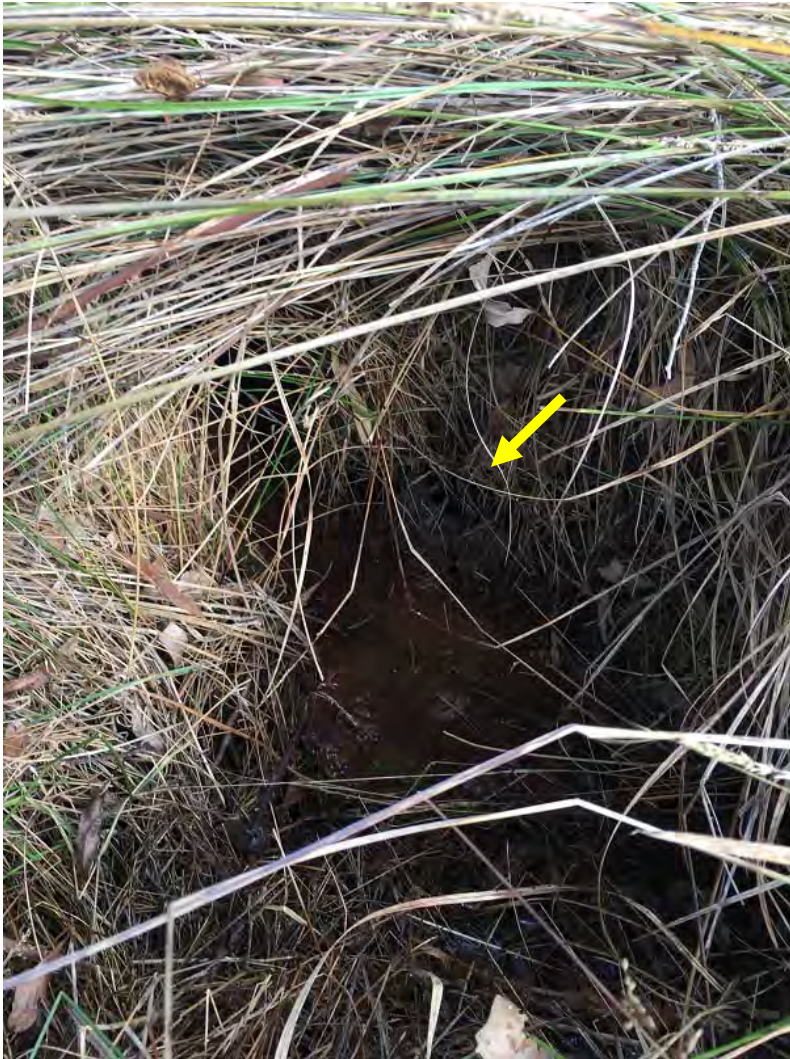
An *Engaeus* burrow (arrow) discovered underneath a dense coverage of sedges and grasses near the main channel of water flow

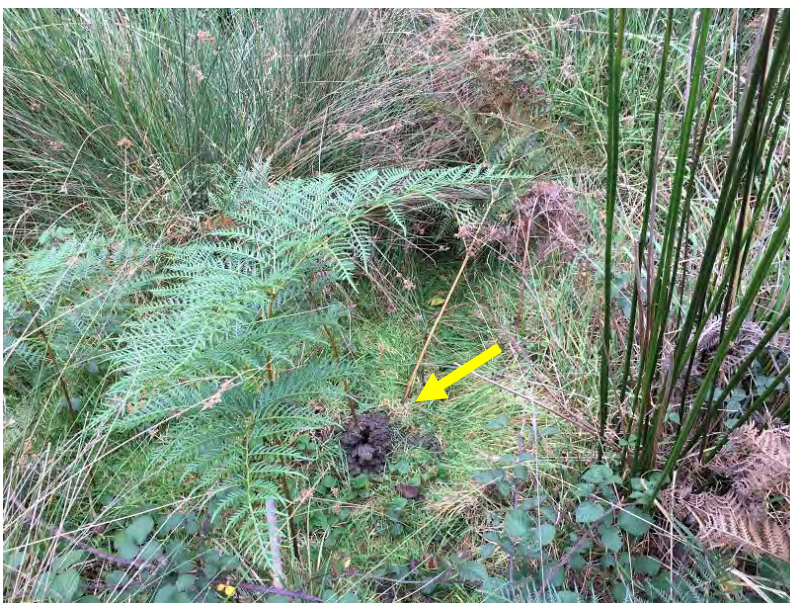
An *Engaeus* burrow (arrow) discovered in an opening within otherwise thick vegetation (wattles, sedges, sagg and bracken) where there it is associated with an animal run. The chimney is supported by a bracken-fern frond.

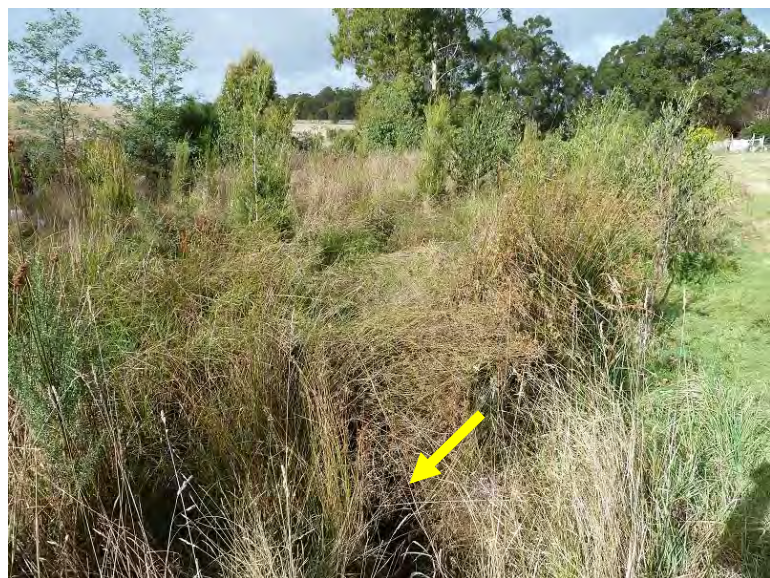
May 2015

The sedges and rushes that have grown in the areas of created habitat provide shelter for bandicoots and other wildlife – several 'runs' are present through these areas (see arrow in adjacent image)

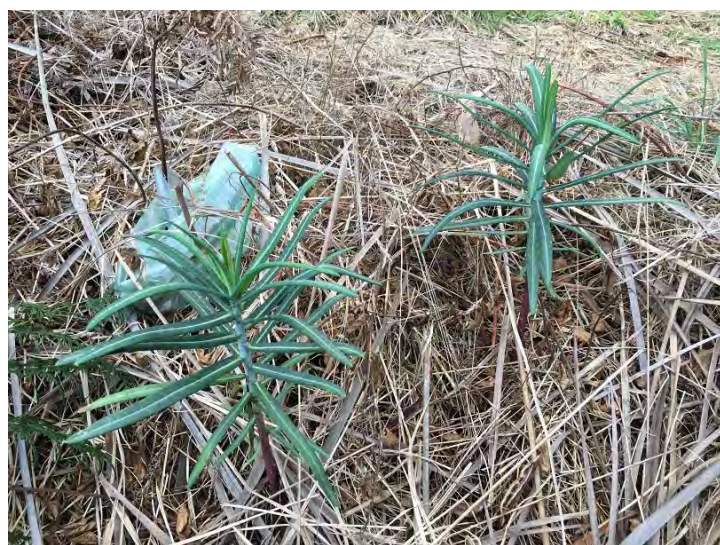
Spurge

The poisonous weed spurge (*Euphorbia* species) was observed in areas where the existing vegetative cover had been lost due to spraying. This is a very opportunistic species which can colonise areas of disturbed ground very quickly.

These plants should be pulled out whilst wearing gloves as the sap (white) of the plant can be toxic. Hands and clothing should be thoroughly washed afterwards or throw-away overalls used.

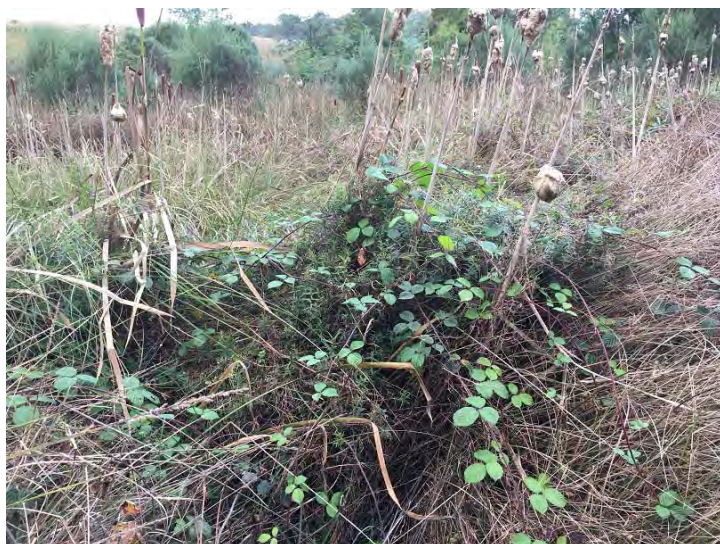
Blackberry

Vines and small thickets of this woody weed occur mainly on the edge of rehabilitated areas and fencelines to the west of the reserve.

Care should be taken when spraying this weed such that other, desirable plants are not impacted upon. There were several areas observed where native species (eg *Carex appressa* and *Juncus pauciflorus*) had been sprayed and were consequently dead or unhealthy.
