3.1 PLANNING APPLICATIONS APPROVED UNDER DELEGATED AUTHORITY.....	2
3.1.1 DELEGATED APPROVALS.....	2
4.1 PA2021.0166 - 49 WENVOE STREET DEVONPORT - RESIDENTIAL (SINGLE DWELLING).....	6
4.1.1 APPLICATION - PA2021.0166 - 49 WENVOE STREET.....	6
4.1.2 REPRESENTATION - PA2021.0166 - 49 WENVOE STREET.....	44
4.2 PA2021.0193 - 547 FORTHSIDE ROAD FORTHSIDE - RECYCLING AND WASTE DISPOSAL (EXPANSION TO AREA OF A LEVEL 2 ACTIVITY).....	47
4.2.1 APPLICATION - PA2021.0193 - 547 FORTHSIDE ROAD.....	47
4.2.2 REPRESENTATION - PA2021.0193 - 547 FORTHSIDE ROAD.....	213
4.2.3 EPA PERMIT CONDITIONS PART B - PA2021.0193 - 547 FORTHSIDE ROAD.....	215

Devonport City Council

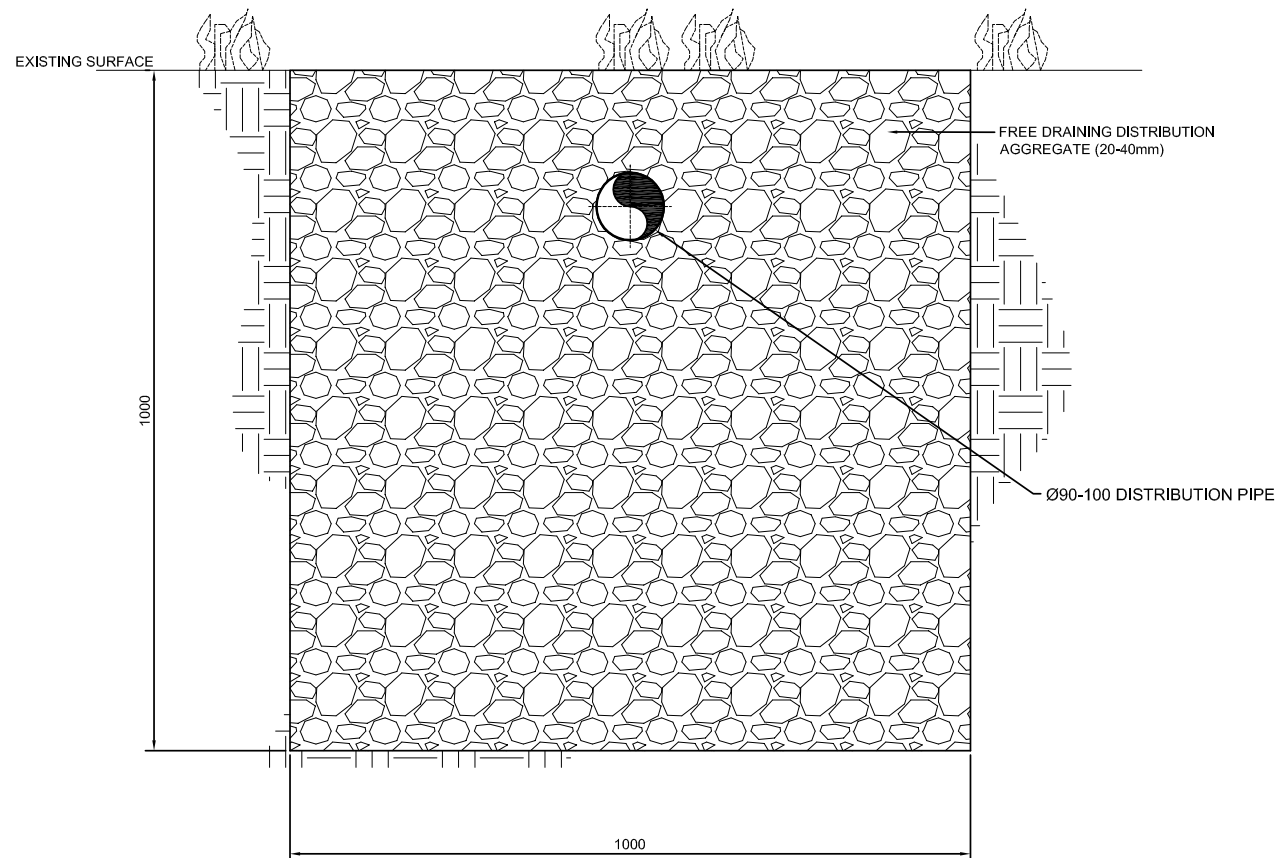
FIGURE:	2
DATE:	18/06/19
REVISION:	A
SCALE:	@ A4
DRAWN:	B.STREET
DESIGNED:	T.BARRIERA
APPROVED:	T.BARRIERA

STORM WATER DISCHARGE TRENCH

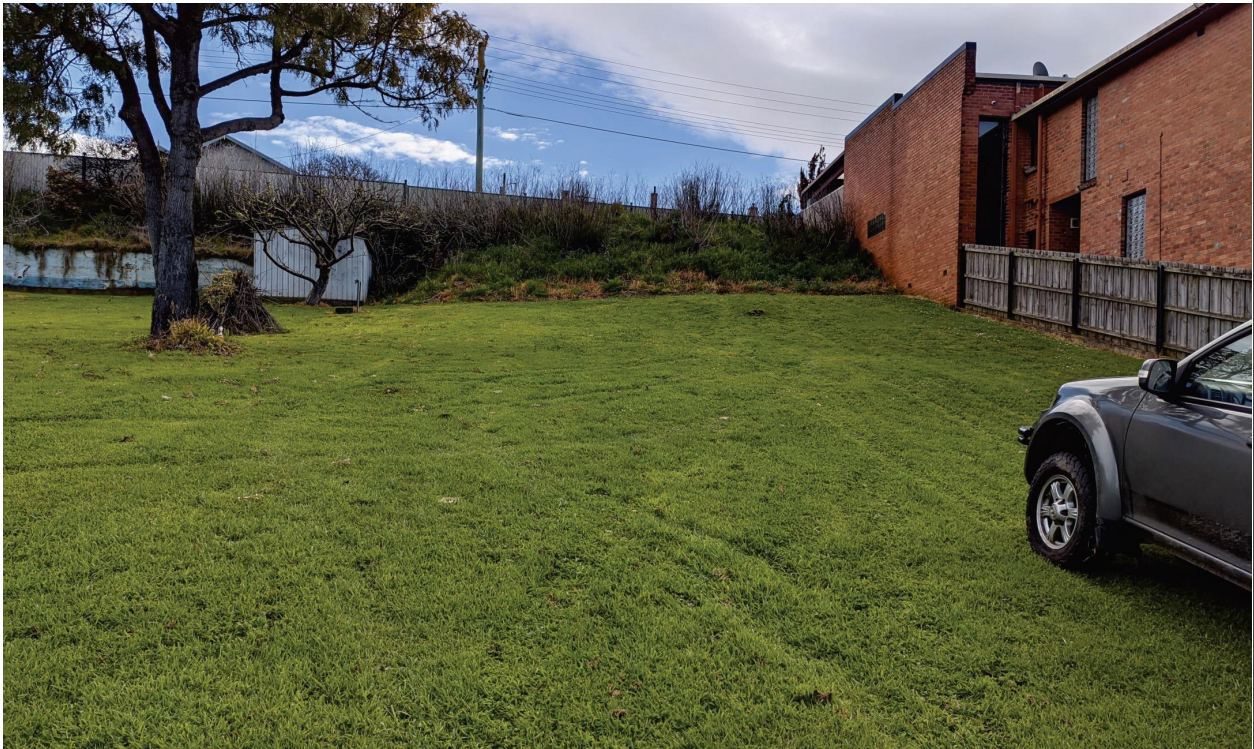
PLATE 1 - View of the site looking to the west

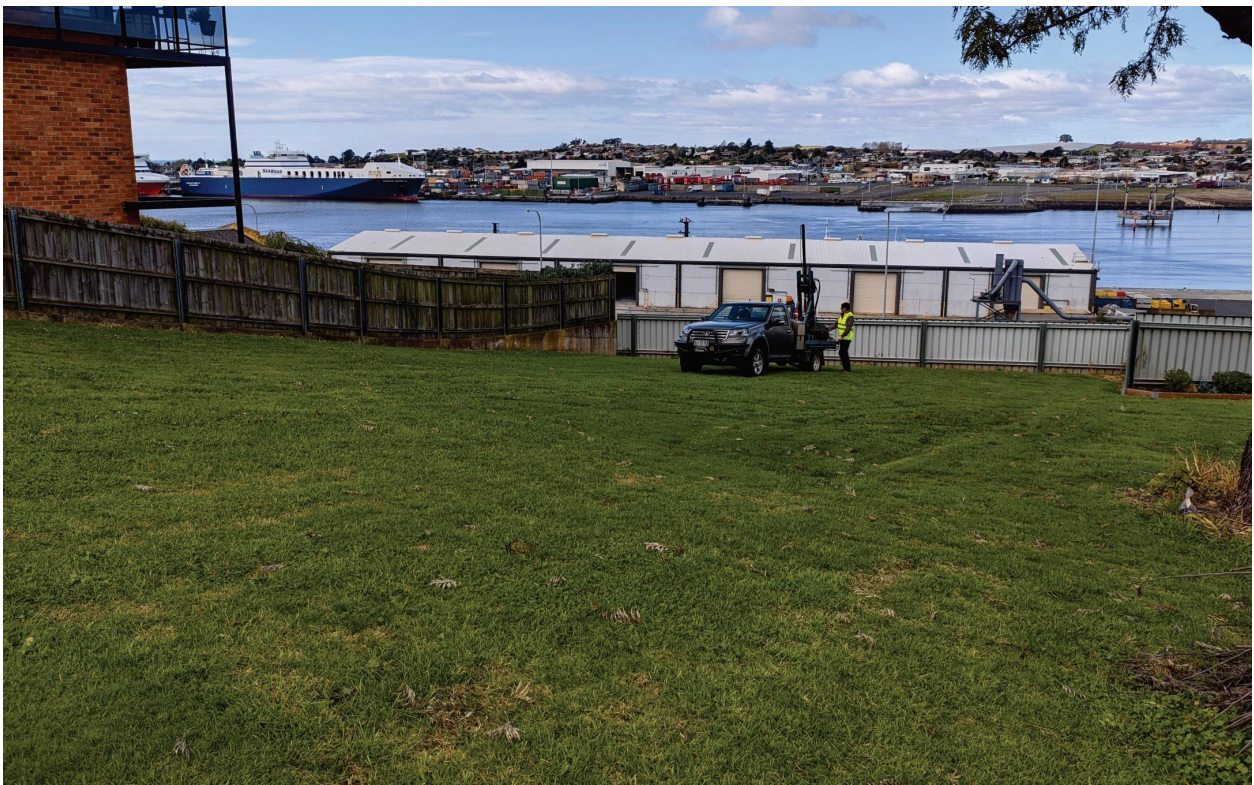
PLATE 2 - View of the site looking to the east

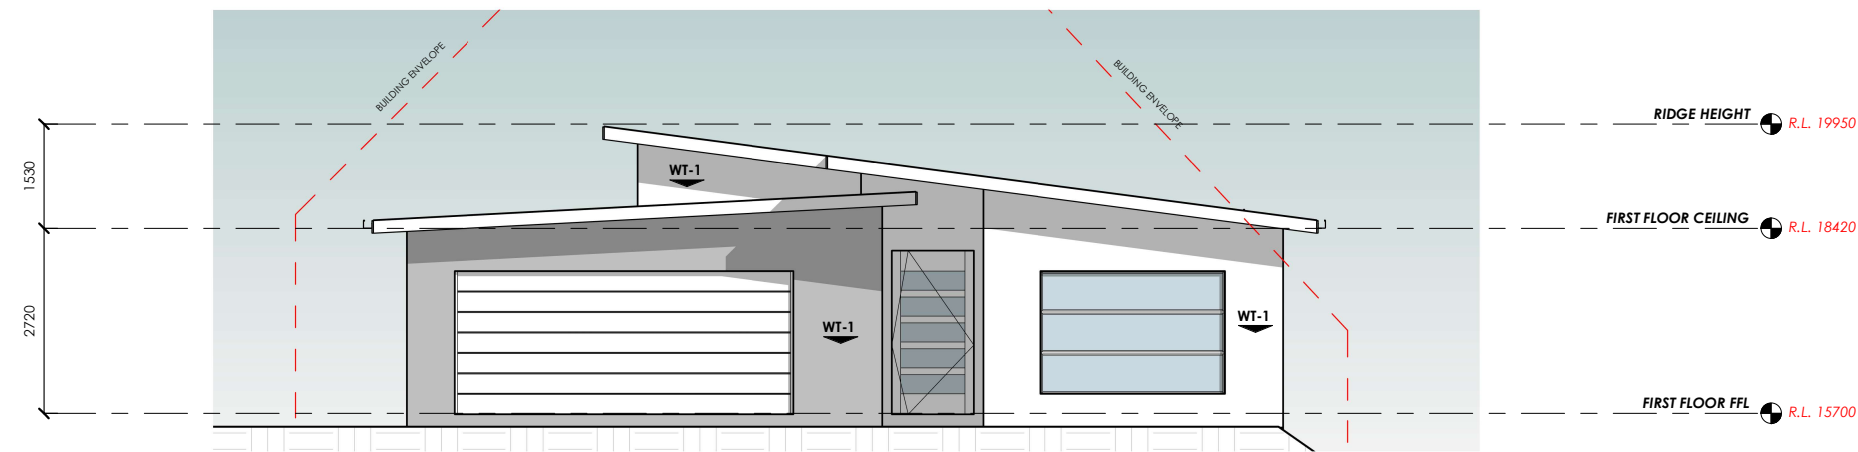
WEST ELEVATION
Scale 1 : 100

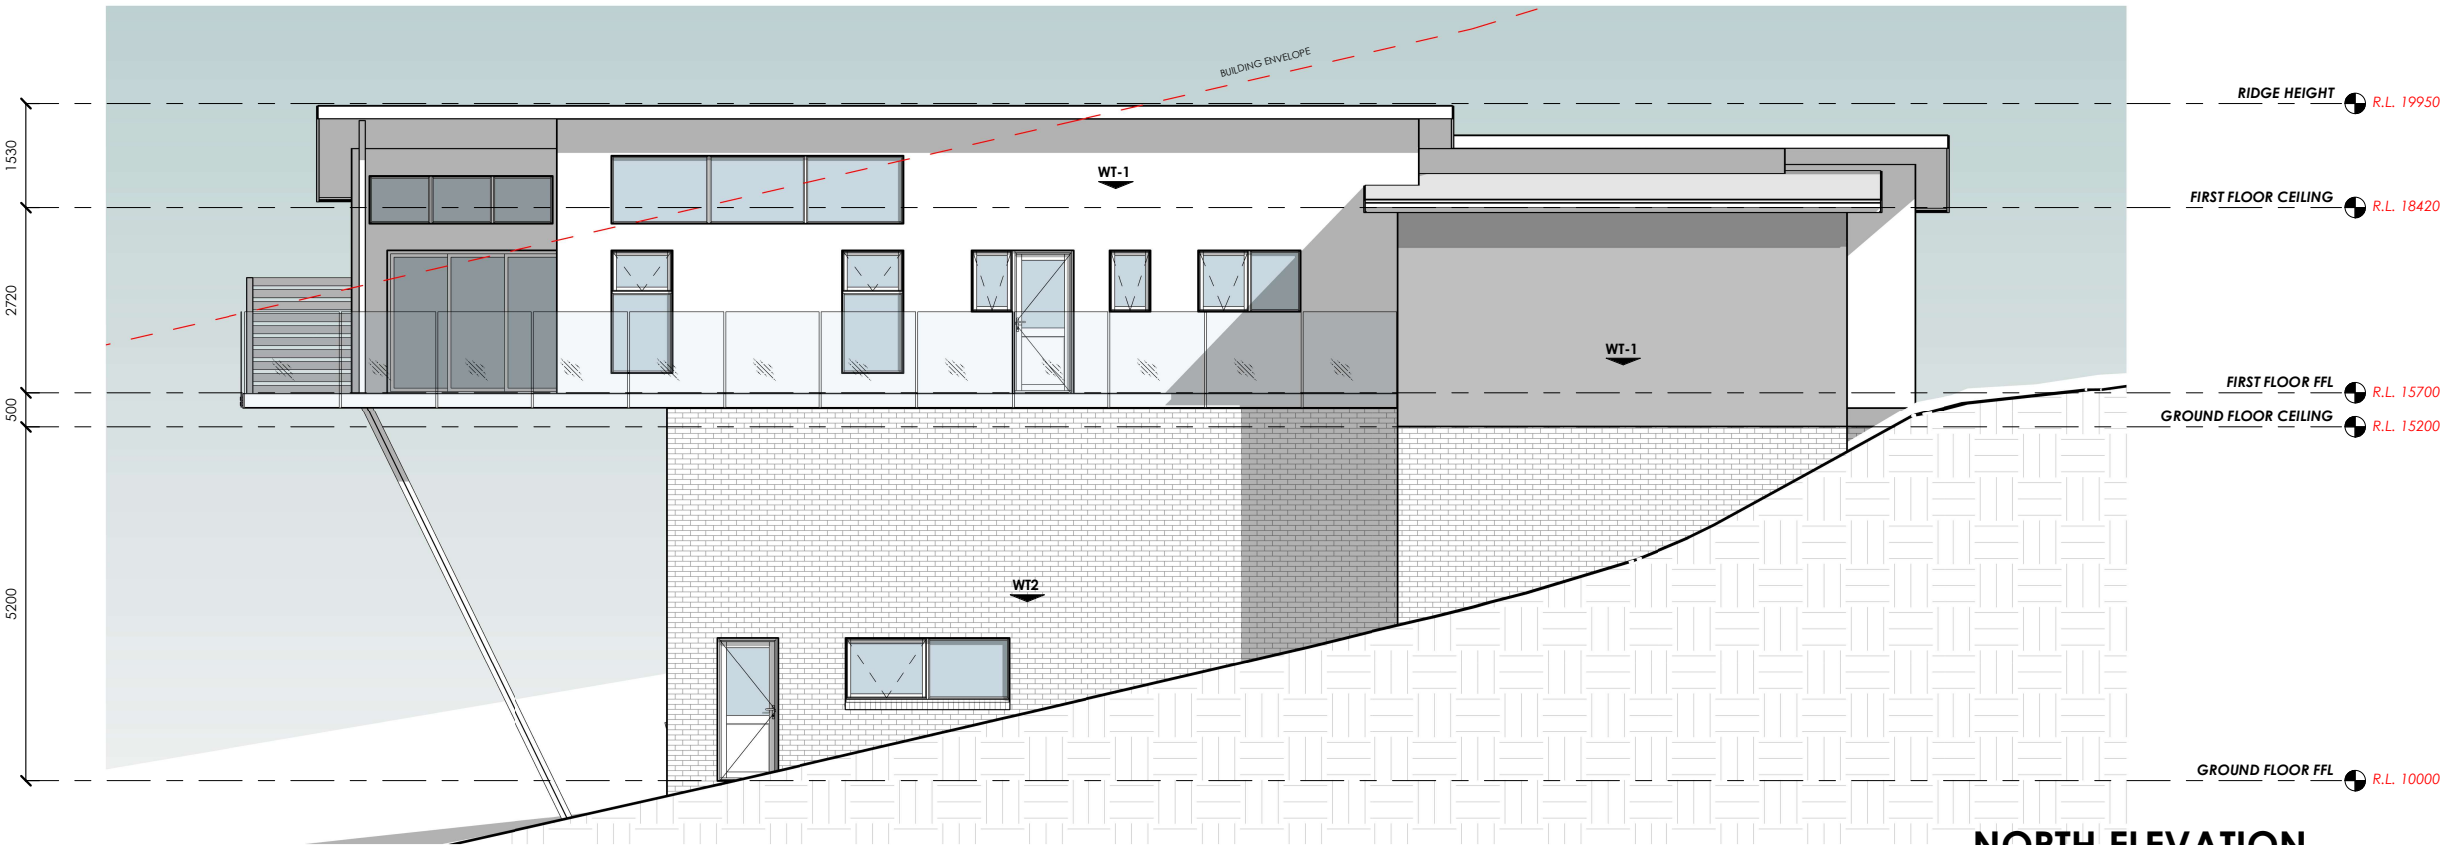
NORTH ELEVATION
Scale 1 : 100

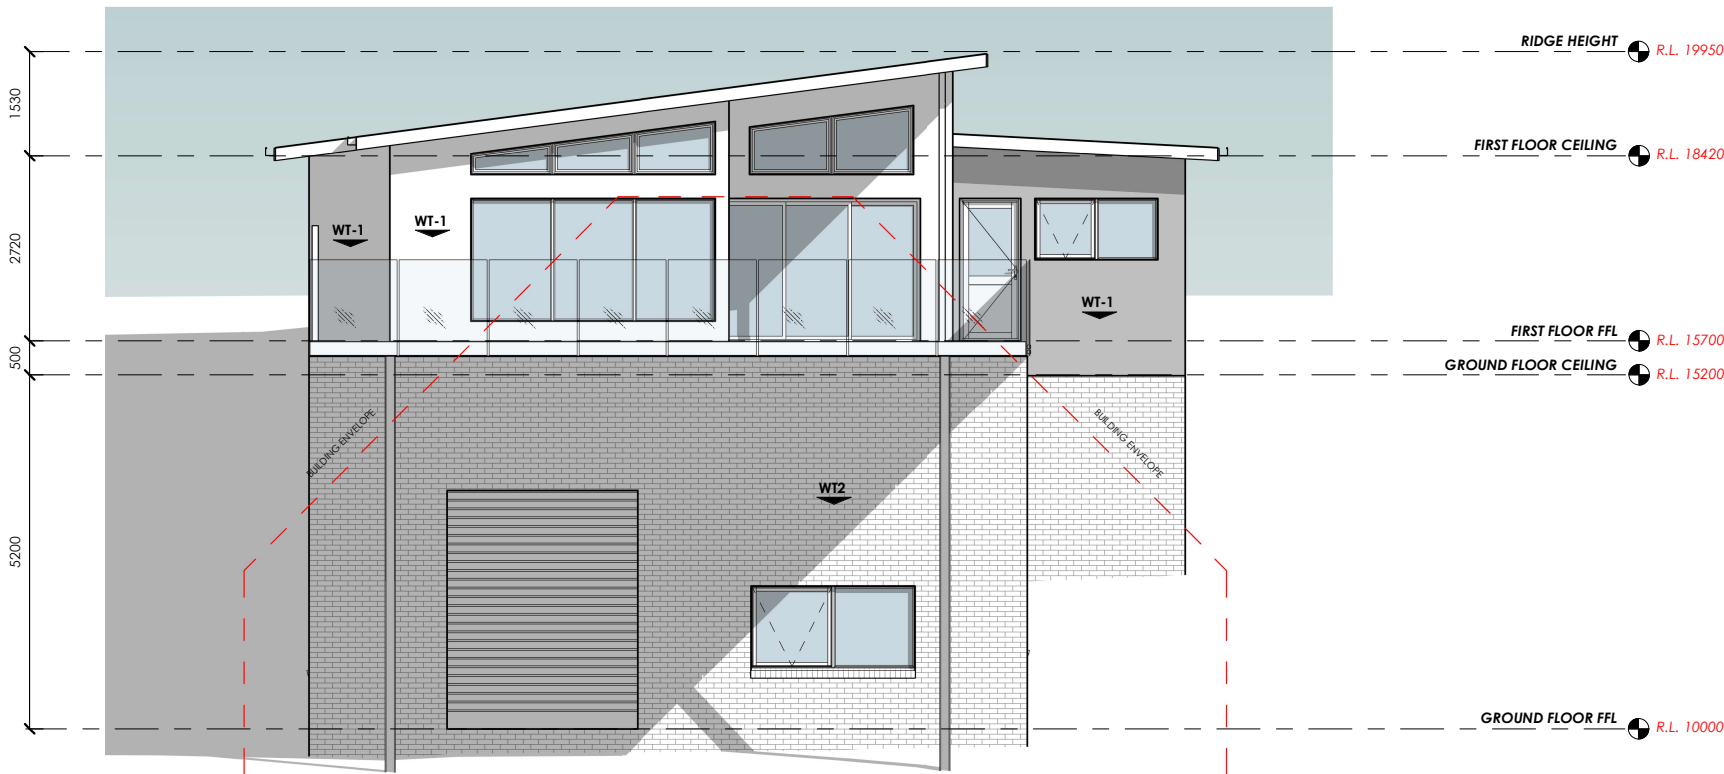
EAST ELEVATION
Scale 1 : 100

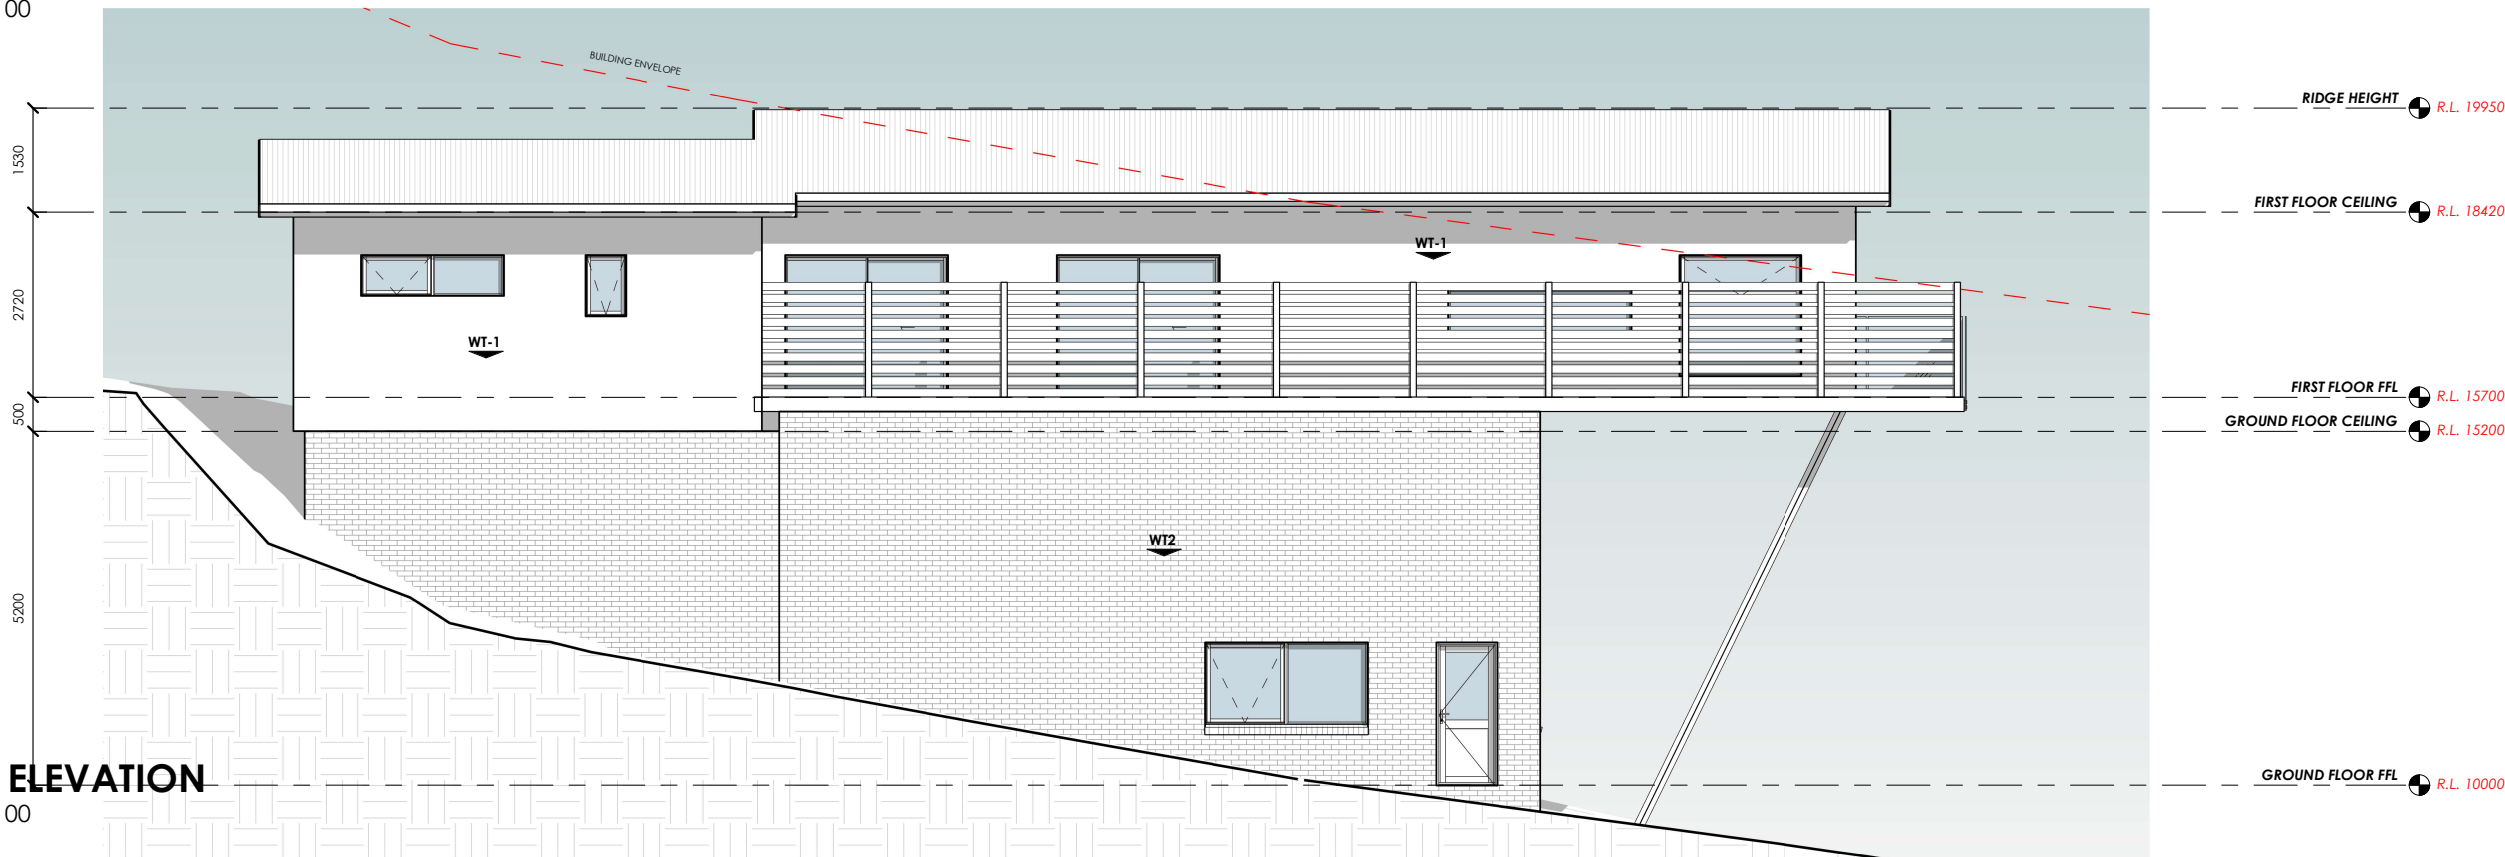
SOUTH ELEVATION
Scale 1 : 100

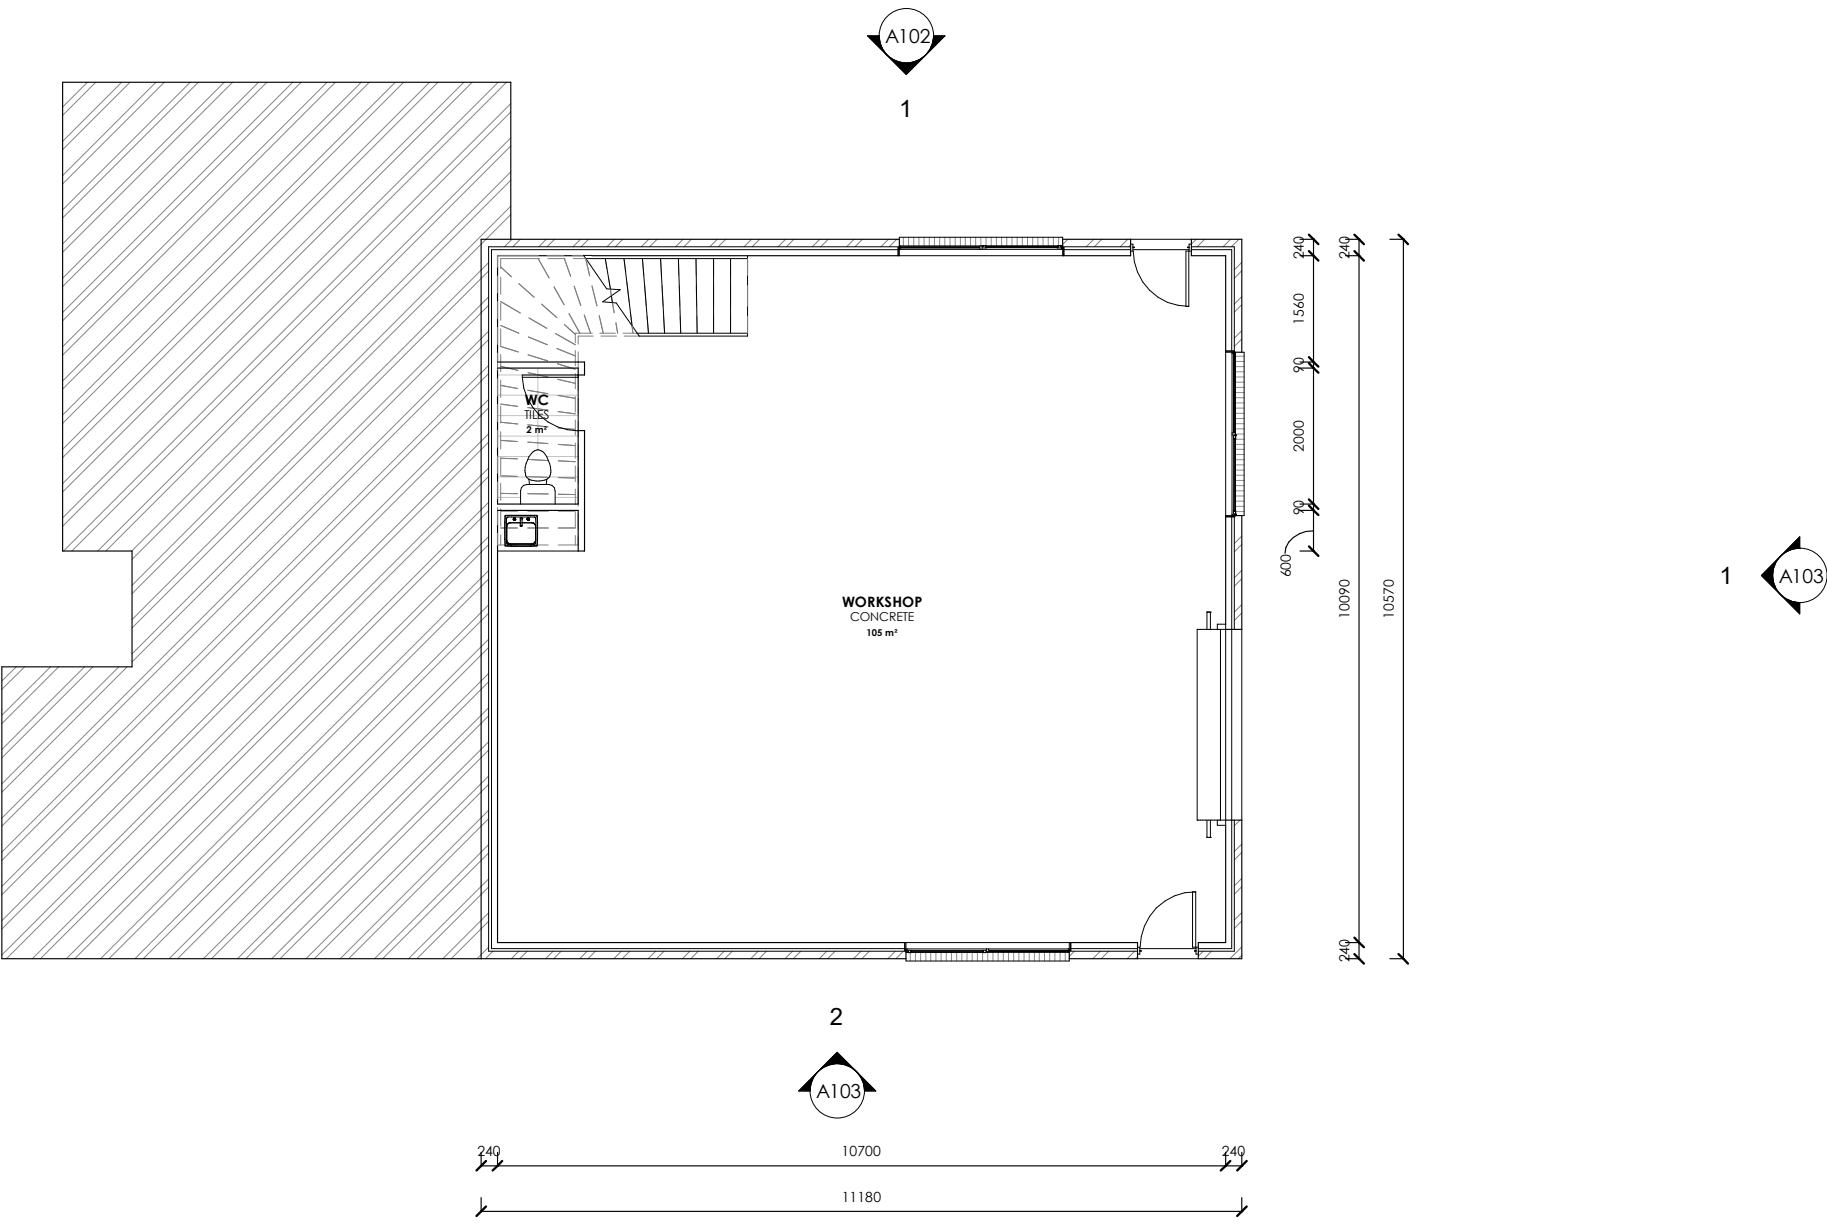
GROUND FLOOR PLAN
Scale 1 : 100

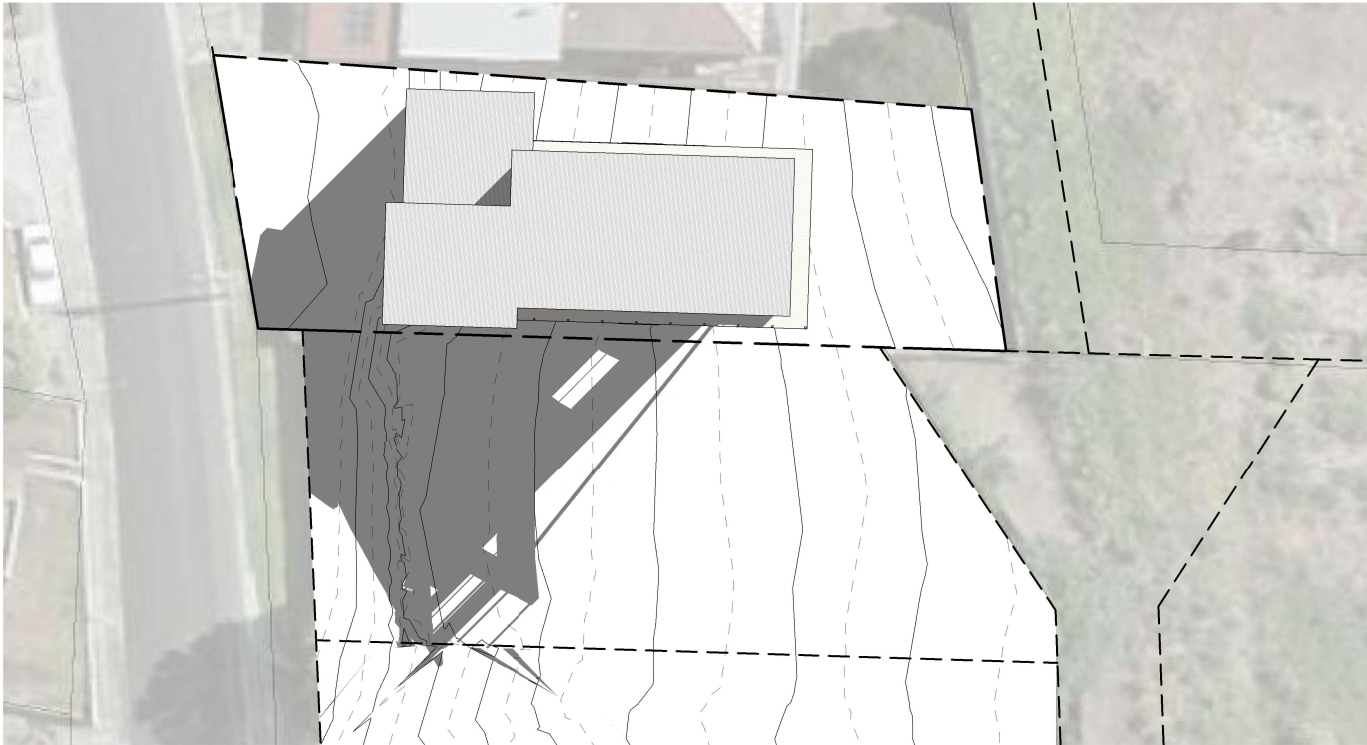
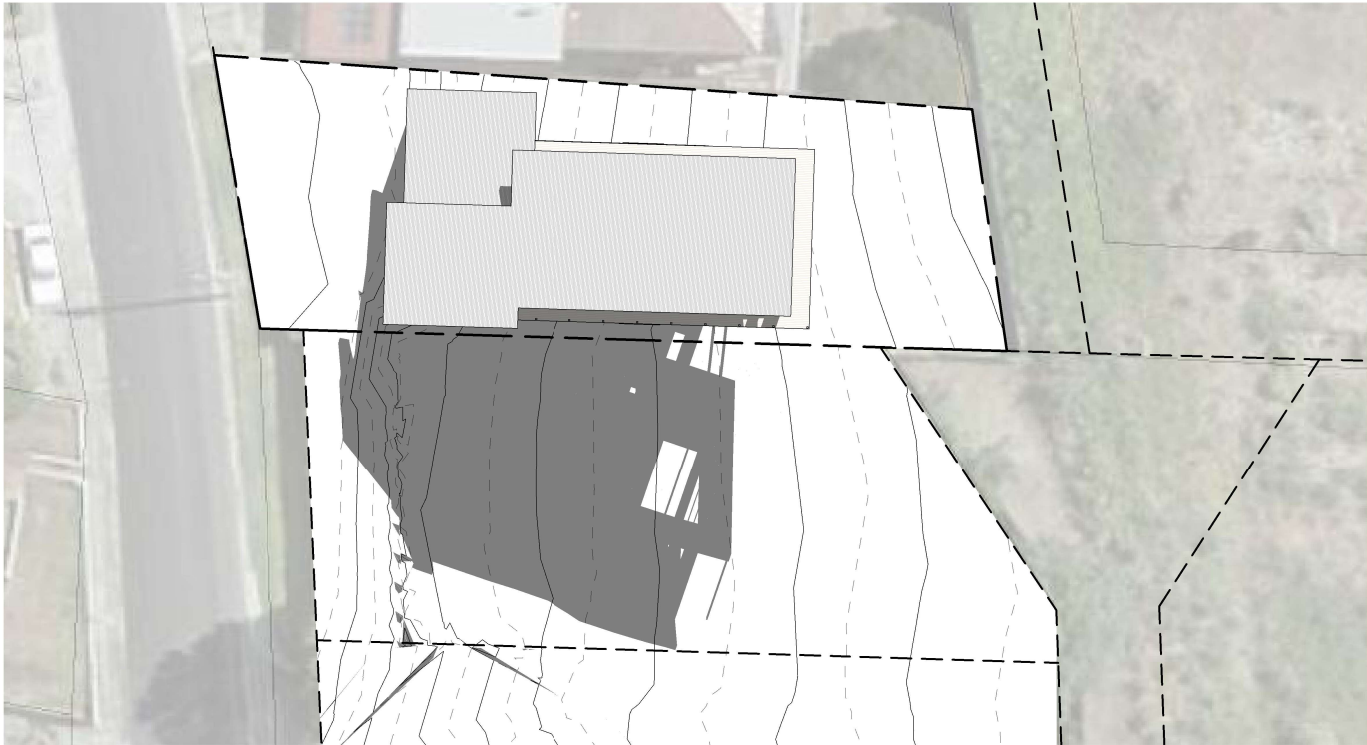
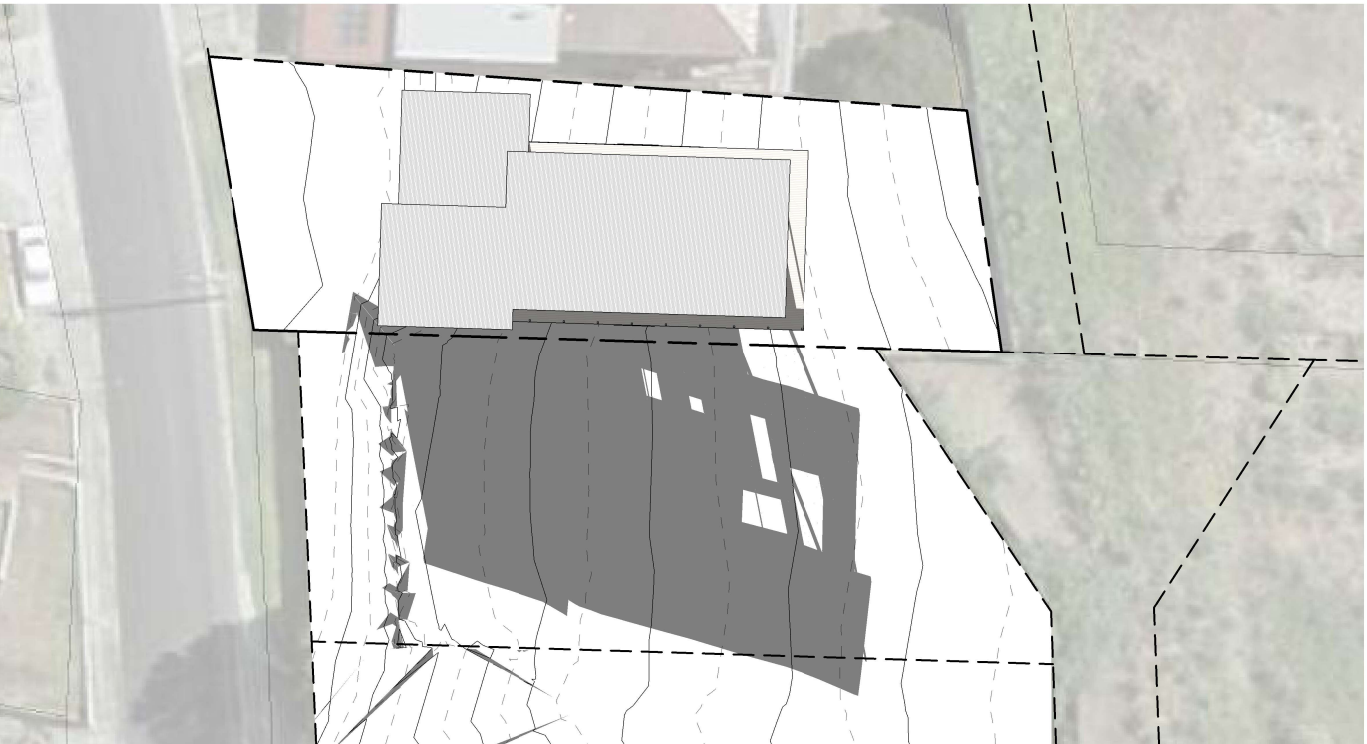
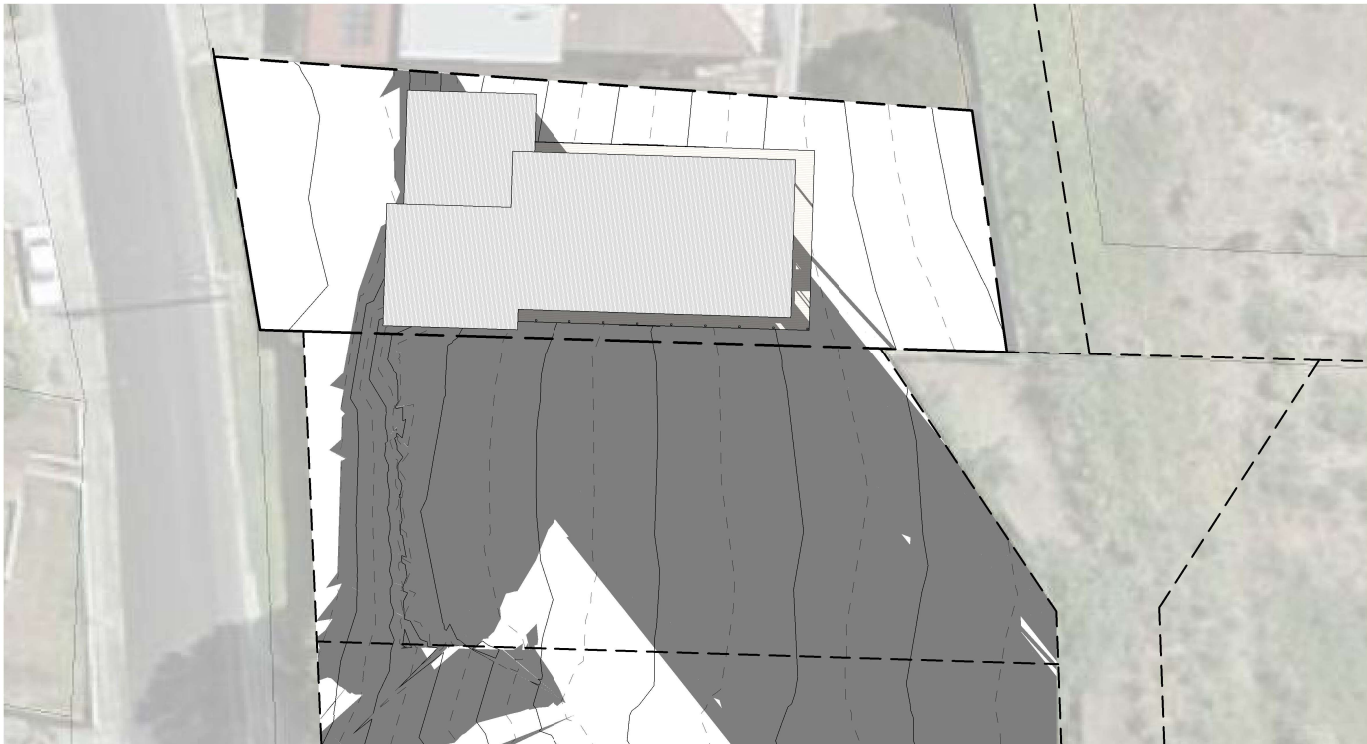
SHADOW DIAGRAM - JUNE 21st 9am
Scale 1 : 400

SHADOW DIAGRAM - JUNE 21st 11am
Scale 1 : 400

SHADOW DIAGRAM - JUNE 21st 1pm
Scale 1 : 400

SHADOW DIAGRAM - JUNE 21st 3pm
Scale 1 : 400

The shadow diagrams are two-dimensional and show the extent of overshadowing on the ground surface. The proposed house will extend over the ground surface, which will mitigate the overshadowing caused by 47 Wenvoe Street. Similarly, it is expected that, taking account of the predominant housing form on the lower side of Wenvoe Street (i.e. floor levels extending over the slope), it is highly likely that any future dwelling at No. 51 is capable of being designed to mitigate the overshadowing from the proposed dwelling whilst also mitigating its impact on No. 53.

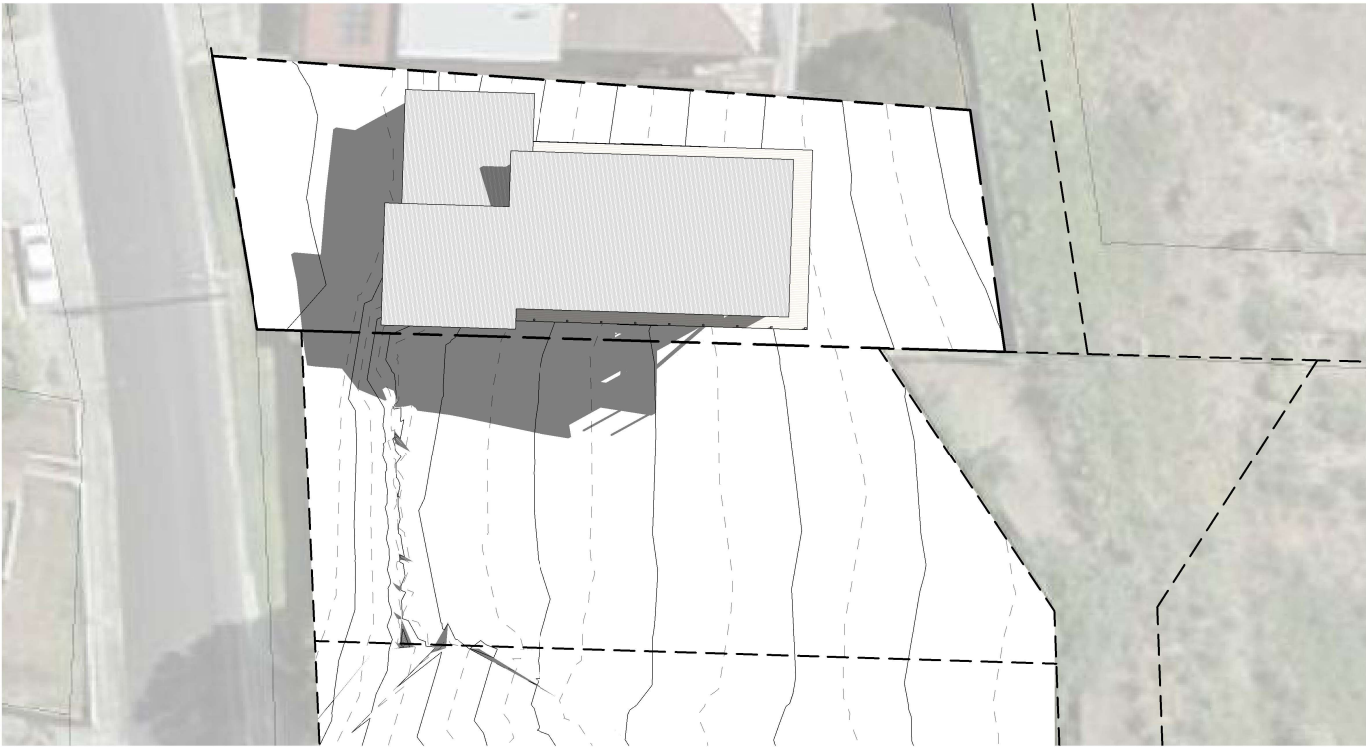
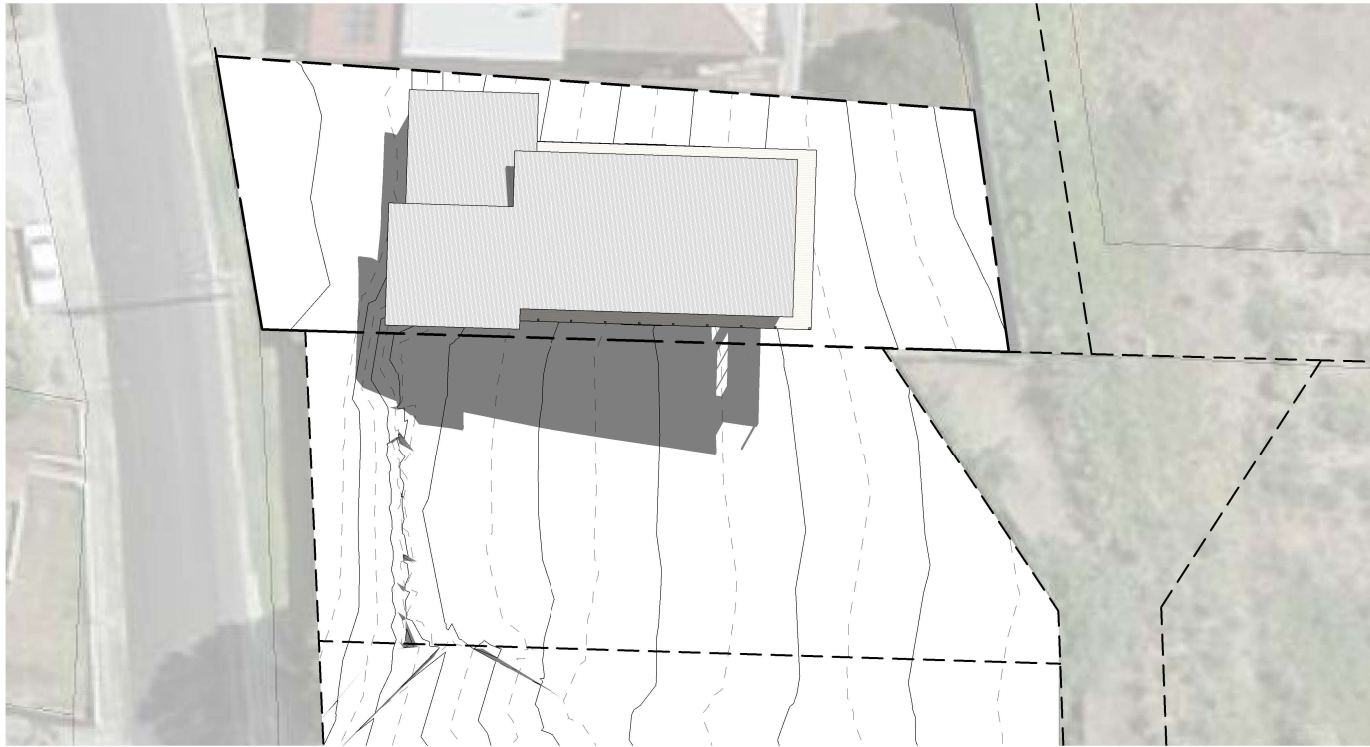
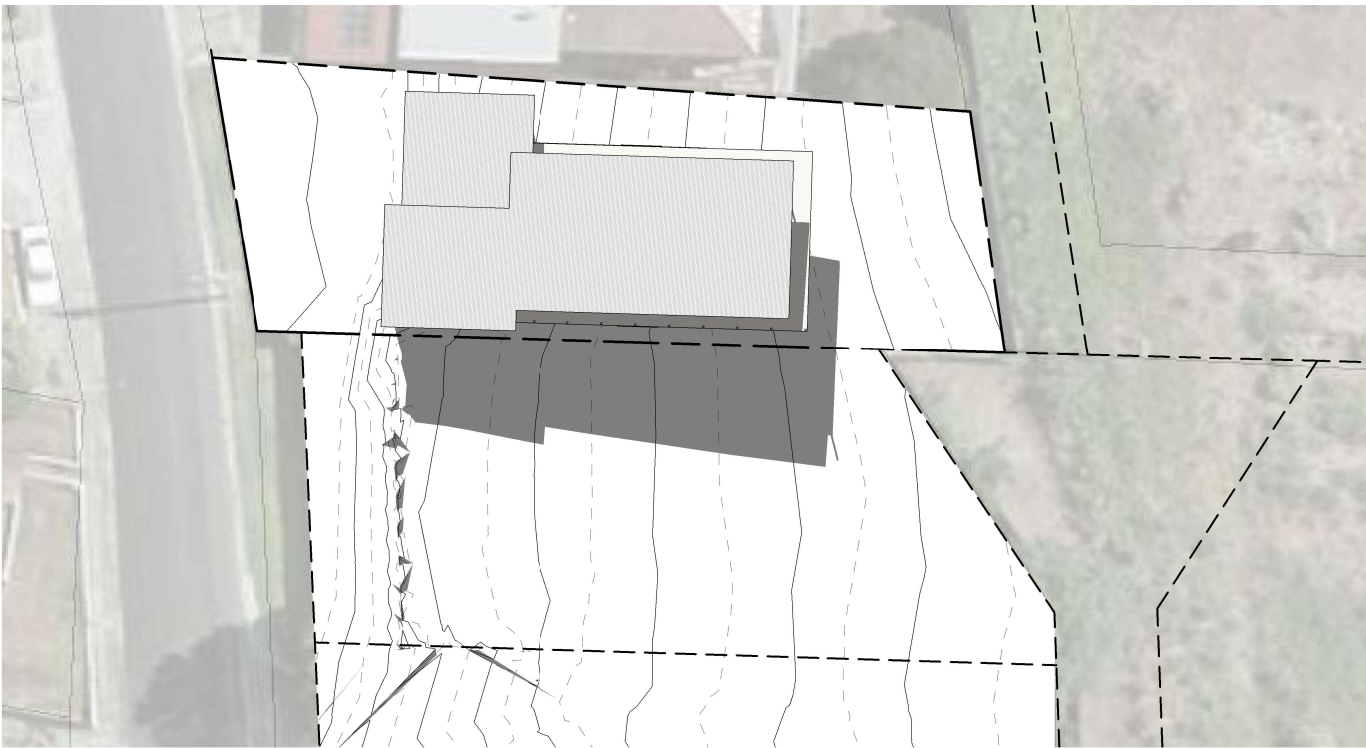
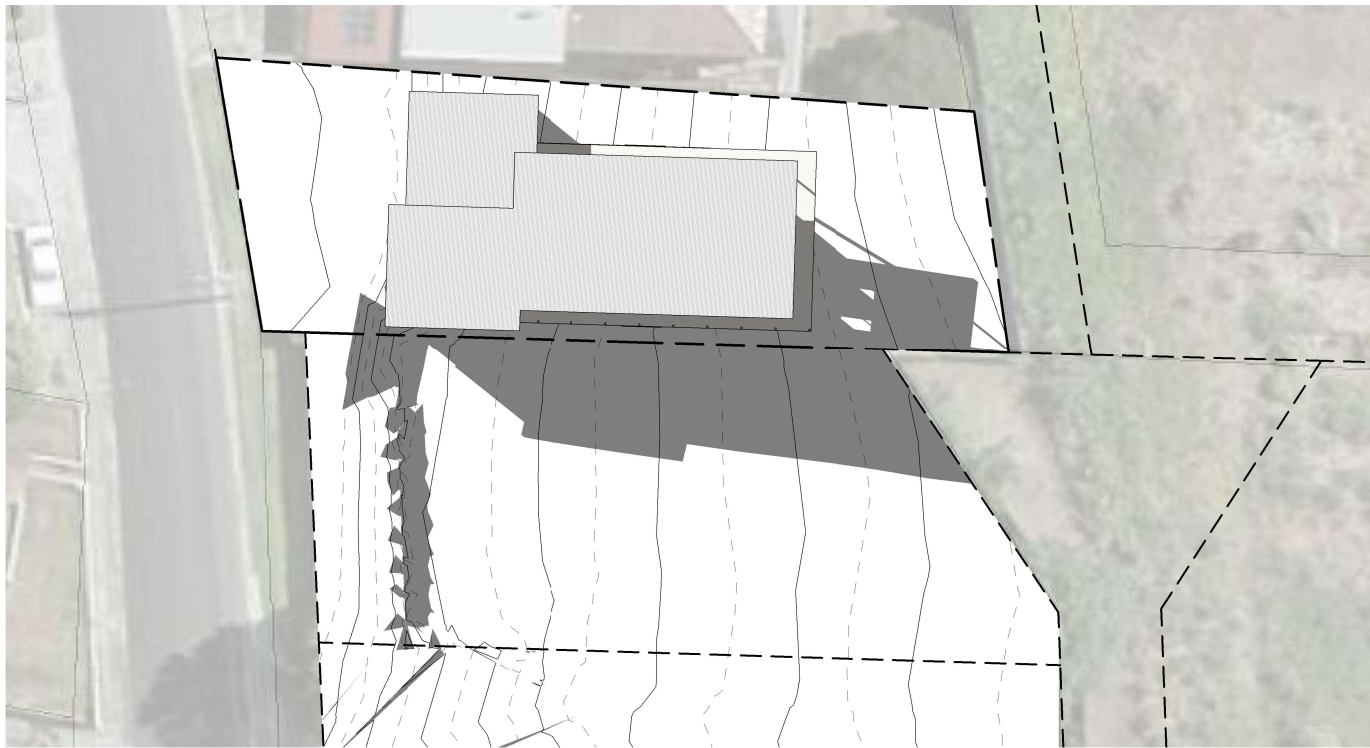
SHADOW DIAGRAM - MARCH 21st 9am
Scale 1 : 400

SHADOW DIAGRAM - MARCH 21st 11am
Scale 1 : 400

SHADOW DIAGRAM - MARCH 21st 1pm
Scale 1 : 400

SHADOW DIAGRAM - MARCH 21st 3pm
Scale 1 : 400

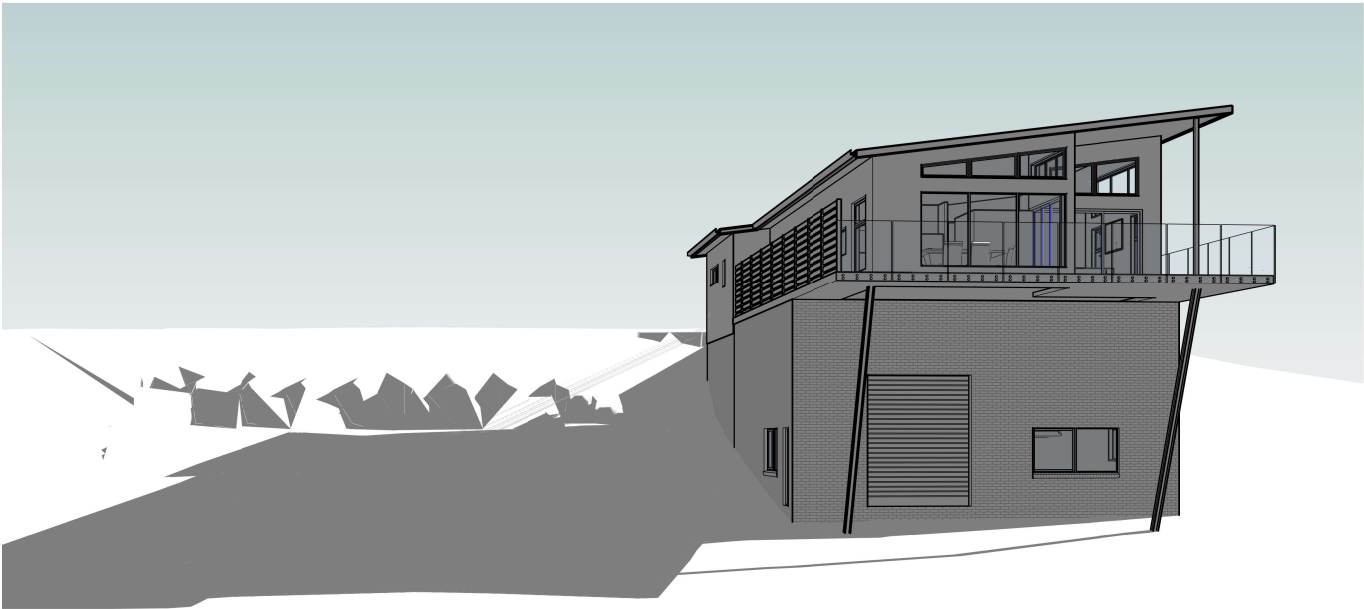
SHADOW DIAGRAM - JUNE 21st 1pm
Scale

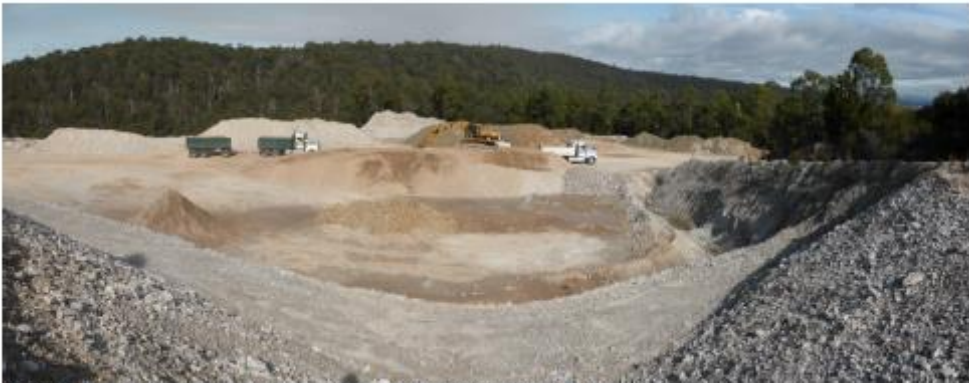
<p>Figure 1. Forthside is a large active hard rock quarry at low elevation</p>			
<p>Drainage: Generally good, but existing drainage needs repair.</p> <p>The quarry floor is generally hard and dry and effectively metalled with quarried material. However, there are two levels of drains running along the benches which need to be improved.</p> <ol style="list-style-type: none"> 1. The mid-level bench is almost driveable and this should be maintained as access for spraying. The drain running along at this level needs repair as water is escaping from here onto the quarry floor. 2. There is a shallow drain running along the back of the road above the top of the quarry. This drain should be cleared out to ensure it prevents any external water from entering the quarry. It is failing near the main access road and the all water is running back into the quarry.

Both of the existing drains require maintenance as they have both failed, and they are diverting run-off water into the active quarry area instead of away from it. Ensure that the drainage works are done with clean machinery.

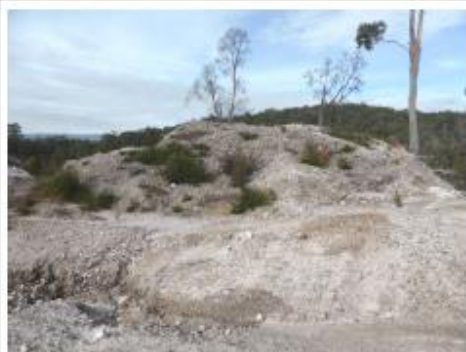
Figure 2. There is an isolated pile of topsoil on the southern edge of the quarry which is contaminated and which should be removed.

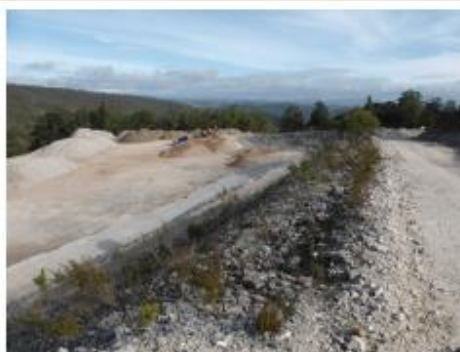
Figure 3. The bank of vegetation running across the top of the active quarry area is also contaminated with *P. cinnamomi*.

Spray off the western end of the internal bank where it has been scalped previously, and remove the vegetation and topsoil from the eastern end which has not been scalped and which has some imported piles of red dirt (and gorse!). Vegetation should be removed to the green waste area to the east of the quarry and the soil and weeds should be trucked to the storage area below the quarry. All machinery and trucks should then be washed down.
