3.1 PLANNING APPLICATIONS APPROVED UNDER DELEGATED AUTHORITY.....	2
3.1.1 DELEGATED APPROVALS.....	2
4.1 PA2021.0166 - 49 WENVOE STREET DEVONPORT - RESIDENTIAL (SINGLE DWELLING).....	6
4.1.1 APPLICATION - PA2021.0166 - 49 WENVOE STREET.....	6
4.1.2 REPRESENTATION - PA2021.0166 - 49 WENVOE STREET.....	44
4.2 PA2021.0193 - 547 FORTHSIDE ROAD FORTHSIDE - RECYCLING AND WASTE DISPOSAL (EXPANSION TO AREA OF A LEVEL 2 ACTIVITY).....	47
4.2.1 APPLICATION - PA2021.0193 - 547 FORTHSIDE ROAD.....	47
4.2.2 REPRESENTATION - PA2021.0193 - 547 FORTHSIDE ROAD.....	213
4.2.3 EPA PERMIT CONDITIONS PART B - PA2021.0193 - 547 FORTHSIDE ROAD.....	215

Devonport City Council

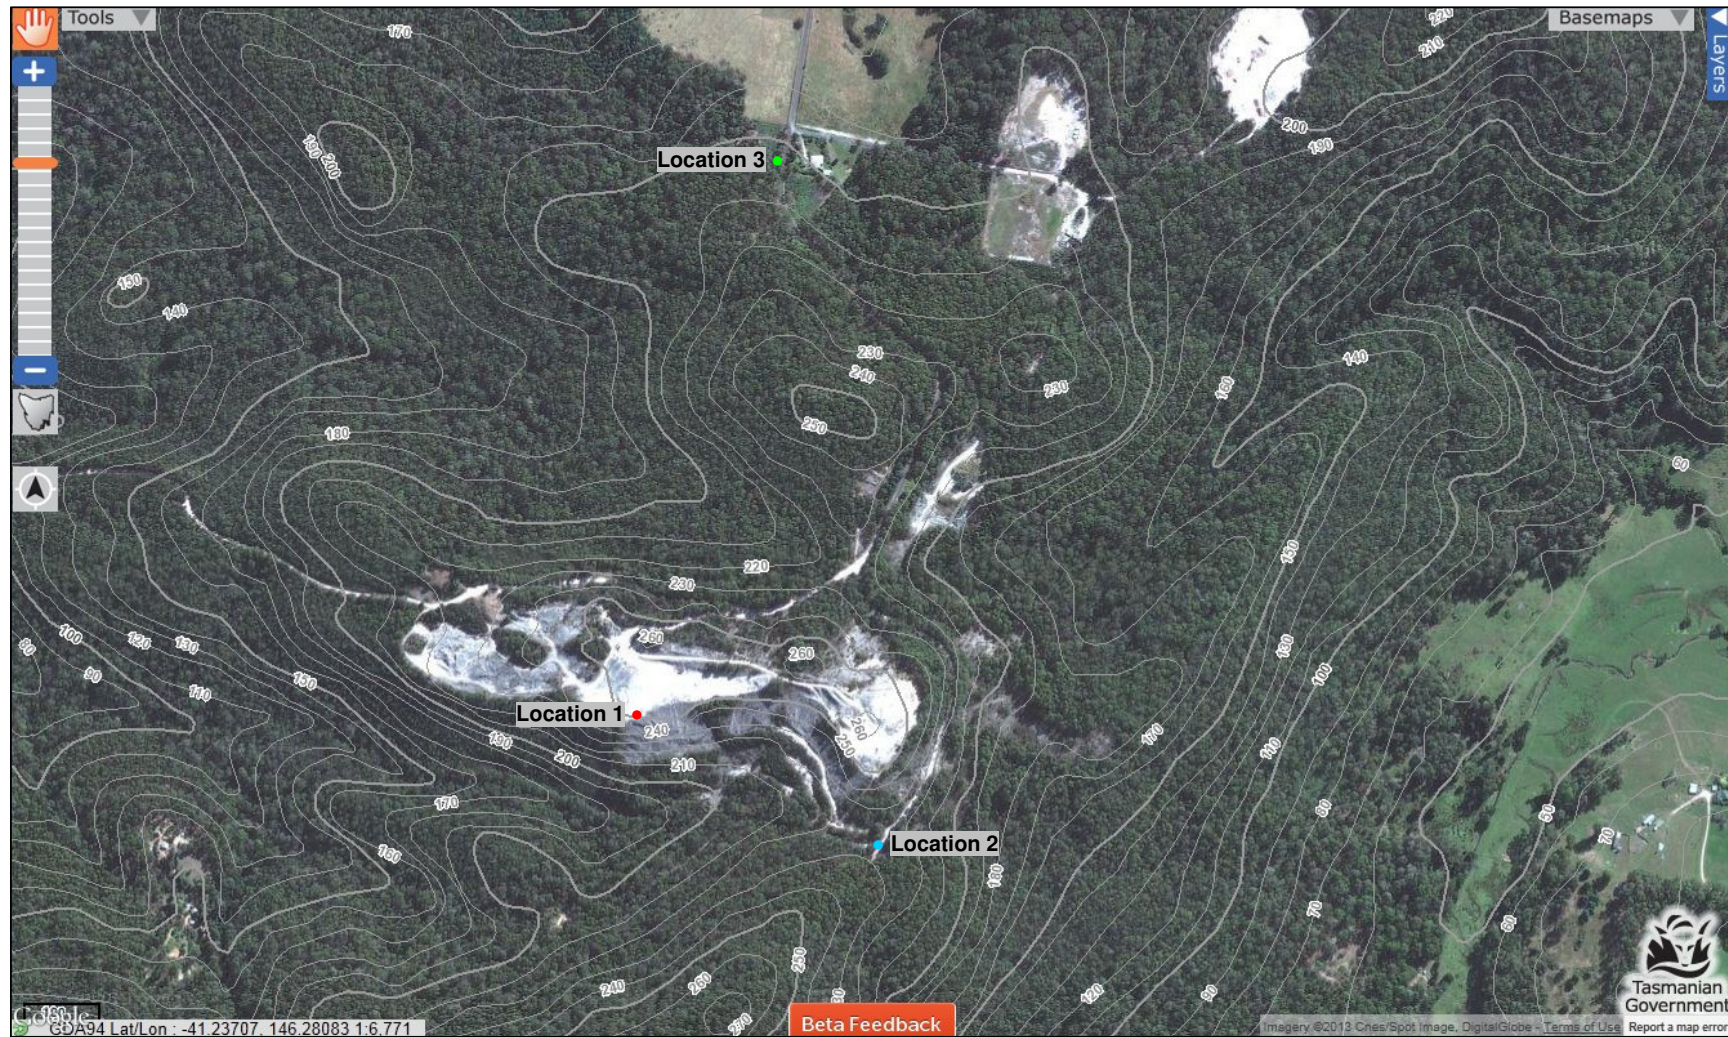
Location – airphoto showing quarry site, monitoring locations and surrounds

Monitoring locations plotted to reasonable accuracy. Imagery sourced from TheList 29/11/2013. Scale bar 100 m.

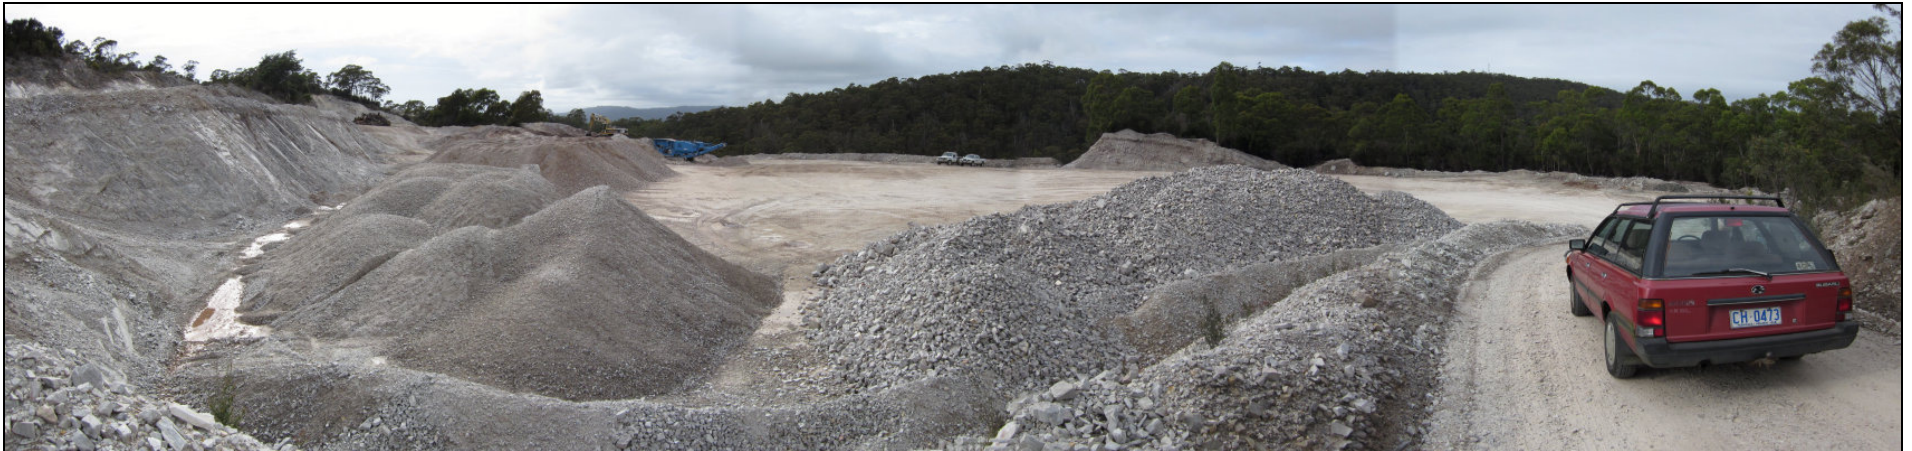
Panorama photograph – Quarry from access decline

View of quarry, looking to east-south arc from access decline. Location 1 was positioned near parked cars, 27/11/2013
Note the 4-photo composite has minor join error and distortion

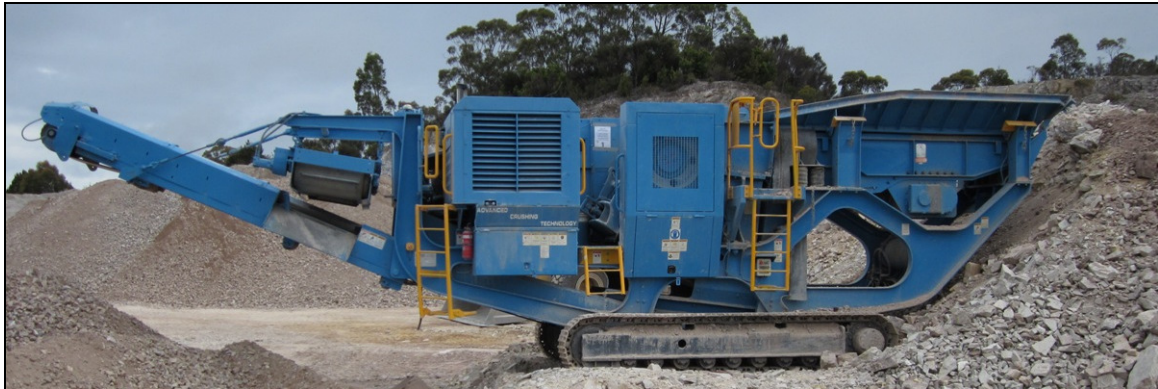
P22 Pegson Jawcrusher 300 HP, 27/11/2013

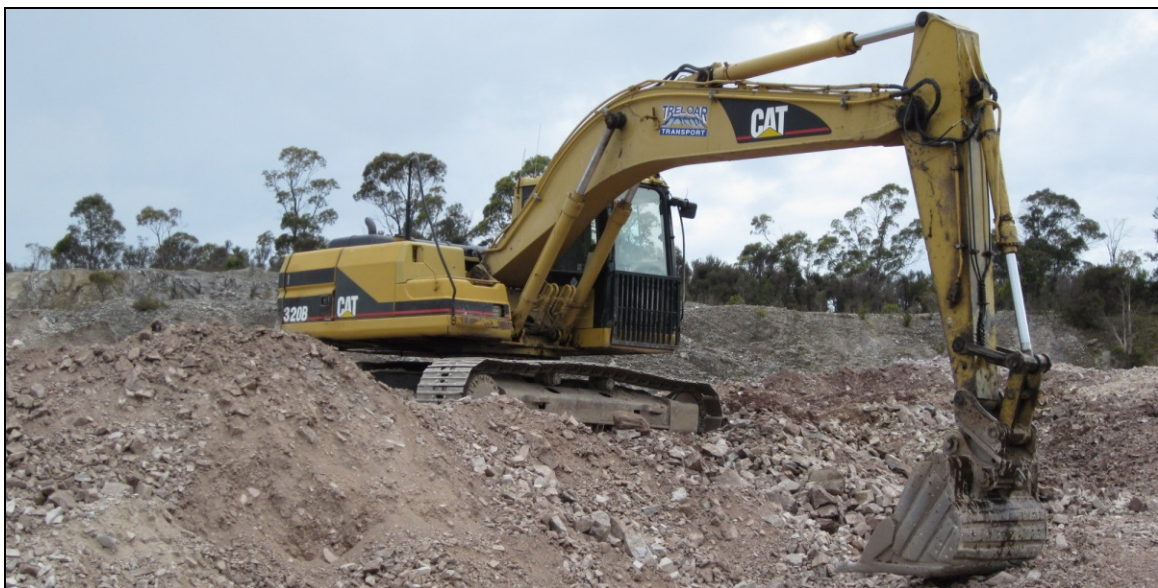
P1 320B CAT excavator 120 HP, 27/11/2013

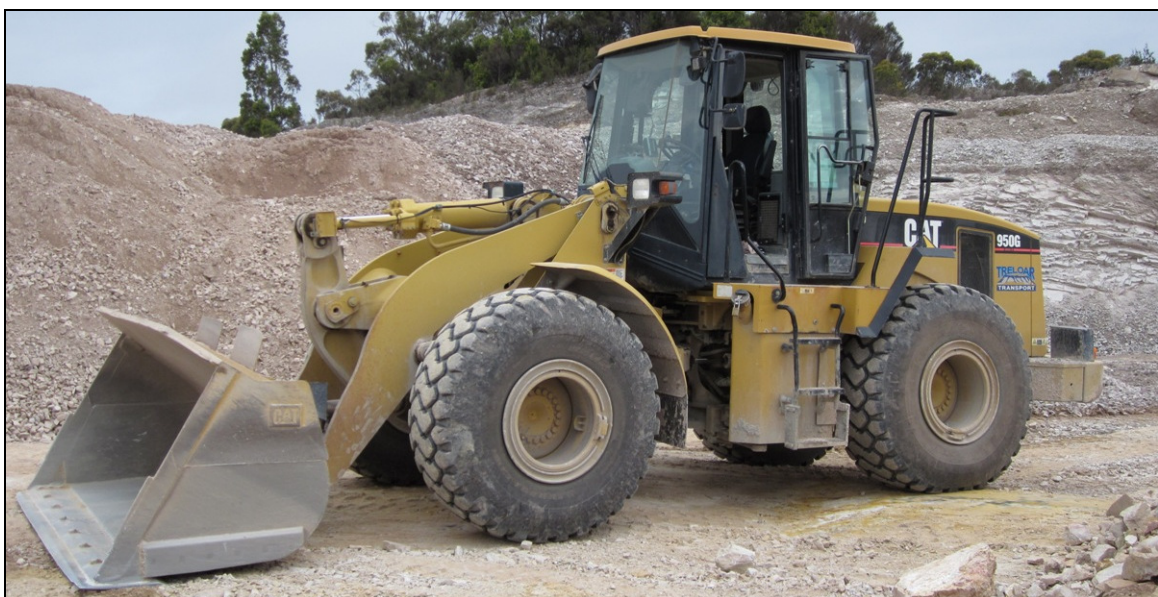
P38 950G CAT loader 180 HP, 27/11/2013

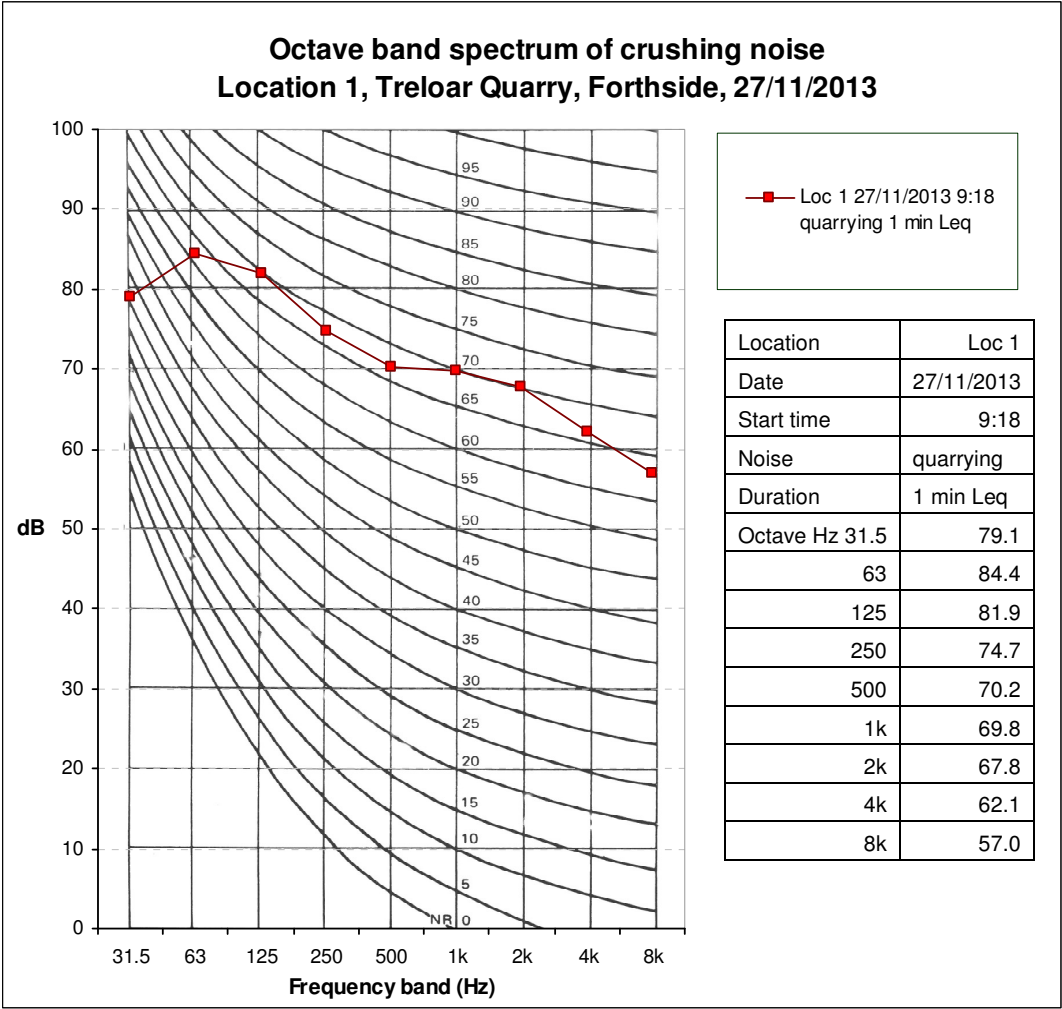
A13

Spectral analysis of quarrying noise at Location 1

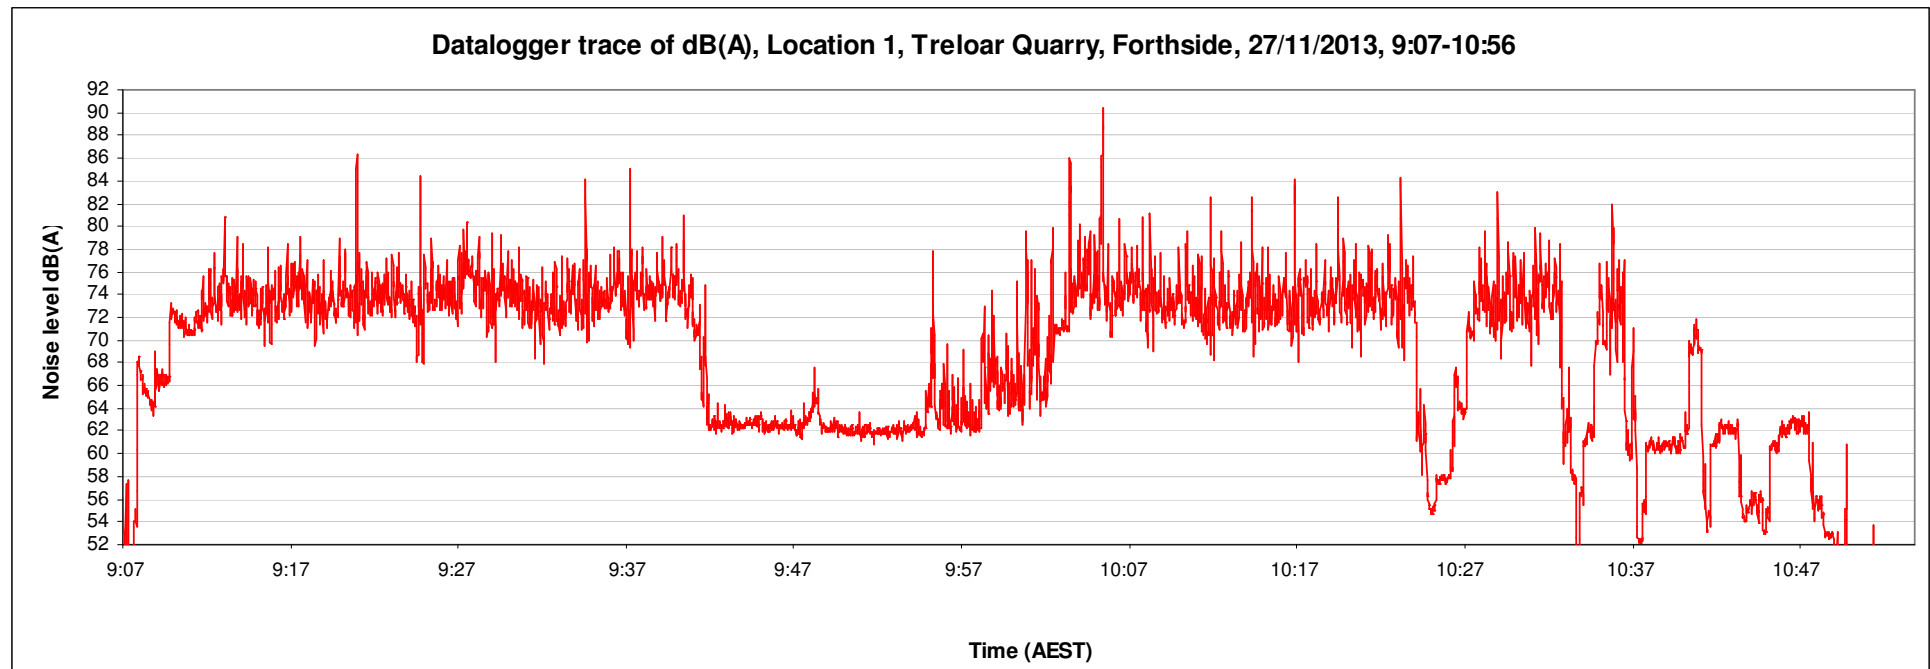
Datalogger monitoring of quarrying noise at Location 1

Note: ambient lulls fell below 52 dB(A), the lower limit of measurement of this instrument.

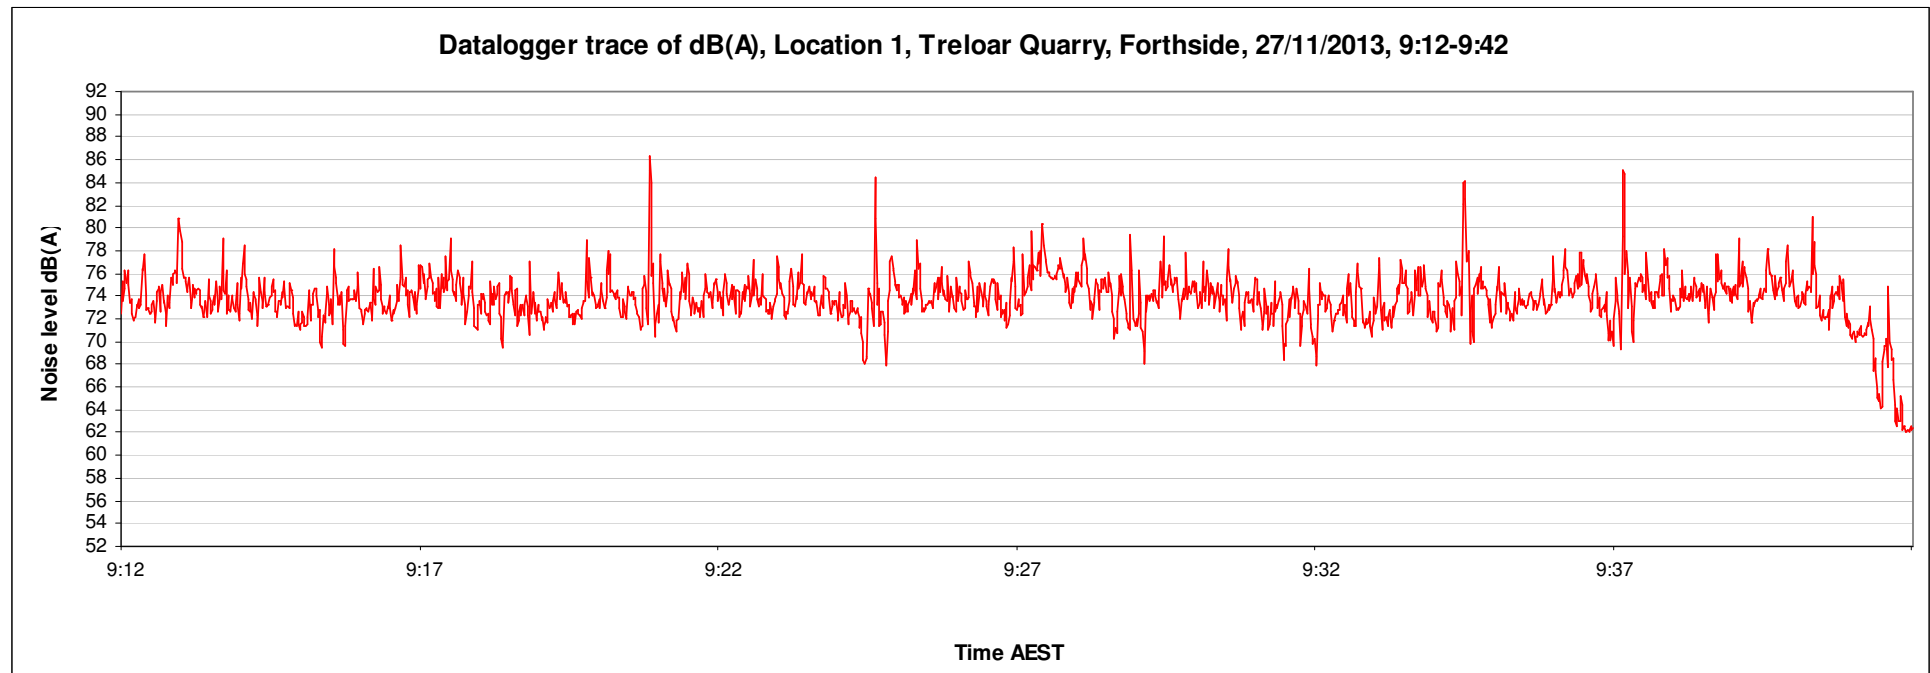
Datalogger monitoring of quarrying noise at Location 1 – 30 minute sub-sample period

The expanded portion of the trace shows the nature of the crushing operation noise at 28 m.

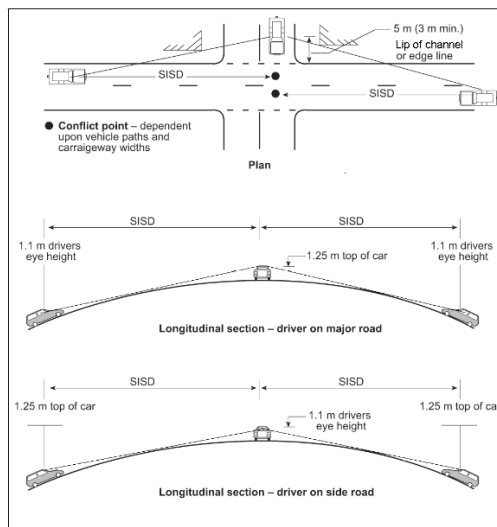
Figure 3.2: Safe intersection sight distance (SISD)

I assessed the site conditions to The Austroads AGRD04A/09 Guide to Road Design Part 4A: Unsignalised and Signalised Intersections. This standard (table 3.2) requires that Safe Intersection Sight Distances (SISD) of 114, 141, 170 and 201m be provided for design speeds of 60, 70, 80 and 90 km/hr, a reaction time of 1.5s and an eye height of 1.1m to a truck at 2.4m. A reaction time of 1.5 seconds is permitted in this instance as the road is rural and the alignment contains many horizontal curves.

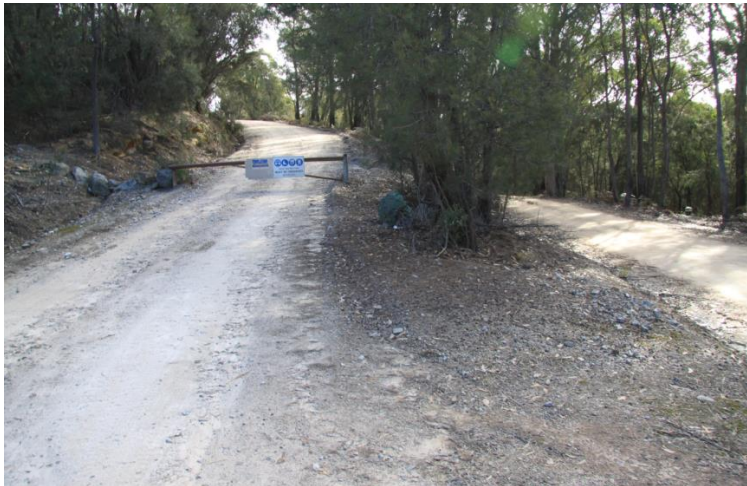
The 3.7m wide gravel access descends from the quarry to Perrys road at a steady gradient of about 17% which flattens out at the merging point. The access merges onto Perrys road making visibility of traffic approaching along Perrys Road difficult for trucks other than by assessing their rear vision mirrors.

The angle of this intersection is nominally 5 degrees which does not comply with the recommended intersection angle of not less than 70 degrees contained in older versions of the Austroads Part 5 Intersections at Grade. The current Austroads AGRD04A 09 Guide to Road Design Part 4A: Unsignalised and Signalised Intersections outlines that intersections should be as close as possible to 90 degrees to make visibility of the road easier for all parties approaching intersections. The older driver demographic particularly finds it difficult to look behind for vehicles approaching.

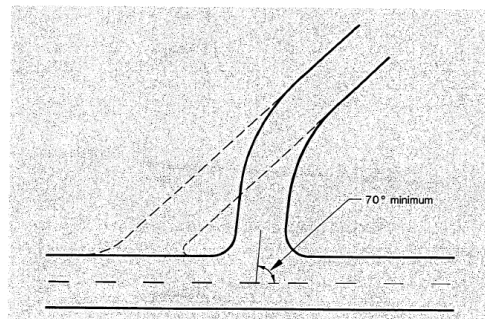
FIGURE 5.4 Treatment of Low Angle Intersection

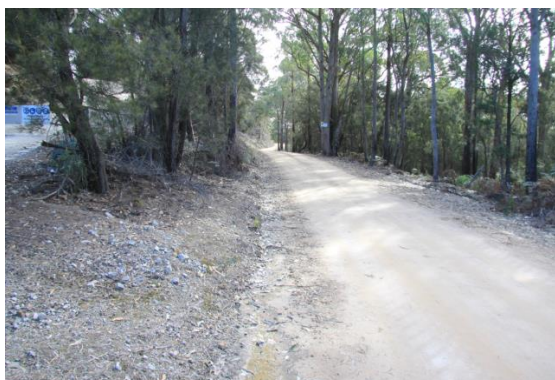
In this instance the truck drivers will be approaching this intersection very slowly down the hill and the likelihood of traffic on Perrys Road is limited. There is some 13m where rear vision along the road will be excellent for the merging trucks before they encroach into the Perrys Road east bound traffic.

The regularly trafficked width of Perrys Road west of the intersection is 3.6m

wide with trafficable widening out to 5.3m available should the need arise.

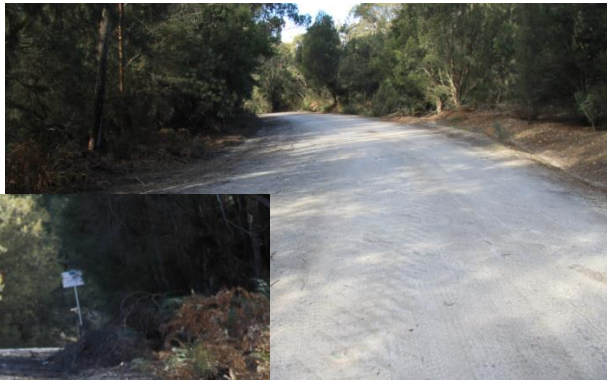
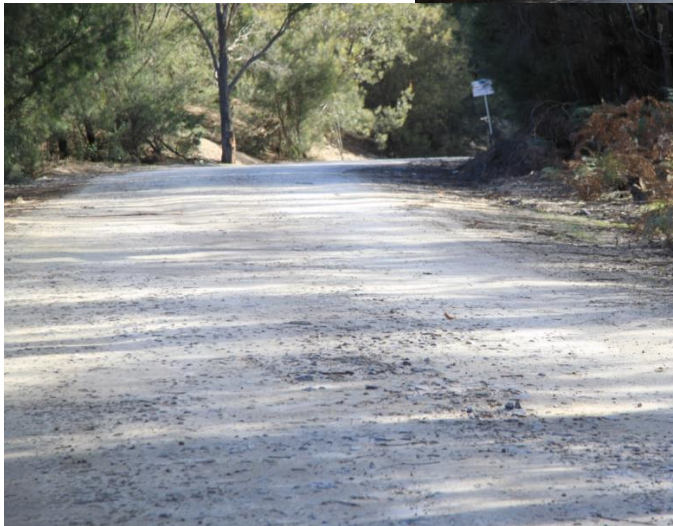
View from the east towards the intersection. Road width at this location is 4m.

The eastern approach to the intersection has additional trafficable pavement at around 7.3m width.

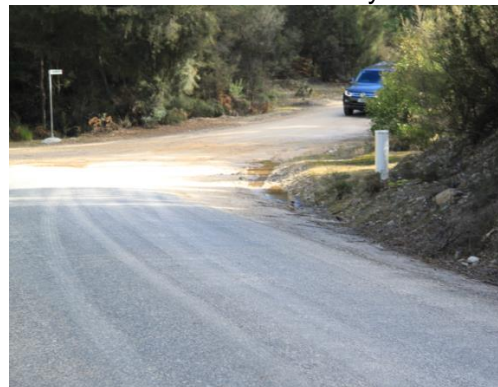
Perrys Road has good visibility south on Forthside Road for about 25m before vehicles impact on the through lane of Forthside Road. A vehicle travelling north on Forthside Road approaching Perrys Road will sight a vehicle on Perrys Road approaching the intersection from approx. 72m.

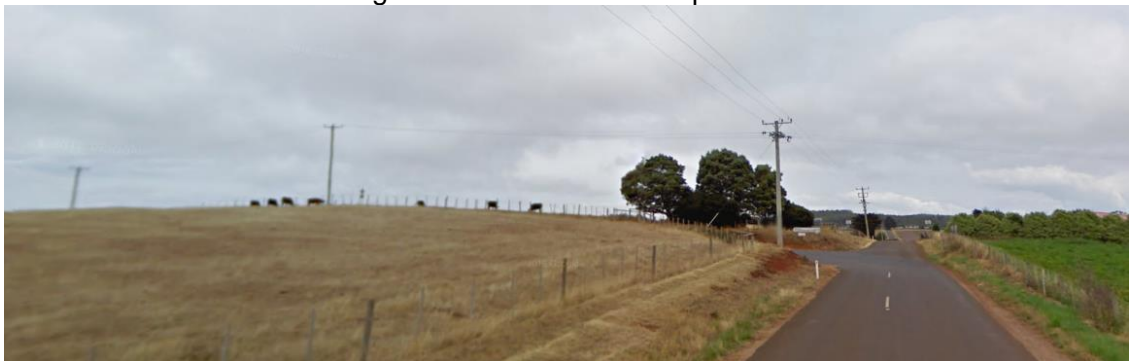
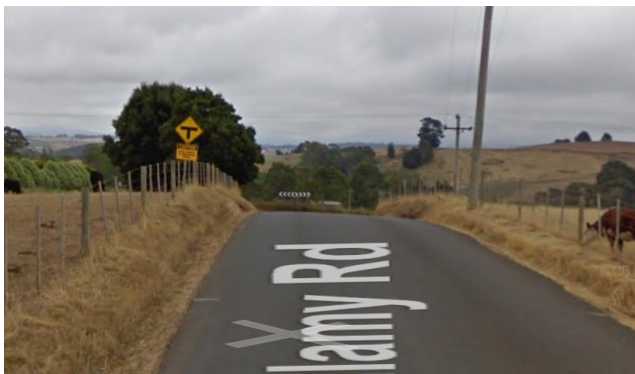
Two advanced T intersection hazard signs are provided for the west bound vehicles approaching this intersection. The bi directional hazard sight board is visible from about 100m from the intersection which is a little over the Safe Stopping Distance for a vehicle approaching the

intersection at 70km/hr. With the long straight on Bellamy Road east of the intersection it is feasible vehicles hit this crest at up to 100km/hr if the signage has not been heeded. **Consideration could be given towards raising the bidirectional hazard board a further meter on new posts to improve visibility as vehicles approach over the crest.**

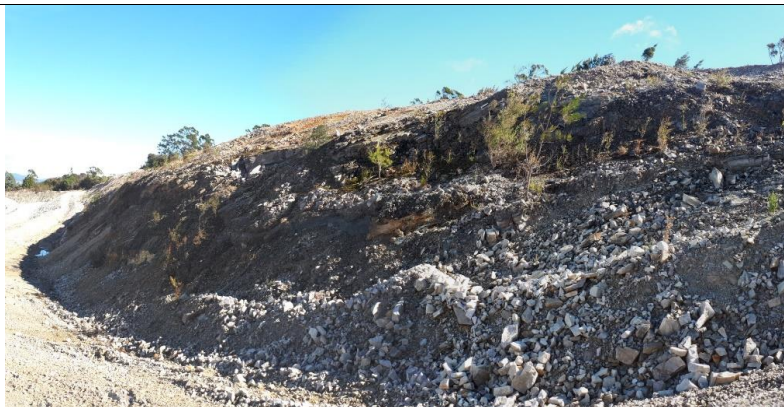
Figures 1 - 3. Native vegetation is colonising the banks within the active quarry area in three places. This is a high risk for continued presence of *P. cinnamomi*.

The scalping work at Forthside has been done very well. However, this hasn't been followed up by the required spraying with herbicide and fungicide (see figures 1 – 3). This is a required as part of the remediation plan to achieve a successful outcome.
