**Squibbs Road
Drainage Improvements,
Spreyton Tasmania**

**Preliminary Documentation
(EPBC: 2017/7956)**

PROJECT TITLE	Sheffield Road – Road Safety and Flood Mitigation Upgrade
ORGANISATION	Devonport City Council (DCC)
PROJECT MANAGER	Mr Randell Stott, DCC
PROJECT REFERENCE	Squibbs Road – Drainage Improvements Preliminary Documentation (EPBC: 2017/7956)
REVISION STATUS	Revision 3.0
DATE:	12 August 2019
PREPARED BY: Signature:	DCC with the assistance of Van Diemen Consulting Pty Ltd

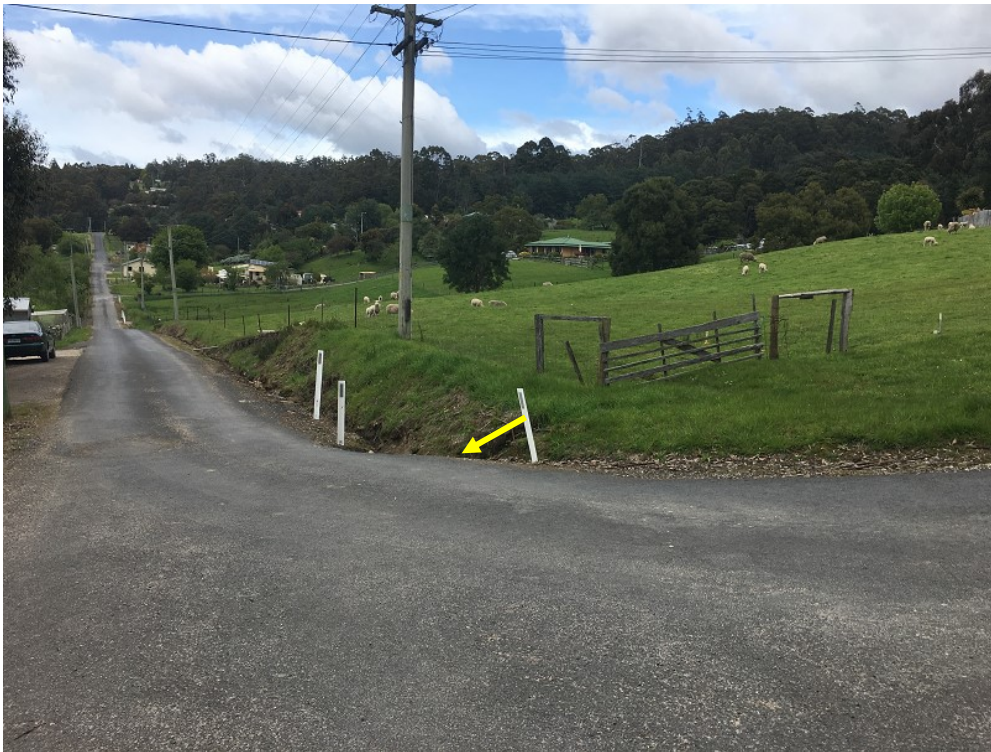
Squibbs Road looking southwards from its corner that leads uphill towards Kelcey Tier. The existing drain (arrow) can be seen on the topside of the roadline.

Plate 1 contains images that show the condition of the existing roadside drain and some of the damage that flooding has caused to the drain and associated road surface.

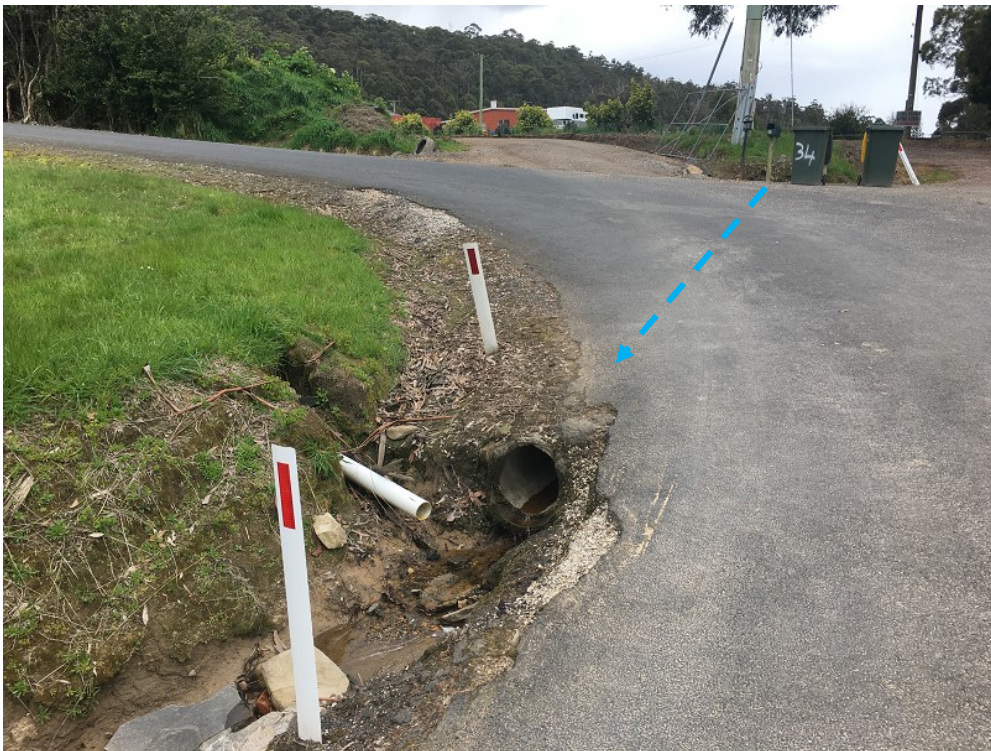
Squibbs Road looking northwards from its corner which leads uphill towards Kelcey Tier. Water flows into the drainage channel are by surface flows and water directed to it by a culvert underneath the road surface. The blue dashed line shows the approximate location of the under-road culvert.

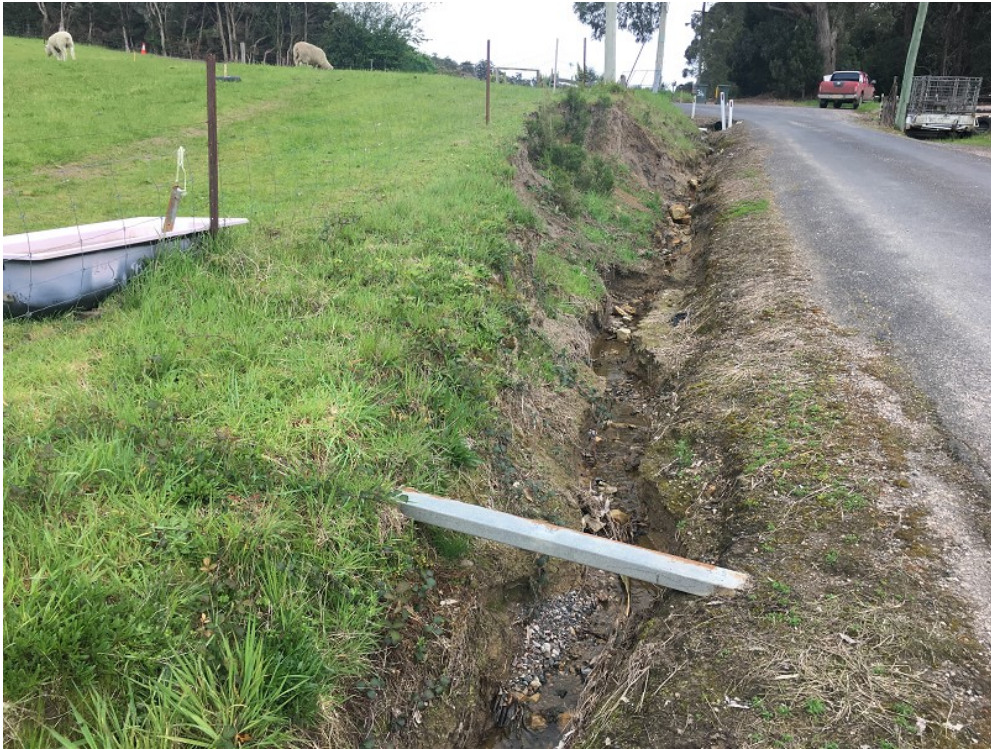
The drainage channel alongside Squibbs Road is scoured.

The drainage channel is scoured and, in many locations, eroded to bedrock. The channel is so deep in some sections that the road surface has been under-cut and is now at risk of collapsing into the drain. The depth of the drain is also unsafe if any driver was to leave the road and enter it – a situation that is possible given the narrow width of the road.

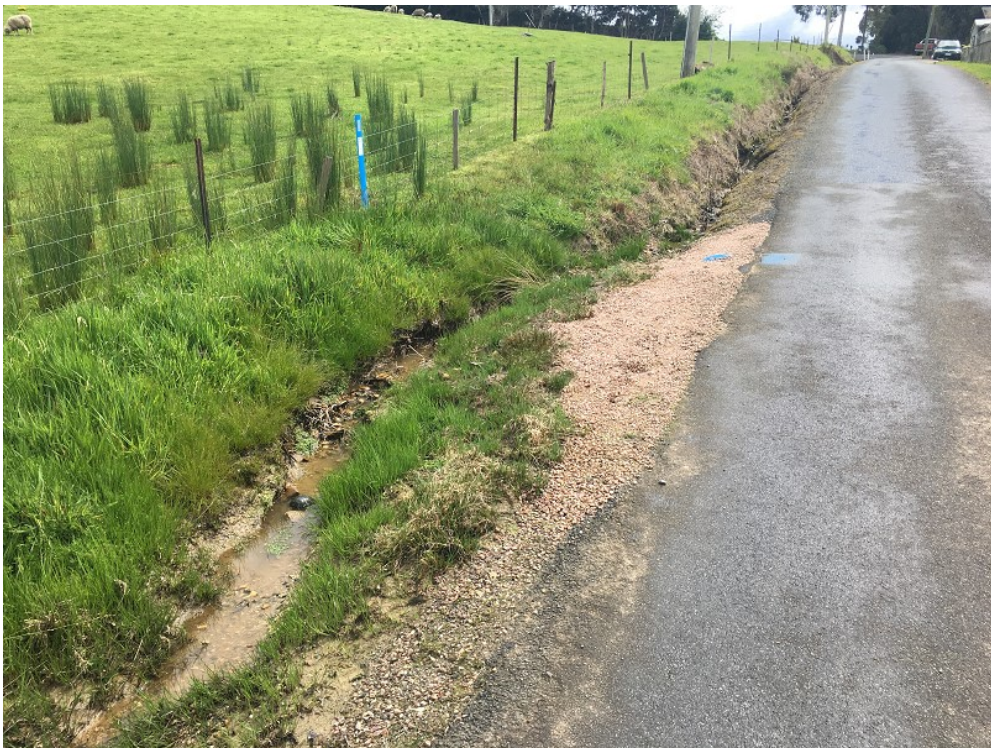
The area where water enters the under-road culvert is dominated by gravels and other sediments transported by flood waters.

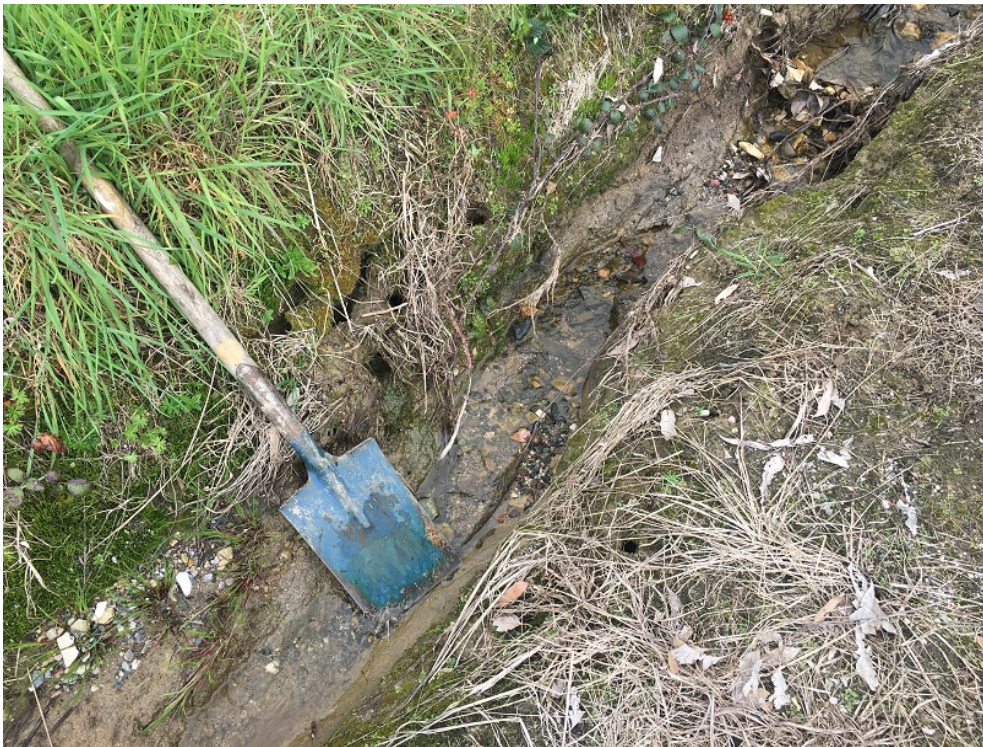
Burrows of CNBC were observed in a few locations in the drain alongside Squibbs Road. There were very few burrows located in the northern section of it due to the lack of sediments/clay for the species to excavate within. It appears that flooding has eroded the clay base of the drainage channel such that burrows have been destroyed.

Figure 7 shows the observed burrowing crayfish locations within and near the Work Area at the Impact Site. The type of burrows present, and their general form are shown in Plate 2.

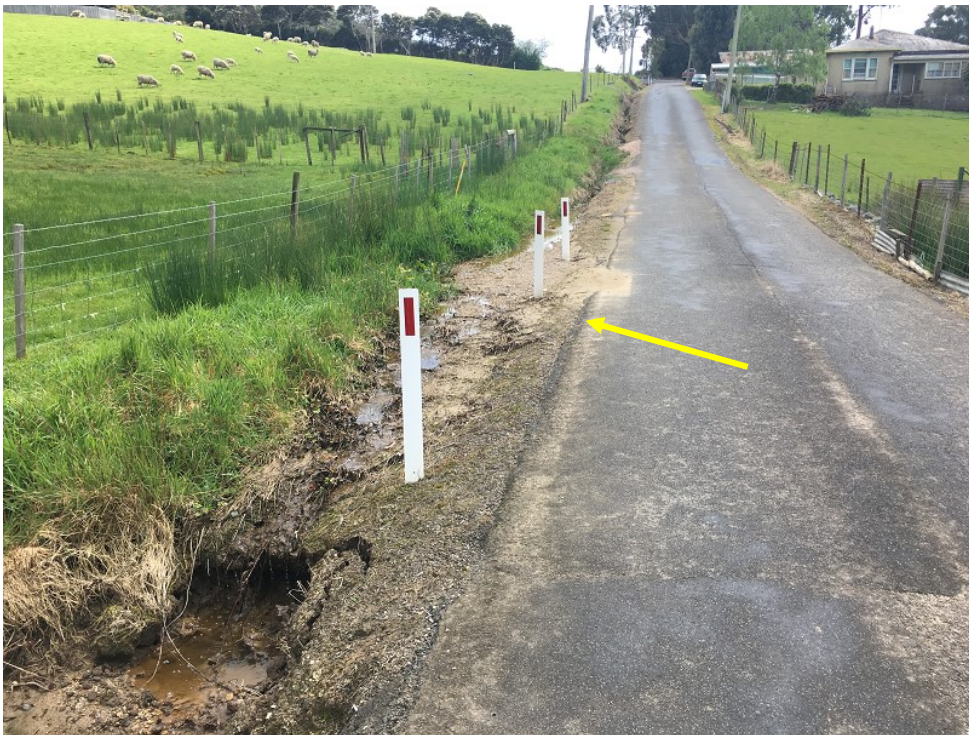
The northern section of the Work Area is a topographic high-point on Squibbs Road, with the low-point of the Work Area being at the southern end (arrow) where there is a large drainage channel on the eastern side of the road.

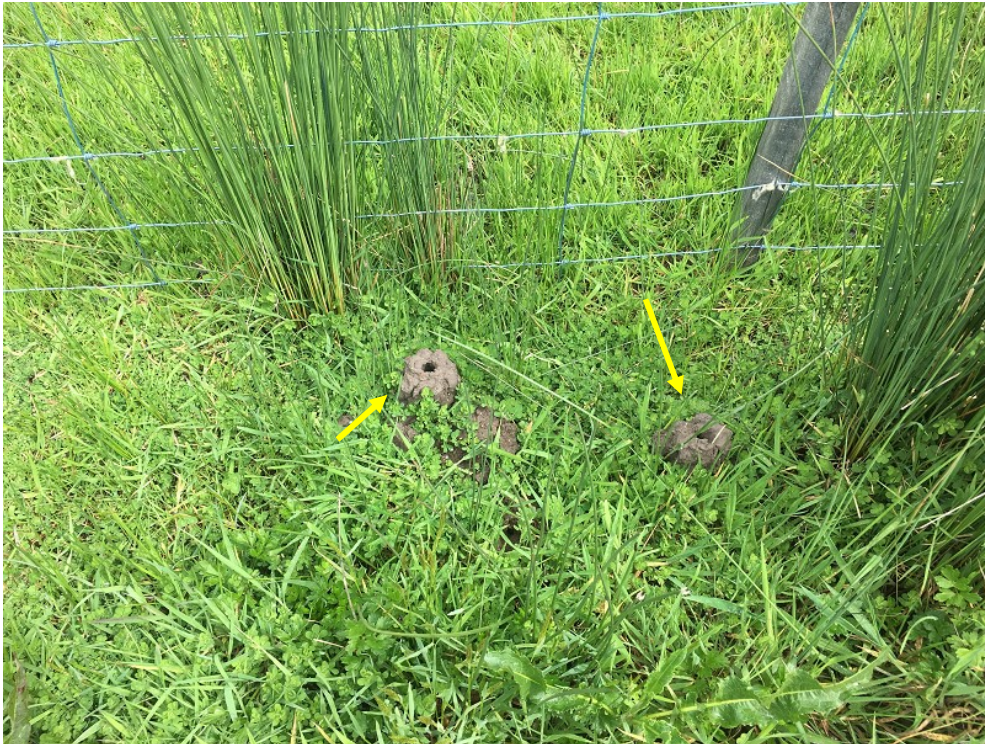
The pasture in the low point of the landscape supports numerous large chimneys (arrows) indicative of the CNBC.

The greatest density of burrows occurs at the lowest topographic location in the landscape where there is a major drainage point for the road and nearby pastures. Burrows were also observed on the eastern side of Squibbs Road (outside Works Area) where there is a large and deep drain which continues southwards towards the junction of Squibbs and Bishops Roads.
