# **CLAYTON DRIVE RESERVE, SPREYTON DEVONPORT CITY COUNCIL**

***ENGAEUS GRANULATUS* MONITORING PLAN  
JUNE 2017**

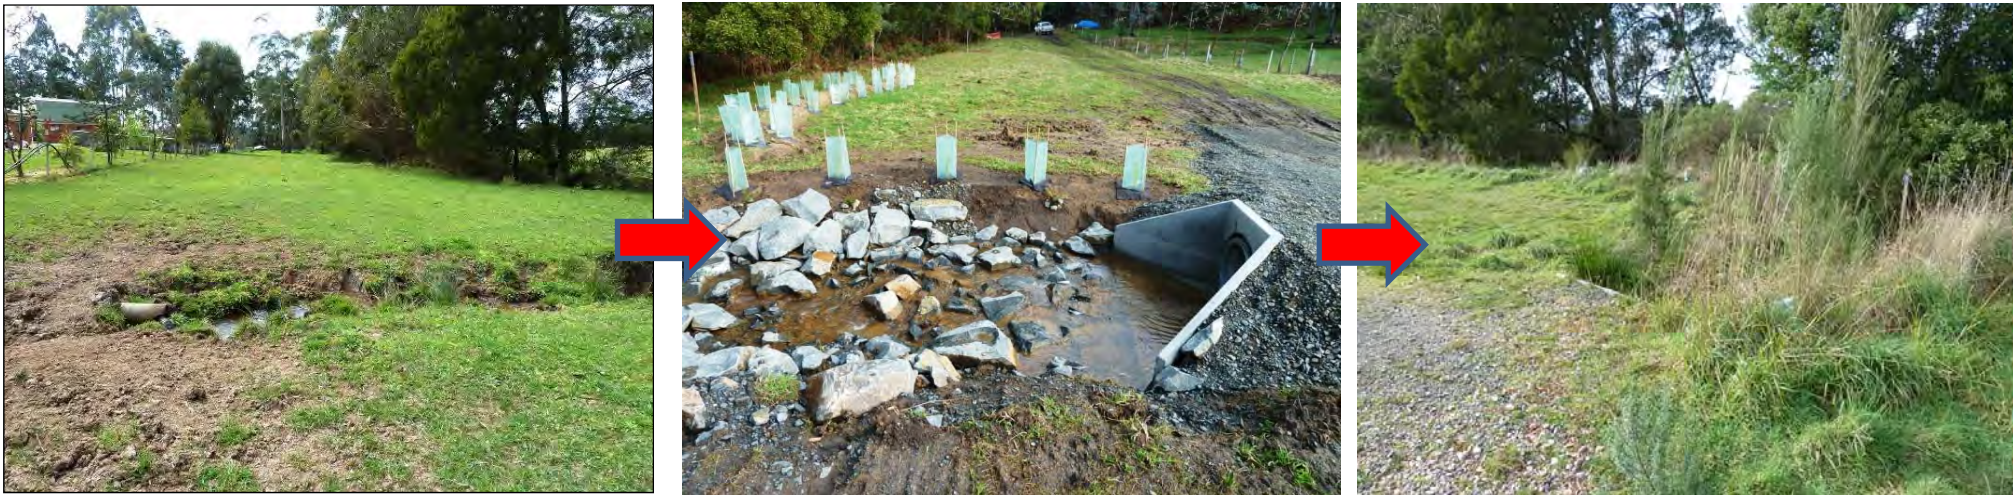
Translocation Area 1 Images from 2011, 2012, 2015 and 2016 (Works Areas 1 on Figure 2)

Adjoining creek with burrows – 14 May 2016

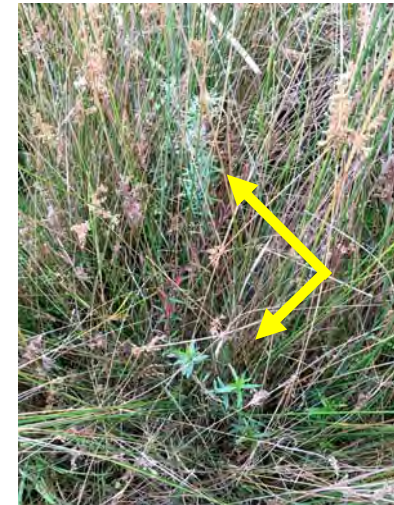
**Showy Willowherb in rehabilitated area – 2016 and 2017**

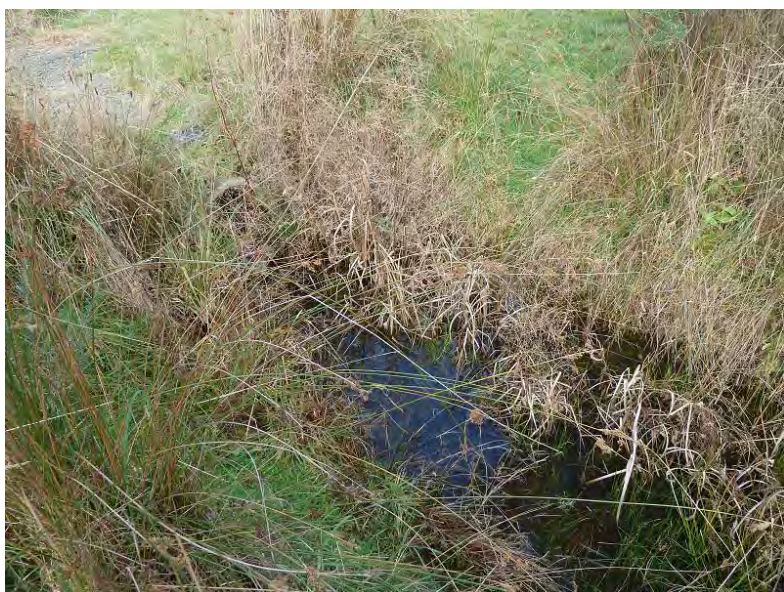
Erosion has virtually ceased in the main channel and associated pooling areas as a grass and herb cover has formed which stabilises the surface over which water is flowing. Those areas where grass has not been able to grow are relatively flat and areas where water ponds, enabling sediment to drop out and accumulate – these areas in particular have accumulated silt which has enabled aquatic species to take root and grow, such as water milfoil (*Myriophyllum*).

Water is ponding in the deepest parts of the drainage system which supports aquatic species such as water milfoil (*Myriophyllum*)
