CLAYTON DRIVE RESERVE, SPREYTON DEVONPORT CITY COUNCIL

***ENGAEUS GRANULATUS* MONITORING PLAN JULY 2018**

CLAYTON DRIVE RESERVE - MONITORING REPORT 2018

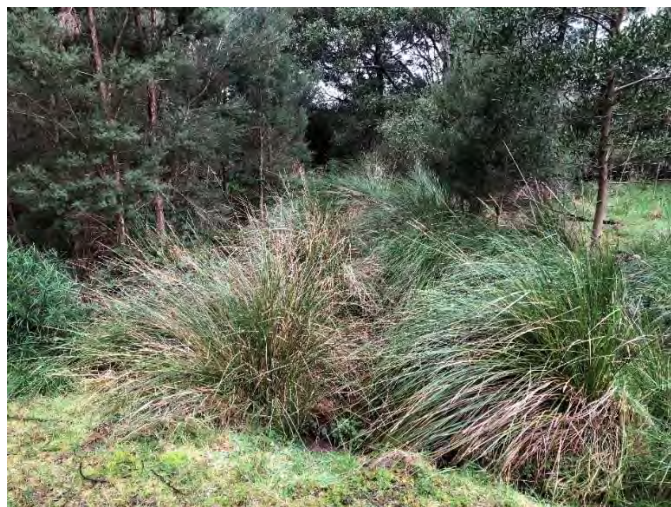
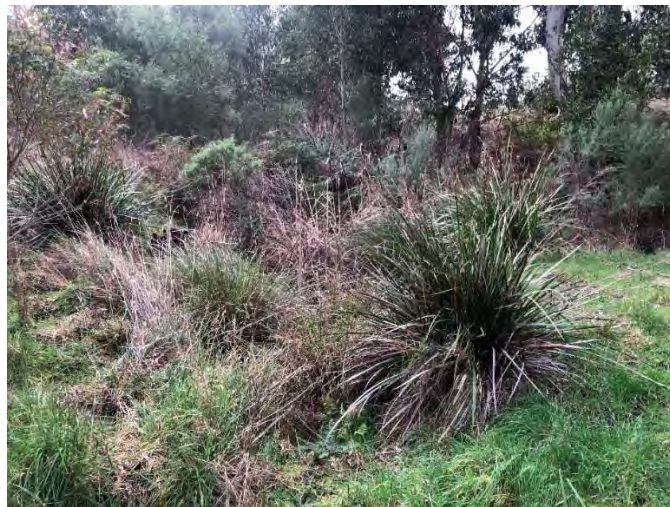
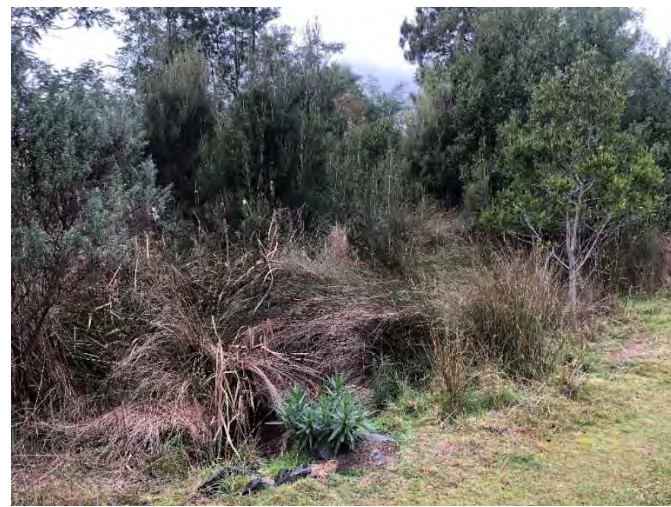
Post-works – 3 July 2018

New Habitat Areas in May 2016 (see Figure 4)

The southern-most damp area within the reserve was observed in May 2016 to have been colonised by *Engaeus* species. Six burrows were observed in May 2016.

The two areas identified in May 2016 as now containing *Engaeus* (see Figure 4) should be physically identified on-ground (eg using wooden stakes with blue tape, comparable to other areas identified in this way) and be left undisturbed from mechanical activities including slashing, mowing etc. These areas could (optional) be planted with sedges and sagg to encourage further colonisation by *Engaeus*.

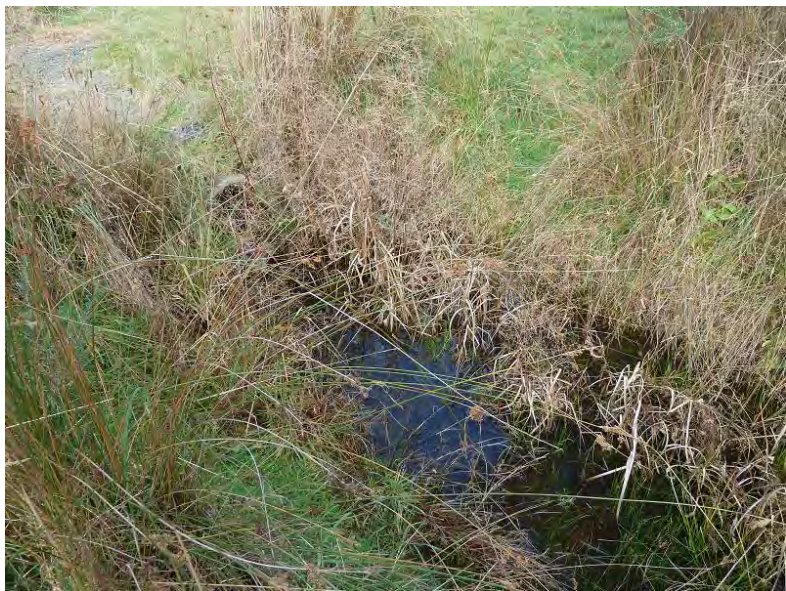
Erosion has virtually ceased in the main channel and associated pooling areas as a grass and herb cover has formed which stabilises the surface over which water is flowing. Those areas where grass has not been able to grow are relatively flat and areas where water ponds, enabling sediment to drop out and accumulate – these areas have accumulated silt which has enabled aquatic species to take root and grow, such as water milfoil (*Myriophyllum*).

Water is ponding in the deepest parts of the drainage system which supports aquatic species such as water milfoil (*Myriophyllum*)

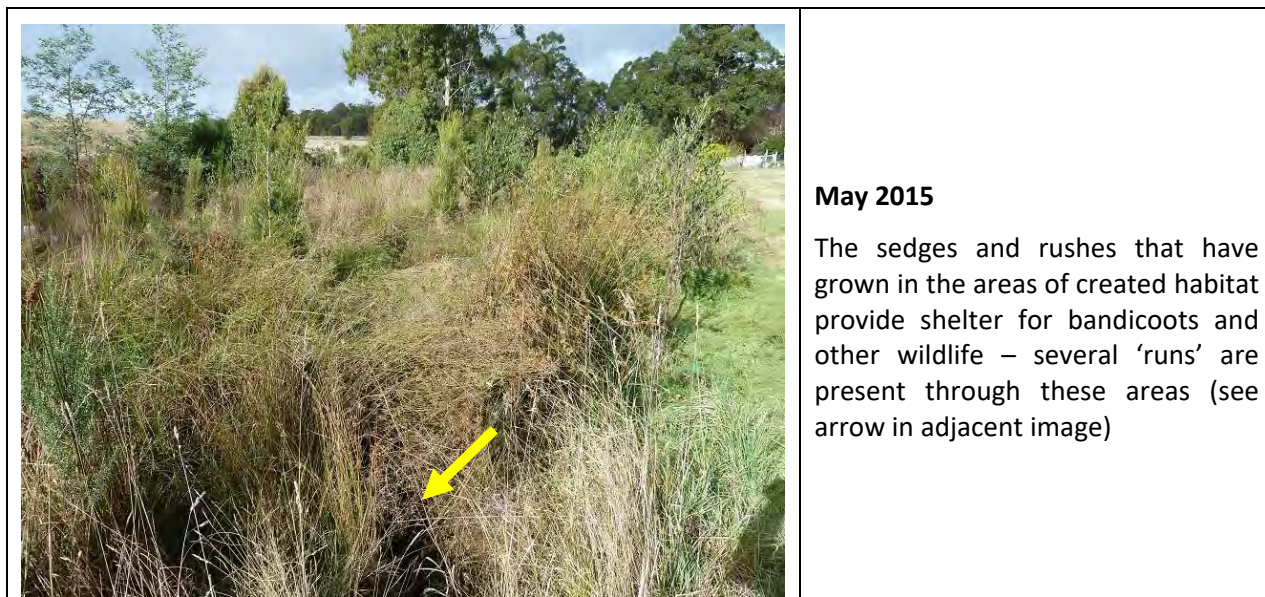
Numerous bandicoot diggings were observed in the reserve in May 2015, May 2016, June 2017 and July 2018, especially in the mown grass areas and moss on slightly elevated areas of the reserve. Diggings were also observed for the first time in July 2018 in areas where trees had been planted and a leaf litter layer had partially formed.

Numerous animal 'runs' were observed through the sedge – rush dominated areas of the created habitat in May 2015, May 2016 and June 2017 – demonstrating that there are native animals in the area.
